Chapter 3 – Signal and Telecommunication

Performance efficiency of Signalling assets – Indian Railways**Executive Summary**

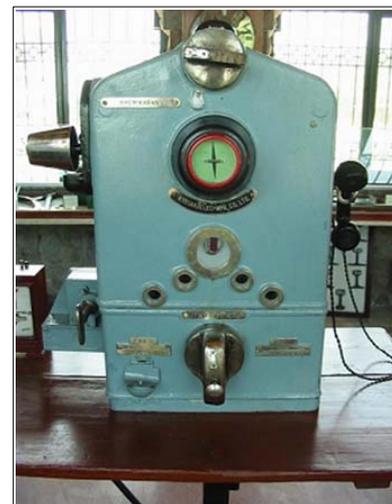
Block instrument

- Equipment failure had been declining during the period (except in 2009-10) in IR. However, it showed an increasing trend in CR.
- Failure due to lamp fusing generally showed an increasing trend (except in 2009-10) despite replacement of filament lamps in signals by LEDs (Light Emitting Diodes).
- Cable failure was on an increasing trend in NCR, SR, and WCR. The total cable failure in IR increased from 4638 (2008-09) to 5890 (2011-12).
- Majority of relay failures (6062 out of 6504) during 2010-11 and 2011-12 (5719 out of 6319) were on account of high resistance in metal to carbon contacts in relays (excluding CR, ECR, SER, SWR, WR).
- Failures on account of bad maintenance of equipment were much higher in 2010-11 and 2011-12 compared to earlier years.
- Block Instrument failure was the single largest cause of signal failure.

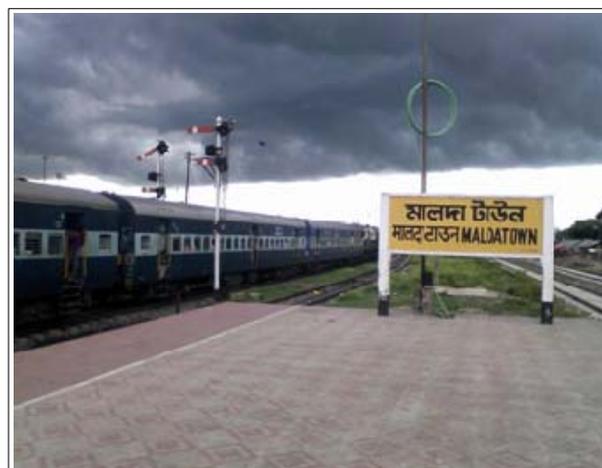
Semaphore signal at Malda Town (ER)

Audit reviewed the progress and observed that 26 sections across the Zonal Railways where utilization was more than 100 per cent of line capacity across the Zonal Railways did not have signalling equipment of similar standard. Existence of equipment with dissimilar standard has safety implications.

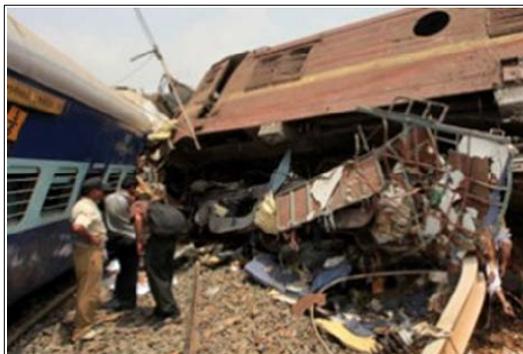
Accident involving Gyaneswary Express in 2010-11 (SER)

signalling technology and equipment and efficiency in maintenance. Audit observed that as a result of the various safety works executed under SRSF, the average number of collisions per annum had come down from 22.5 during 1998-99 to 2001-02 to 8.25 during 2008-09 to 2011-12. However, during 2008-09 to 2011-12, out of 587 consequential accidents, 33 were due to collision. Analysis of the inquiry reports in 27 cases revealed that human error of judgment and non-observance of the rules was cited as the major cause.

It was thus evident that in order to realize a collision-free system, the Indian Railways would have to expedite completion of up-gradation of signalling technology that would significantly reduce human intervention, upgrade preventive maintenance and human resource skills.
