Chapter 1

FIRE ACCIDENTS IN PASSENGER COACHES IN INDIAN RAILWAYS

1.1 Executive Summary

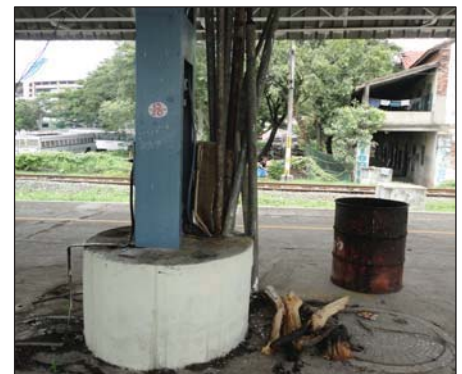
Remains of half burned fire wood at Chennai Central (SR)

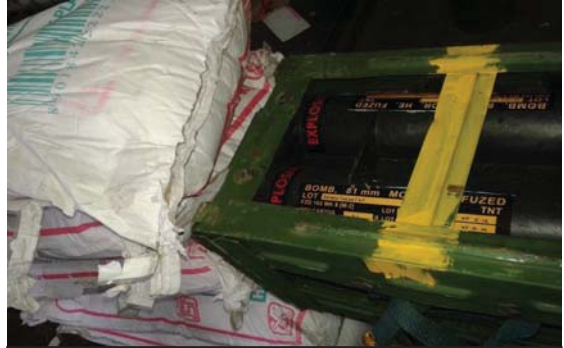
9	Explosives(Defence Dept.) kept in open area along with other luggage	Pune station platform (CR)

Explosives along with other luggage at Pune (CR)

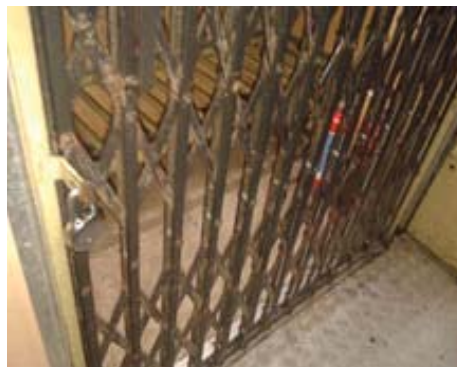
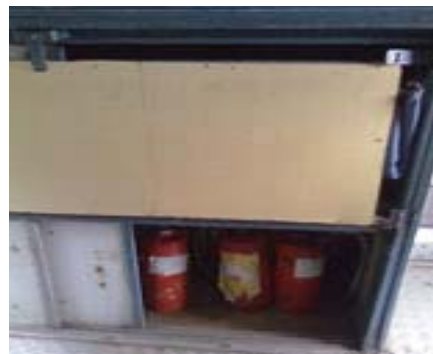
Fire extinguishers in locked condition in 2A-Train No. 22639(SR) and kept in Linen cabinet under the Caretaker's berth in 3A-Goa express (SWR)

- Audit noticed that the fire extinguishers were placed under the seats, on the floor and inside the locked linen cabins. In SLRs, fire extinguishers were kept in a closed cupboard with one time use pad lock. In some SLRs, instead of pad locks, the doors were tied with threads which cannot be opened easily. Hence, during emergency these fire extinguishers could not be easily accessed.

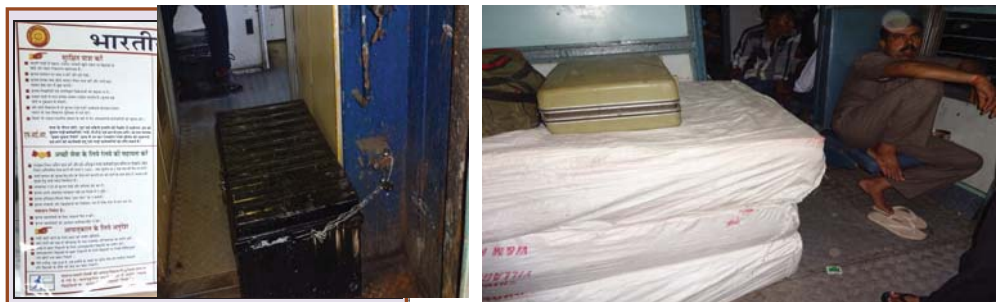
Fire safety stickers pasted in trains

Vestibule area in coach No.05106(3A)- Train No.15960 and SL coach No.14202- Train No. 12506 on 29/07/2014(NFR)
