REPORT OF THE COMPTROLLER AND AUDITOR GENERAL OF INDIA

PERFORMANCE AUDIT OF MANAGEMENT OF STORM WATER IN BENGALURU URBAN AREA

GOVERNMENT OF KARNATAKA
REPORT NO. 2 OF THE YEAR 2021

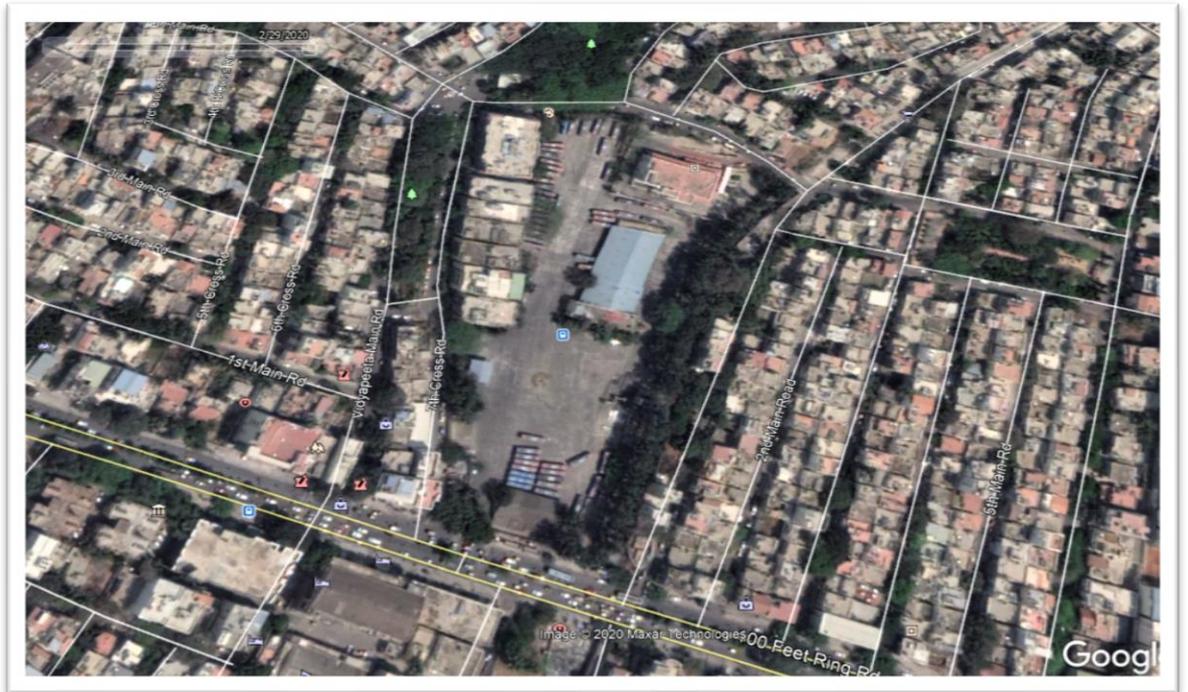
Chennamma kere

It could be observed that while 66 lakes were yet to be developed, 18 lakes with a total area of 254 acres and 17 guntas were reported as disused lakes. The current status of the disused lakes as per the Google Earth images is shown in **Exhibit 3.2** and the list of disused lakes is given in **Appendix 3.2**. There is a significant risk of these lakes being vulnerable to encroachments and future conversions.

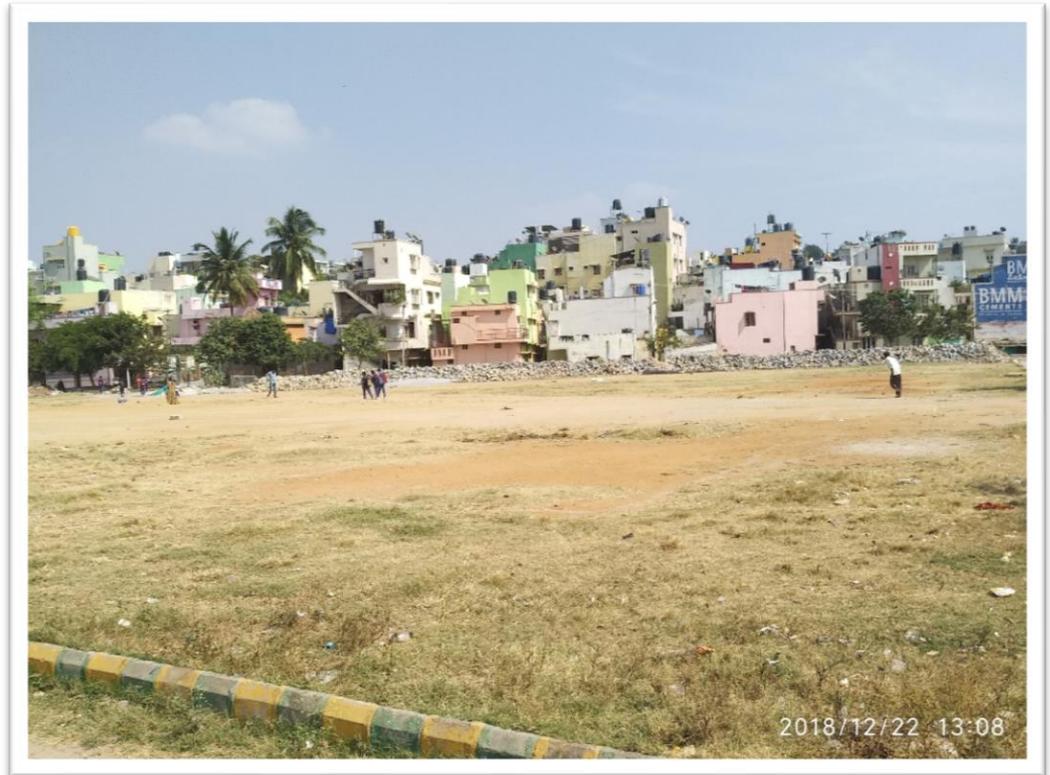
Kamakshipalya lake converted as sports ground

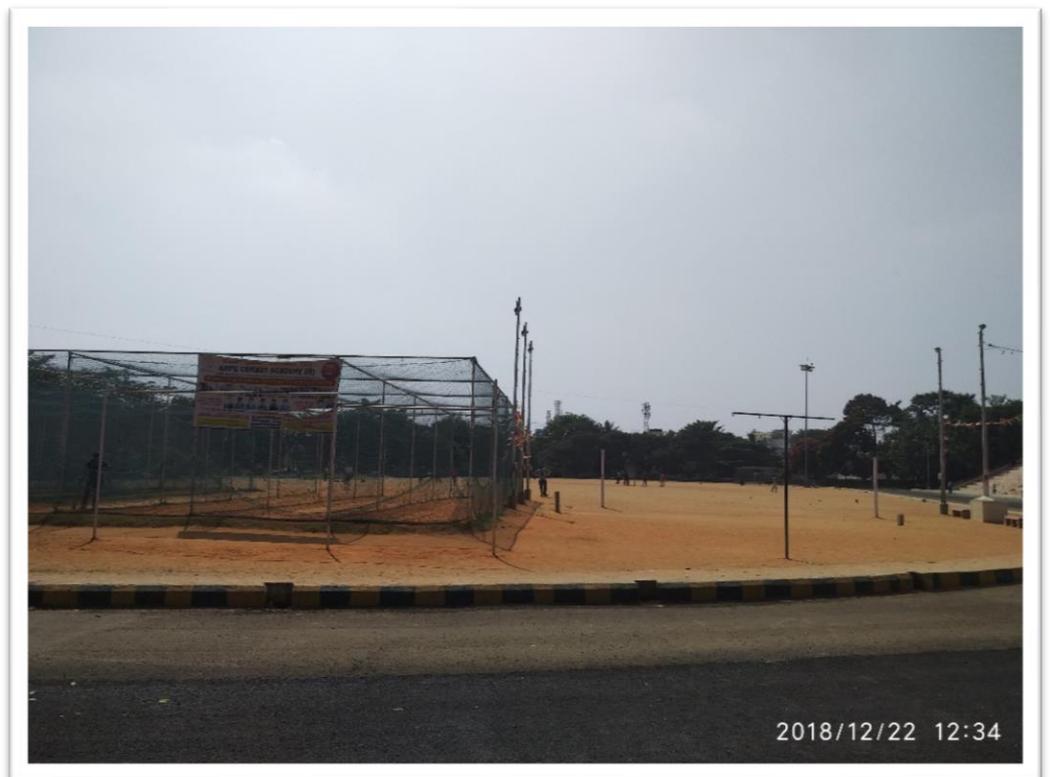
Dasarahalli tank converted as Dr. B.R. Ambedkar Stadium

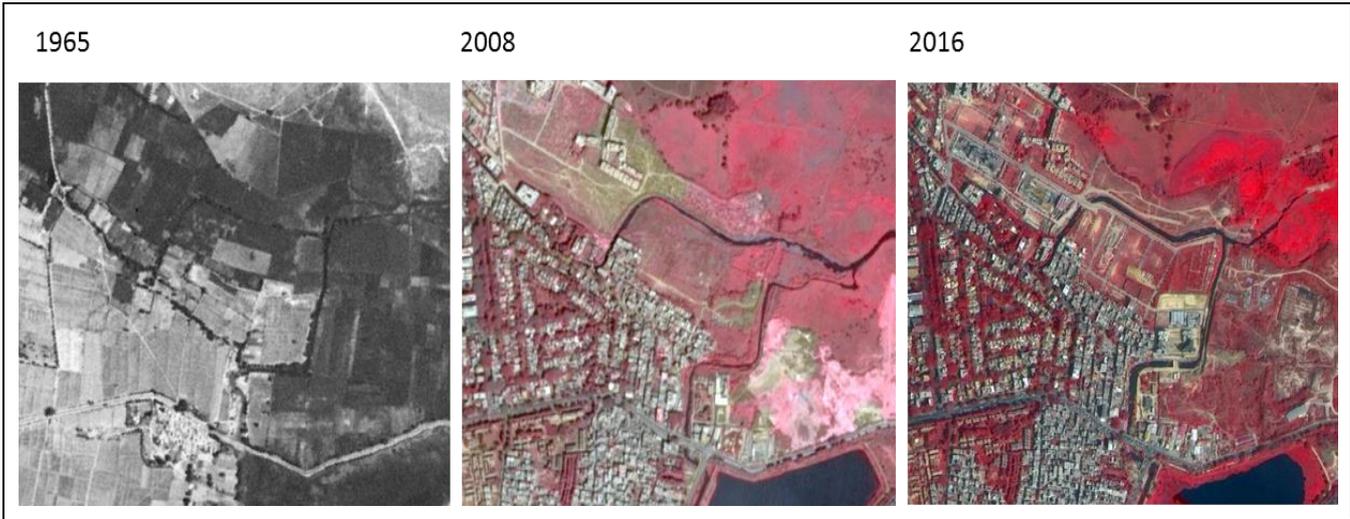
Exhibit 3.4: Realignment and remodelling of drainage network near Bellandur Lake

The spatial analysis also showed significant changes in the alignment of drains mainly due to remodelling. For example, in Koramangala valley, the length of two drains which merge before entering into Bellandur Lake was reduced from 338 m to 136 m (**Exhibit 3.4**) between the years 2008 and 2016 which allowed constructions thereby affecting the free flow of storm water. In Vrishabhavathi valley, the drain passing along the border of Hosakerehalli lake was remodeled and diverted to flow through the lake thereby reducing the area of the lake (**Exhibit 3.5**).

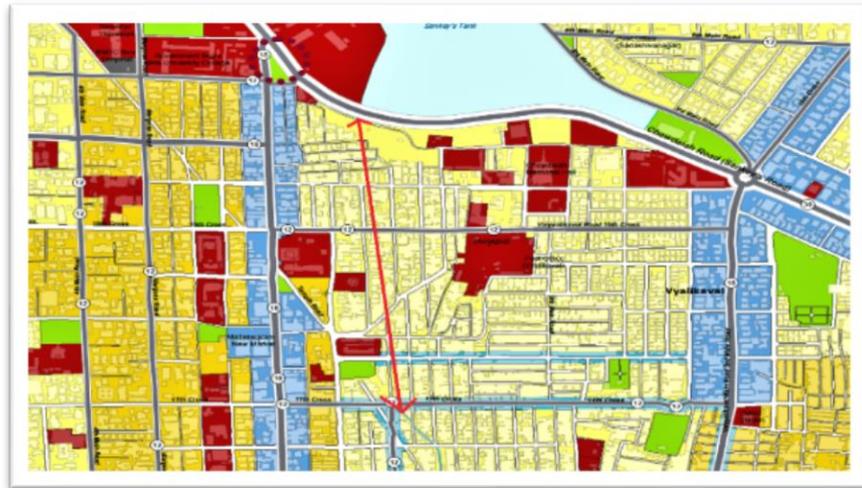
The existing outlet drain (shown in red arrow) from Sankey tank not mapped either in Master Plan of SWDs or RMP-2015

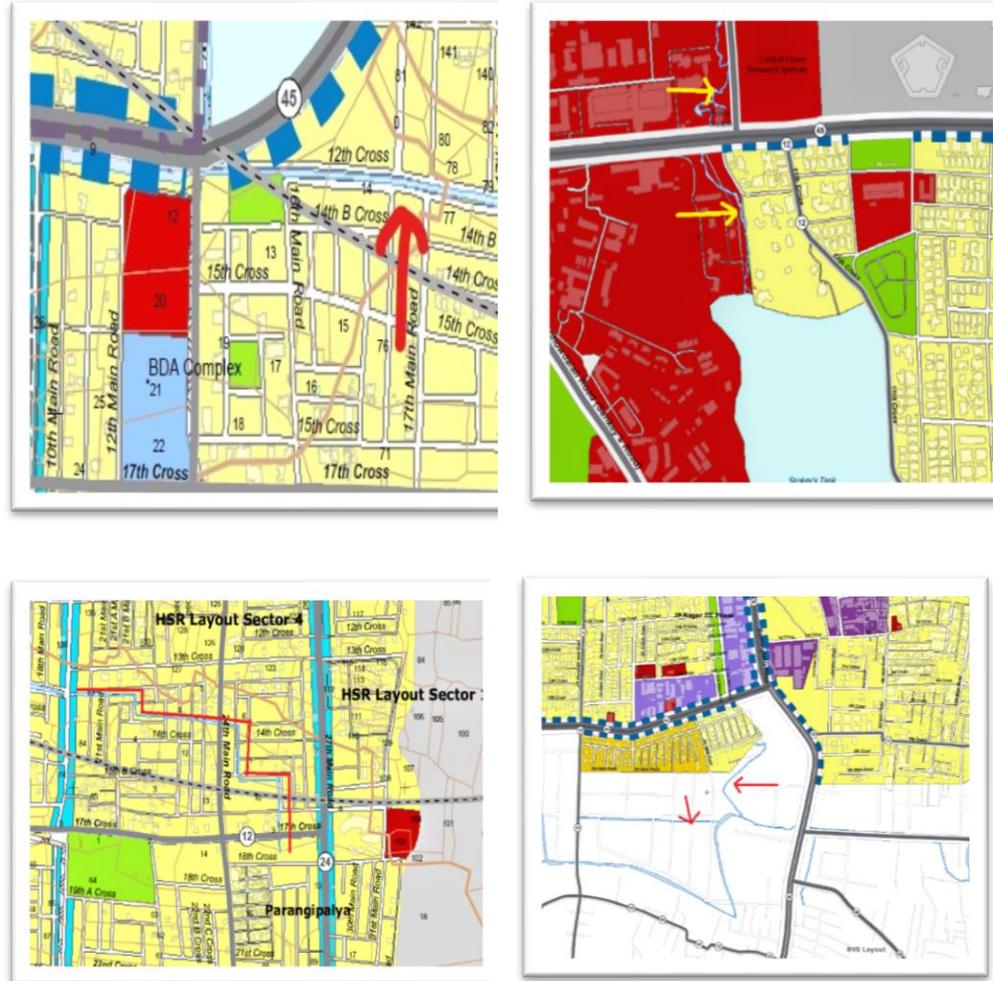
Exhibit 4.3: Photographs showing drains identified in RMP-2015 but not exhibited in master plan of drains of BBMP (Arrows show stretches of missing drains)

- the master plan did not provide for buffer zones along the different kind of drains, despite being clearly spelt out in RMP-2015, which was in force.

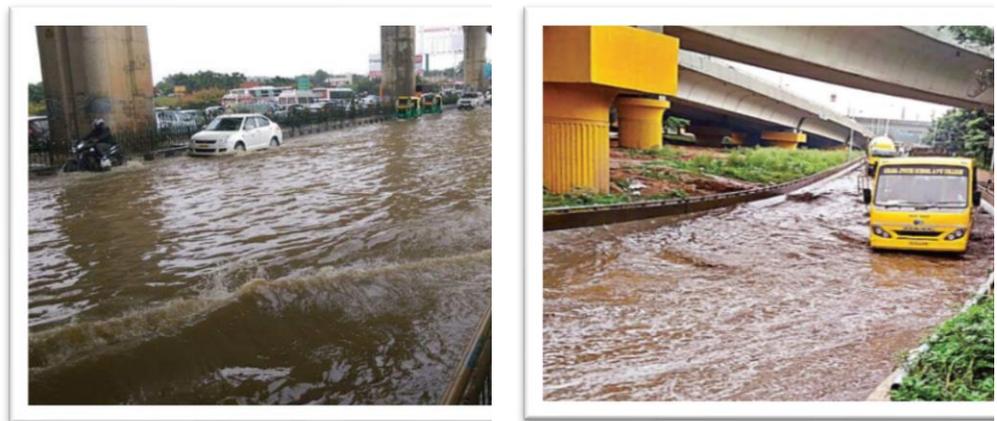
Exhibit 4.6: Photograph showing flooding under flyovers

Further as per Paragraph 4.13.2.1 of NDM guidelines, road and rail bridges in cities crossing drains should be designed such that they do not block the flows resulting in backwater effect due to the fact that the piers of roads and railway bridges located in major storm water drains are known to cause backwater effects as much as 1 m high and as far away as 5 km upstream thereby resulting in flooding of the upstream catchments.

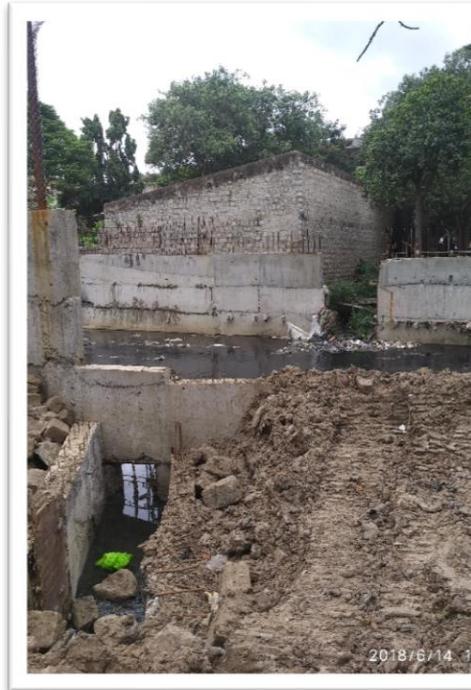
Bommanahalli zone

Exhibit 4.9: Photographs showing unscientific construction of roads/drains – absence of proper linkage

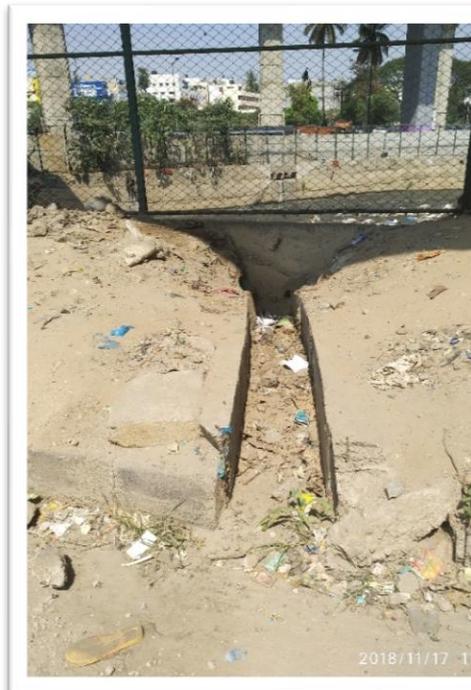
South zone

Drains without connectivity

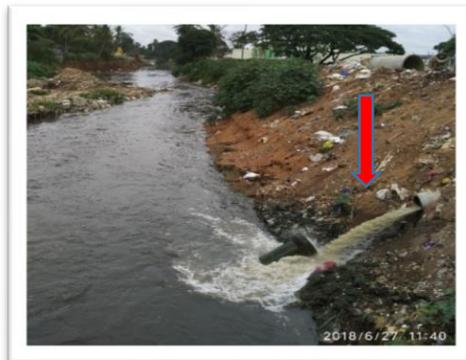
Direct discharge of sewage into SWD at Pattanagere, RR Nagar Zone

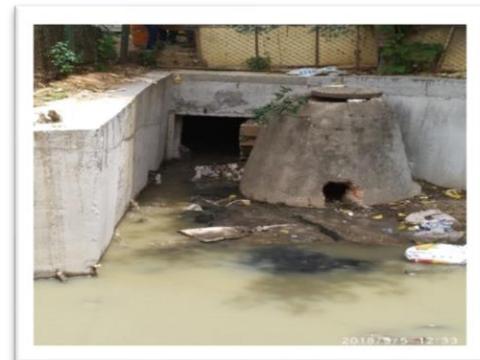
Discharge of sewage into SWD through fractured manhole at Seshadripuram, West Zone

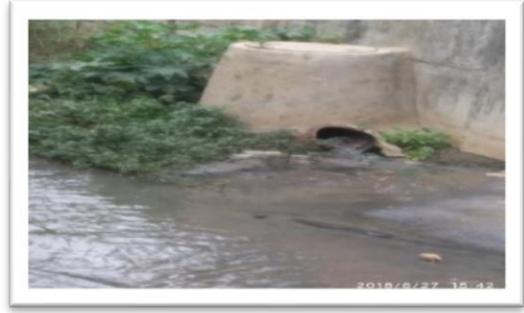
Discharge of sewage into SWD through fractured manhole at Yeshwanthpur, RR Nagar Zone

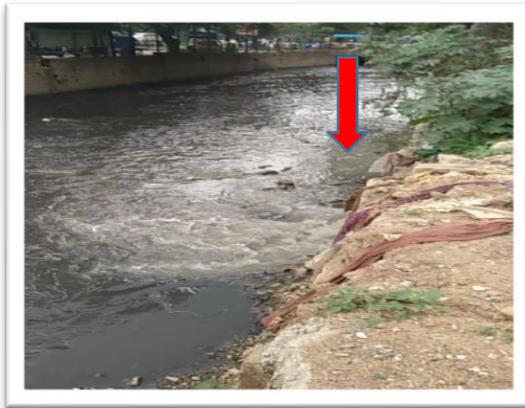
Discharge of sewage into SWD through BWSSB pipeline at Silk Board Junction, Bommanahalli Zone

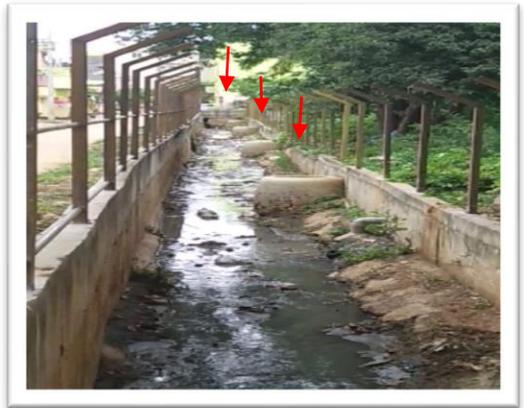
Sewage flowing in the SWDs due to chain of fractured manholes in the drain connecting to Herohalli Lake, Dasarahalli Zone

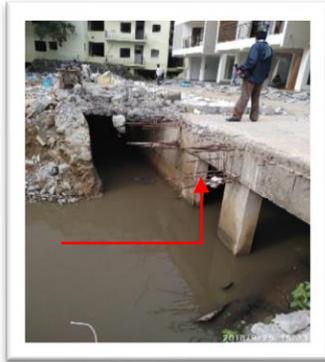
*Himagiri Meadows Apartments,
Bommanahalli Zone*

Exhibit 5.4: Photographs showing the encroachments on SWDs

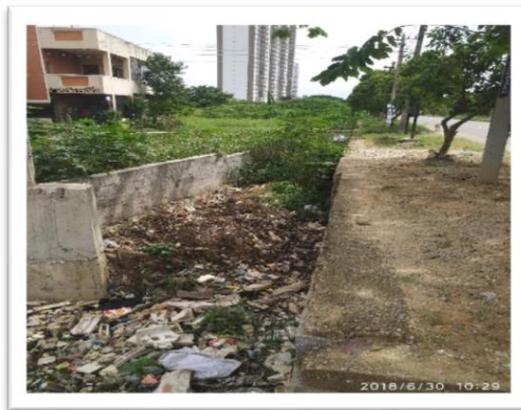
Near Hulimavu lake, Bommanahalli Zone

Exhibit 5.8: Photographs showing the blockage of drains

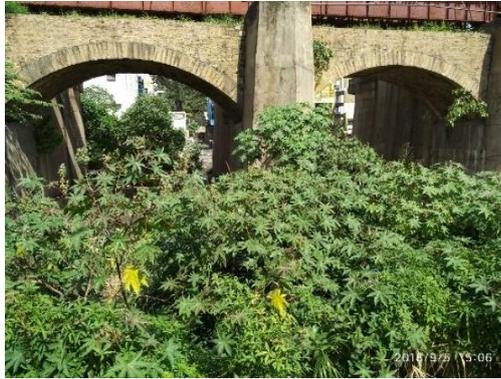
Vegetation inside SWD at Magadi Road Railway Bridge, West Zone

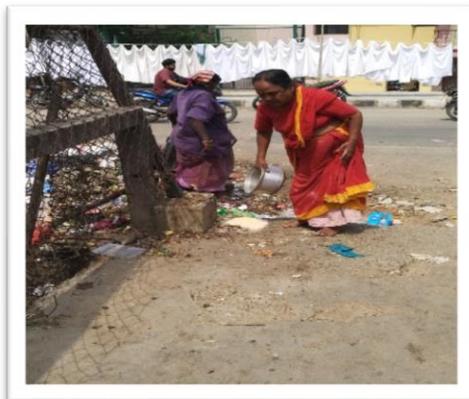
Austin Town, Koramangala Zone

Exhibit 5.10: Photos showing dumping of debris/wastes in/adjacent to SWDs and breakage of chain link fence of SWDs

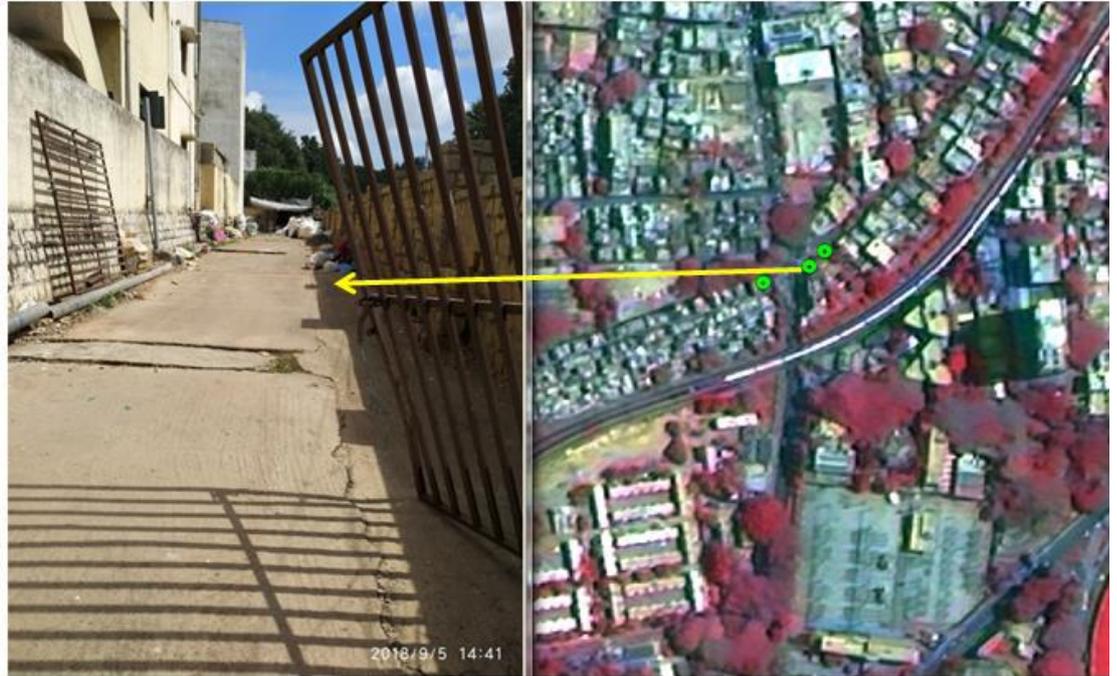
Covered drain in Sheshadripuram

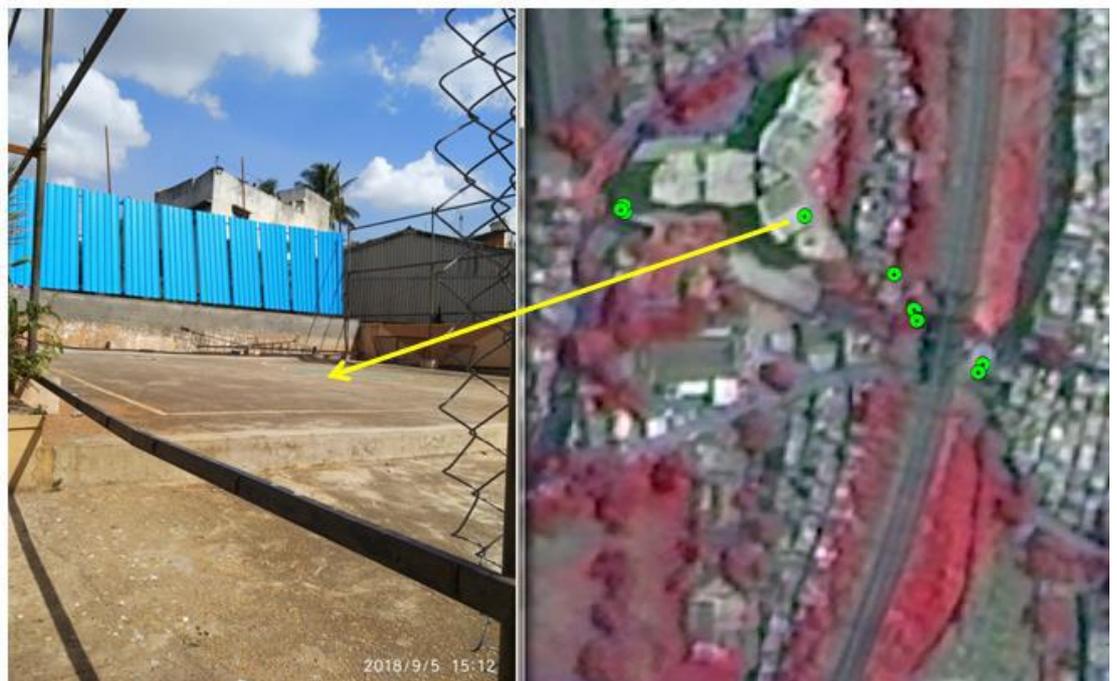
Drain encroached and covered by an apartment

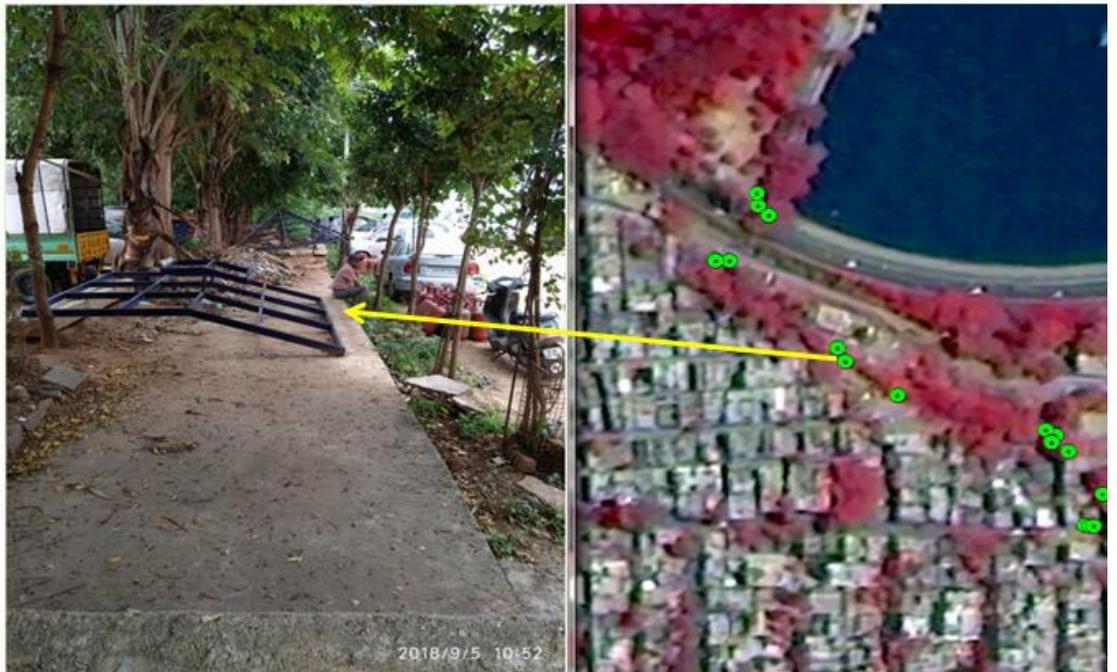
Covered drain adjacent to Sankey tank

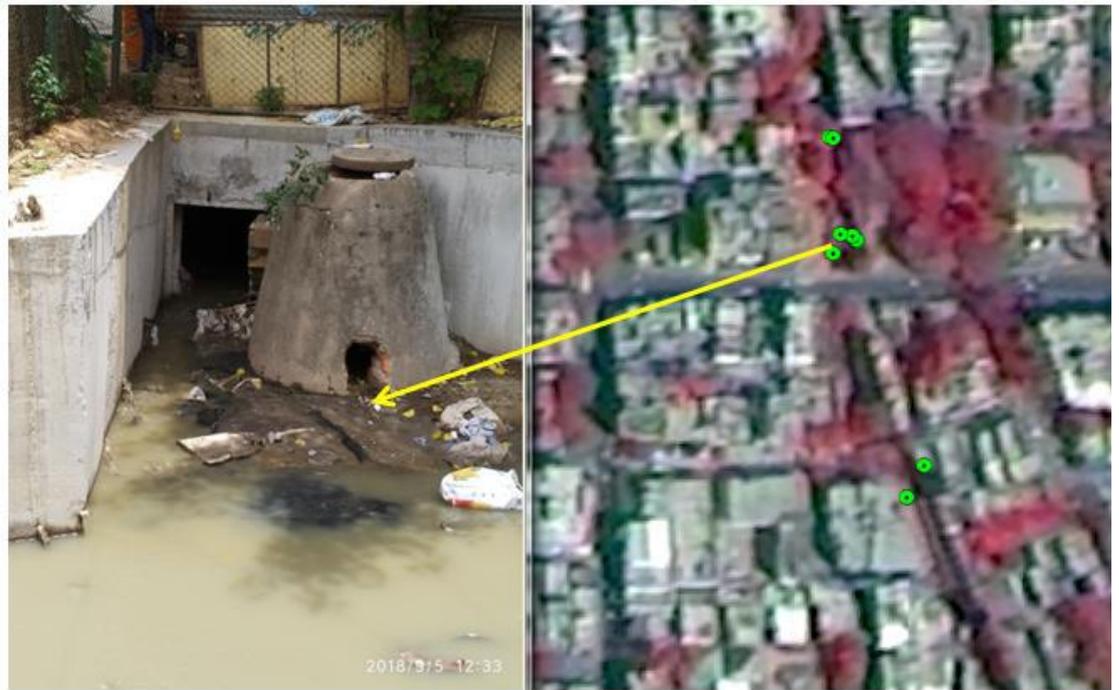
Discharge of sewage into SWD through fractured manhole

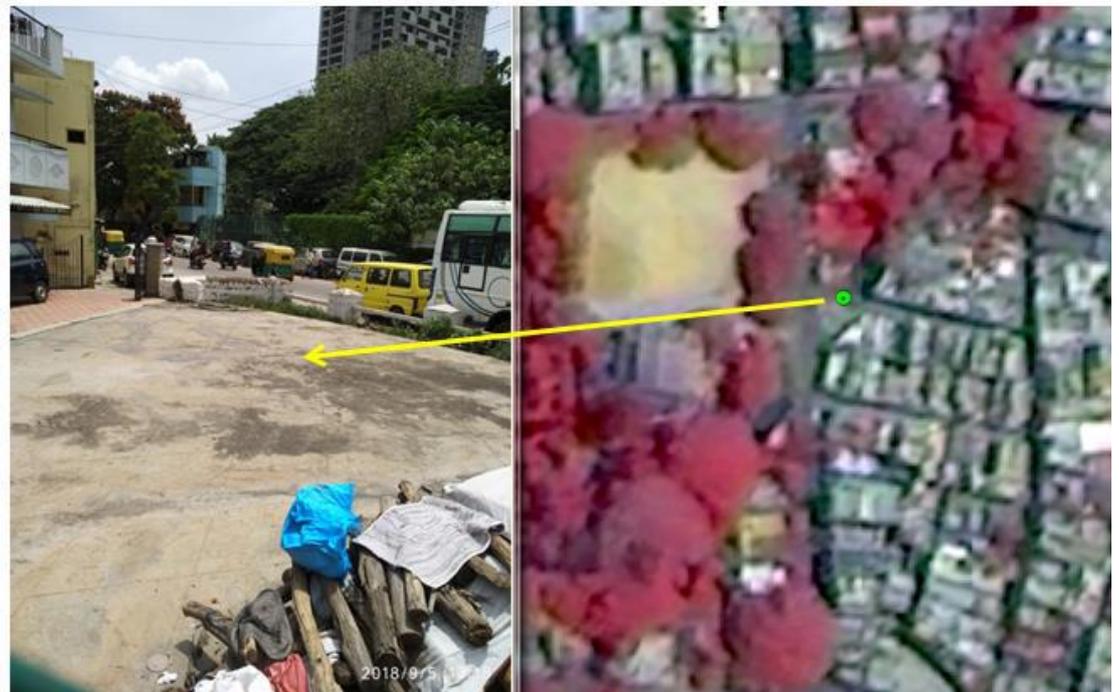
Covered drain
