5 Chapter

Protection and maintenance of storm water management systems

5.1 Protection of storm water drains

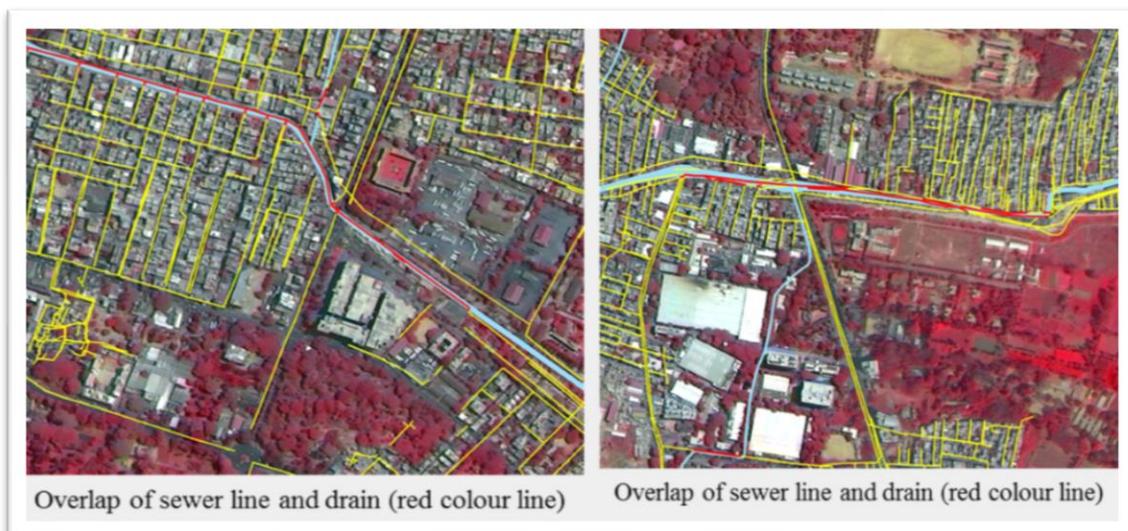
The study conducted by Audit with RRSC to analyse the time series land use changes and status of drains (as mentioned in Paragraph 2.4) revealed intersection or overlapping areas between drains and sewer lines that were the likely areas/ zones of possible intermixing of rain water and sewage, a few of which were validated by field visits. The sewer line layer obtained from BWSSB was overlaid on drainage maps and the intersection of the two layers was extracted to identify the overlapping areas. Audit observed that there were continuous stretches where the drains and sewer lines intersect/overlap each other. The total length of such stretches was about 16.0 km with about 728 points of intersection in Koramangala valley and about 28.09 km with about 342 points of intersection in Vrishabhavathi valley. Typical example of overlapping of drains and sewer lines is depicted in **Exhibit 5.1**.

Overlap of sewer line (yellow colour) and drain (blue colour)

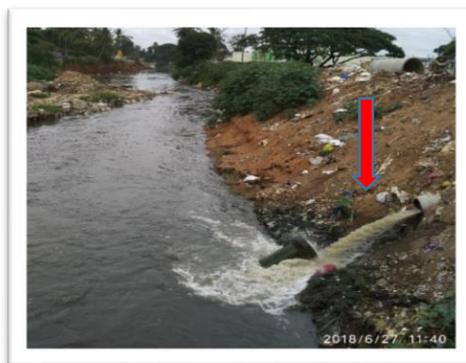
The joint inspection of drains confirmed the existence of sewerage lines within SWDs. Further, audit noticed sewage being discharged into the SWDs directly or through fractured manholes at many places (**Exhibit 5.2**). This can be attributed to the absence of regular inspections by BBMP as indicated in Paragraph 5.2.1. Consequently, none of the SWDs were dry irrespective of the rainfall.

Direct discharge of sewage into SWD at Pattanagere, RR Nagar Zone

Recommendation 16: BBMP should accord high priority to prevent discharge of sewage into SWDs. There is a need to prepare and execute (i) medium term strategy for complete cessation of sewage contamination of storm water and lakes eventually and (ii) a short-term strategy for installation of sewage treatment plants in coordination with BWSSB to prevent contamination of water bodies.

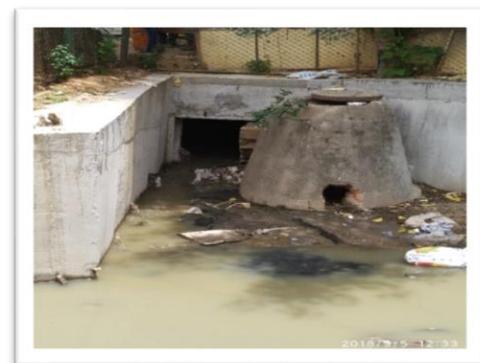
Discharge of sewage into SWD through fractured manhole at Seshadripuram, West Zone

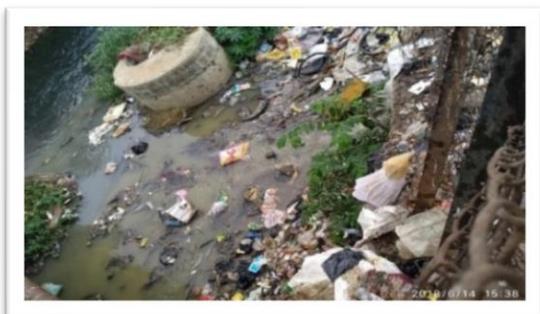
Sewage flowing in SWD at Ejipura, Koramangala Zone

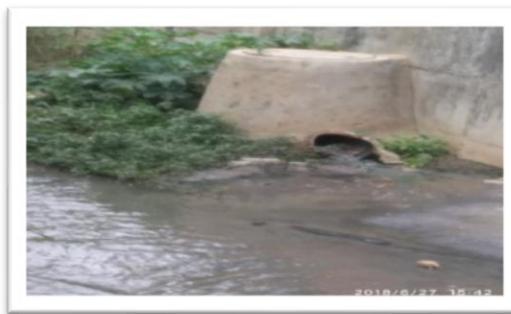
Discharge of sewage into SWD through fractured manhole at Yeshwanthpur, RR Nagar Zone

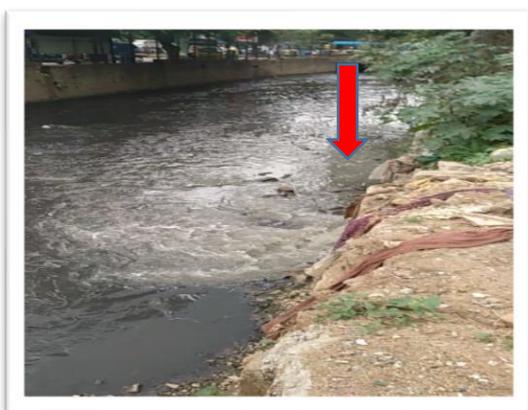
Discharge of sewage into SWD through BWSSB pipeline at Silk Board Junction, Bommanahalli Zone

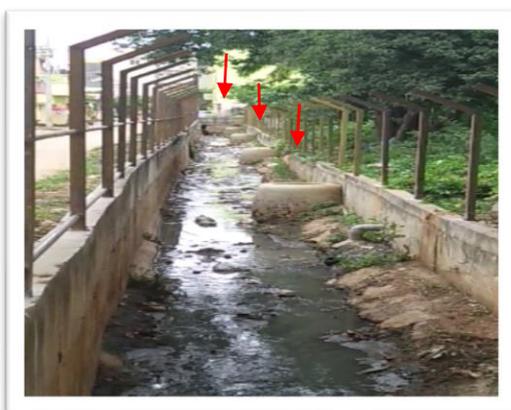
Sewage flowing in the SWDs due to chain of fractured manholes in the drain connecting to Herohalli Lake, Dasarahalli Zone

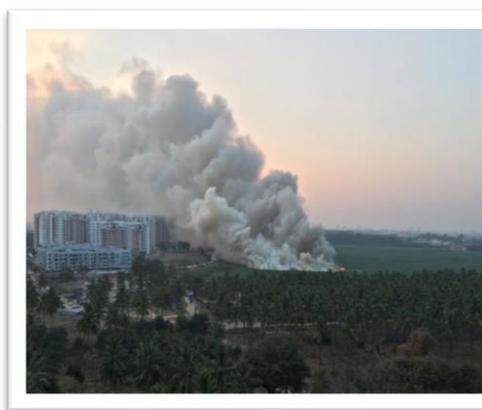
Despite being aware that the drains were connected to water bodies and the runoff gets ultimately discharged into rivers which would be used for human consumption downstream, BBMP had not taken any action to either involve the Pollution Control Board in getting the water samples tested at different stretches, to maintain the quality of water or arrange for any study on the ecological impact of the SWDs on environment. In the absence of required quality control methodology for SWDs, the lakes of Bengaluru are extremely polluted due to sustained flow of untreated sewage and industrial effluents, resulting in lakes frothing/catching fire repeatedly through solid/liquid waste floating on its surface, or flammable methane generated from its oxygen-starved waters (**Exhibit 5.3**).

Fuming Bellandur Lake

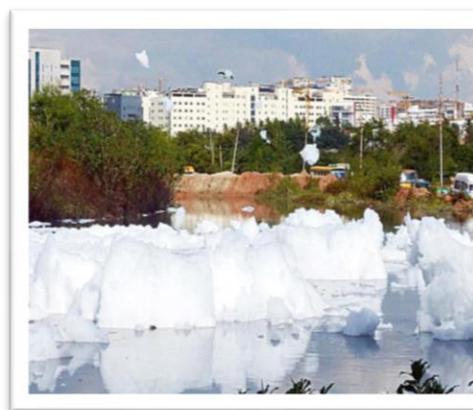
Frothing Yamaluru Lake

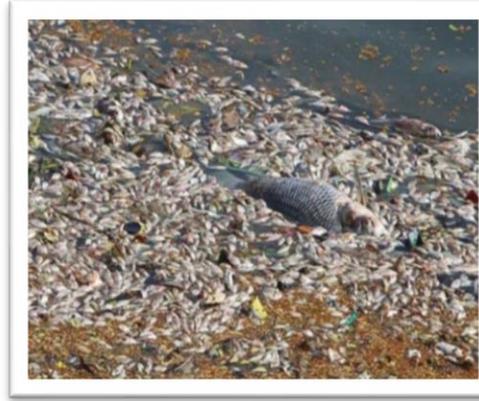
Dead fish in Ulsoor Lake

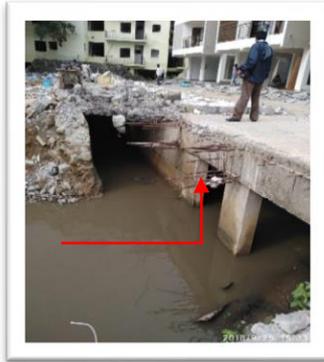
During the joint inspection of about 70 drains²⁵, Audit observed 23 cases of significant encroachments (**Exhibit 5.4**) as listed in **Appendix 5.1**. Out of these, 16 cases were not in the list provided by BBMP. Thus, the completeness and reliability of the data on encroachments available with CE, SWD was doubtful.

*Himagiri Meadows Apartments,
Bommanahalli Zone*

Recommendation 17: BBMP needs to escalate its efforts to conduct robust surveys to identify and evict all encroachments on SWDs and maintain the stipulated buffer zone.

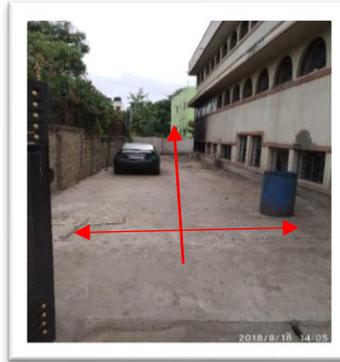
*Naurang Function Hall,
Tavarekere, Koramangala Zone*

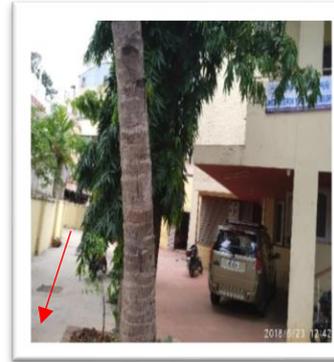
*Private Property at Koramangala
5th Block*

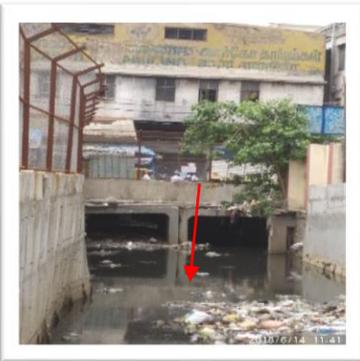
*Private property on JC Road,
Koramangala Zone*

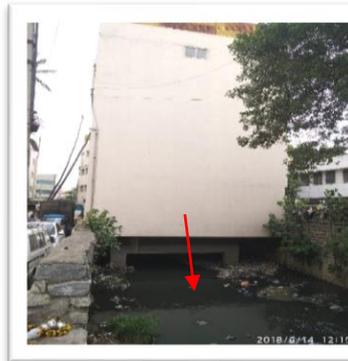
*Private property, Lalbagh Road,
Koramangala Zone*

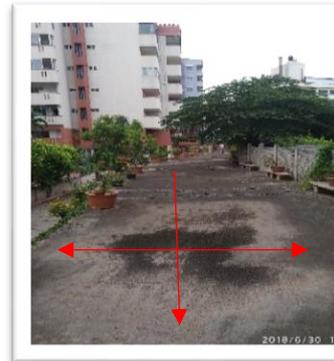
*Ansal Forte Apartment, Near
Silk Board, Bommanahalli Zone*

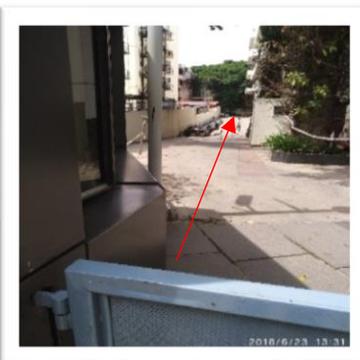
*Commercial building at
Koramangala 7th block*

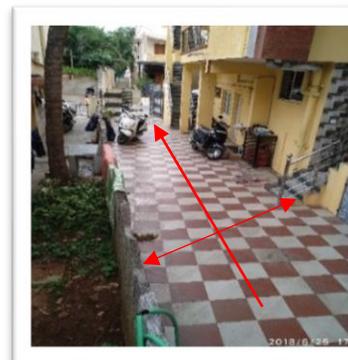
*Private property at BSK 1st Stage,
Srinivasanagar, South Zone*

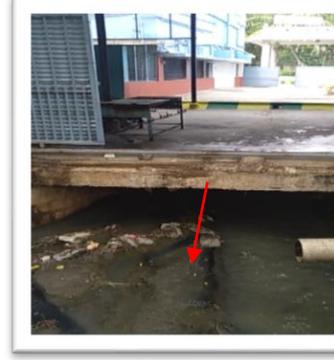
*Padmavathi Kalyana Mantapa,
Rajarajeshwarinagar Zone*

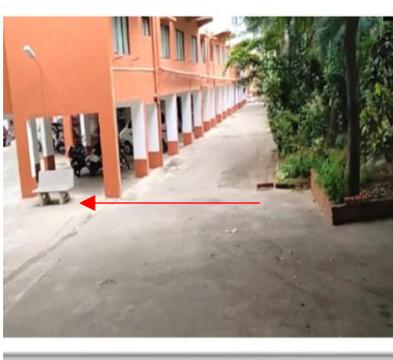
Spartacus Apartments, 4th T Block,
Jayanagar, Koramangala Zone

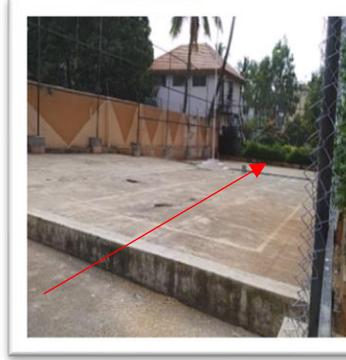
Ranka Nest Apartments, West
Zone

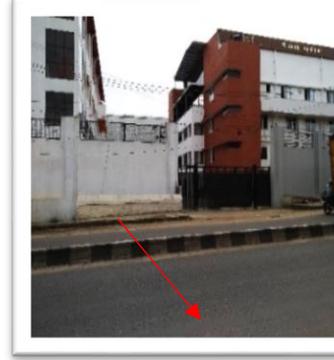
Surana College,
Rajarajeshwarinagar Zone

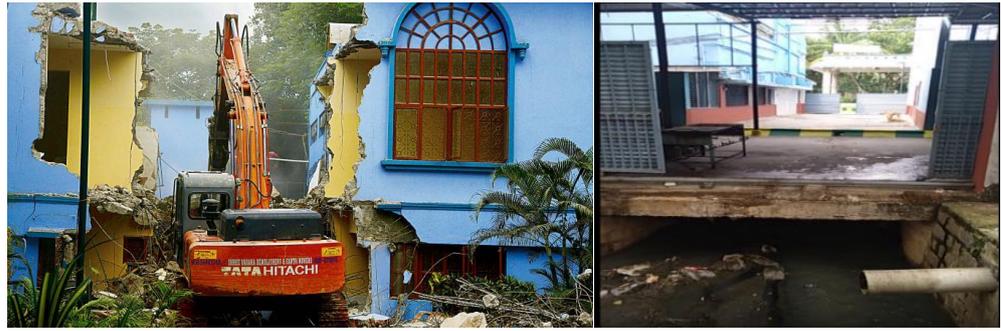
Exhibit 5.5: Existence of kalyana mantapas and concrete platform on drain

RN193 (Primary SWD) under Rajarajeshwari Nagar zone was encroached upon by way of constructing Padmavathi and Meenakshi Kalyana Mantapas. As per the information furnished to audit by BBMP, the said encroachment was removed on 18.08.2016. However, a joint physical inspection (11 June 2018) showed that the kalyana mantapas were existing on either side of the drain and were connected with a concrete platform linking the two buildings (Exhibit 5.5). The impact of the continued encroachment could be seen by way of rainwater entering (20 October 2020) into the dining area of the kalyana mantapa (Exhibit 5.6).

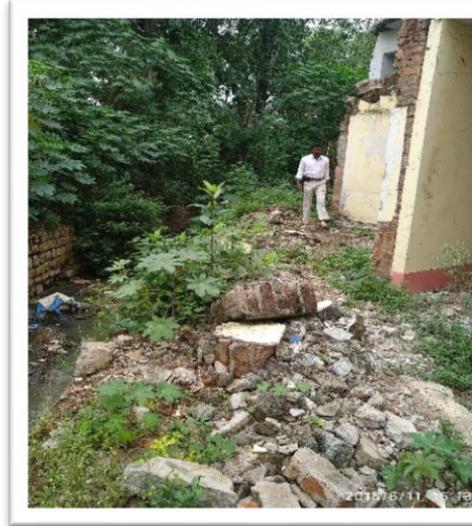
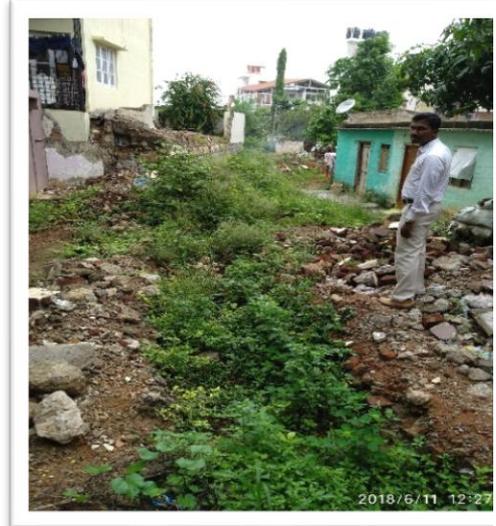
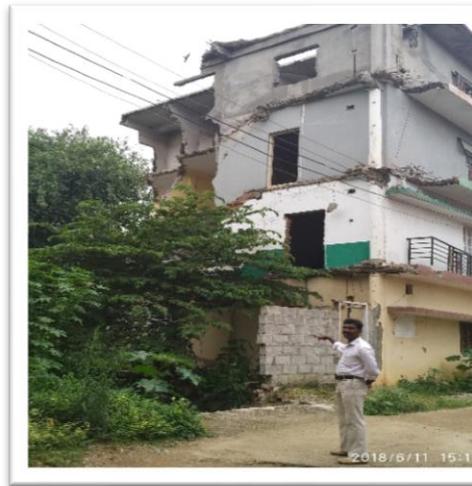
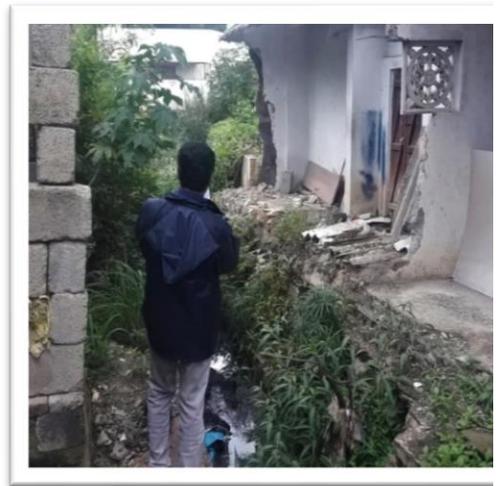
Exhibit 5.7: Status of evictions stated to have been carried out by BBMP under RR Nagar zone

Apart from the above, audit also observed that the evictions so carried out were incomplete as only certain portions of the encroached buildings were razed and no further action was taken for improving the conditions of the drains (**Exhibit 5.7**). Hence, the claim of BBMP that 1,912 encroachments were removed cannot be accepted at face value.

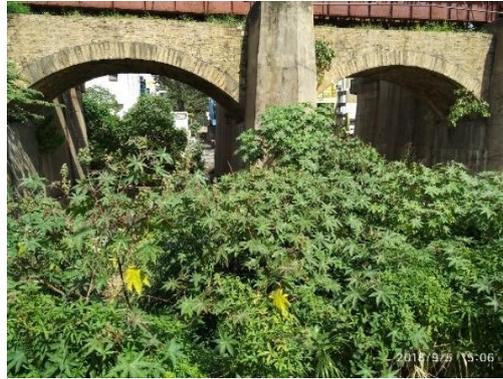
Audit observed during joint inspections of drains that SWDs were filled with debris, vegetation and were heavily silted indicating absence of regular maintenance of drains (**Exhibit 5.9**).

Vegetation inside SWD at Magadi Road Railway Bridge, West Zone

Recommendation 18: BBMP should put in place adequate mechanism to conduct and document periodical inspection and maintenance of all categories of drains.

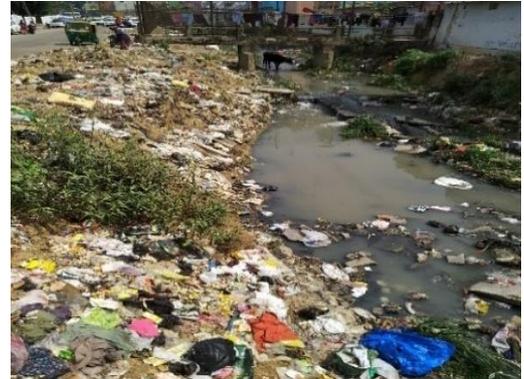
Dumped debris/wastes and garbage inside SWD at Ejipura, Koramangala Zone

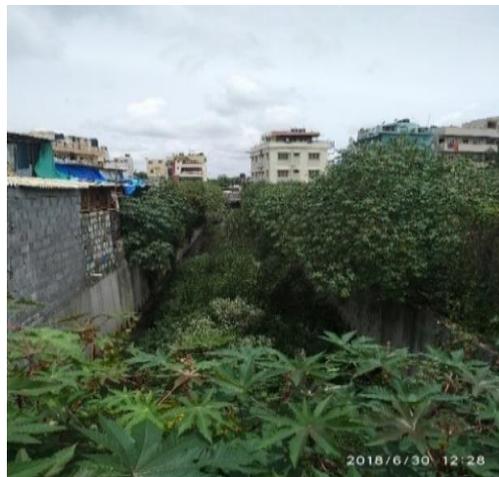
Vegetation inside SWD Akshaya Nagar, Bommanahalli Zone

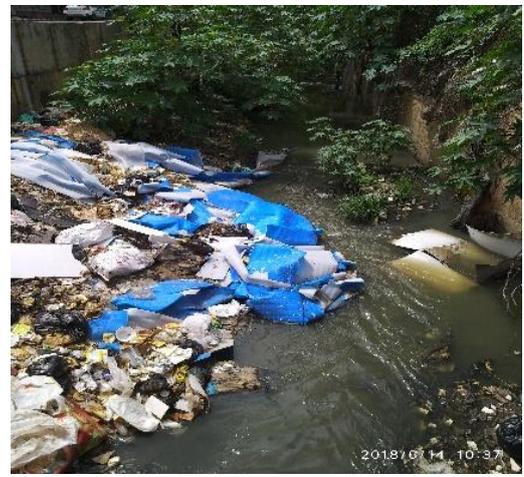
Dumped wastes and garbage inside SWD near Football Stadium, Koramangala Zone

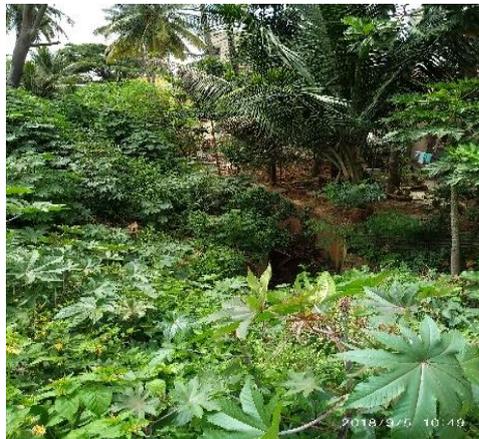
Vegetation inside SWD at Vyalikaval, West Zone

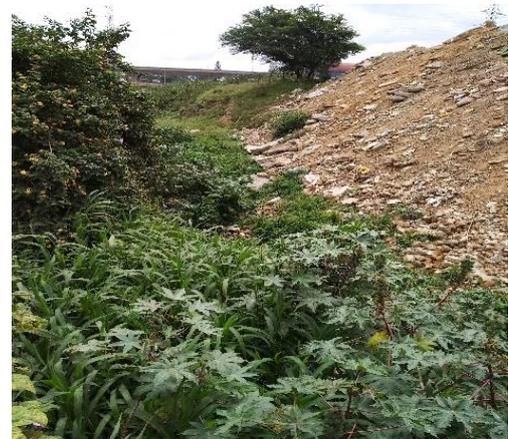
Vegetation inside SWD at Peenya, Rajarajeshwarinagar Zone
