**Report of the  
Comptroller and Auditor General of India  
for the year ended March 2021  
Derailment in Indian Railways**

**Union Government (Railways)**  
Performance Audit  
Report No. 22 of 2022

## **Derailment in Indian Railways**

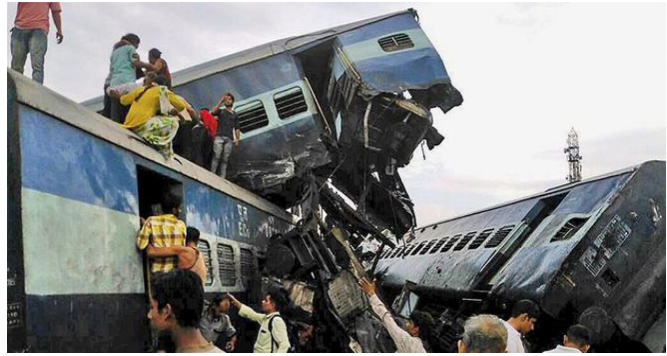
On 19 August 2017, the 18478 Puri-Haridwar Kalinga Utkal Express derailed in Khatauli near Muzaffarnagar, Uttar Pradesh
