Chapter - VI Landslides

Landslides

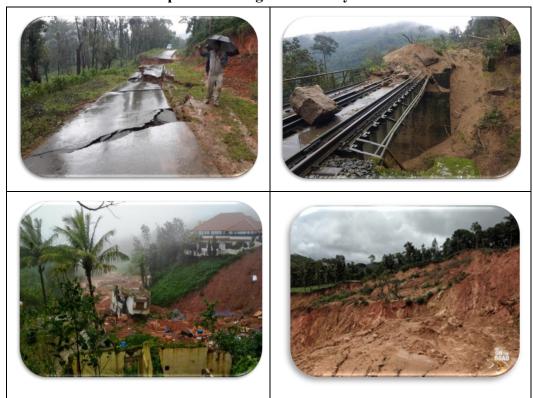
Exhibit 6.1: Media reports showing the intensity of landslide destruction

Illustrative photographs showing the intensity of destruction caused by landslides in various parts of the State are depicted in **Exhibit 6.1**.
