**MINISTRY OF STEEL**

**CHAPTER IX**

**Steel Authority of India Limited.**

**Coal Dust Injection system in the blast furnaces**

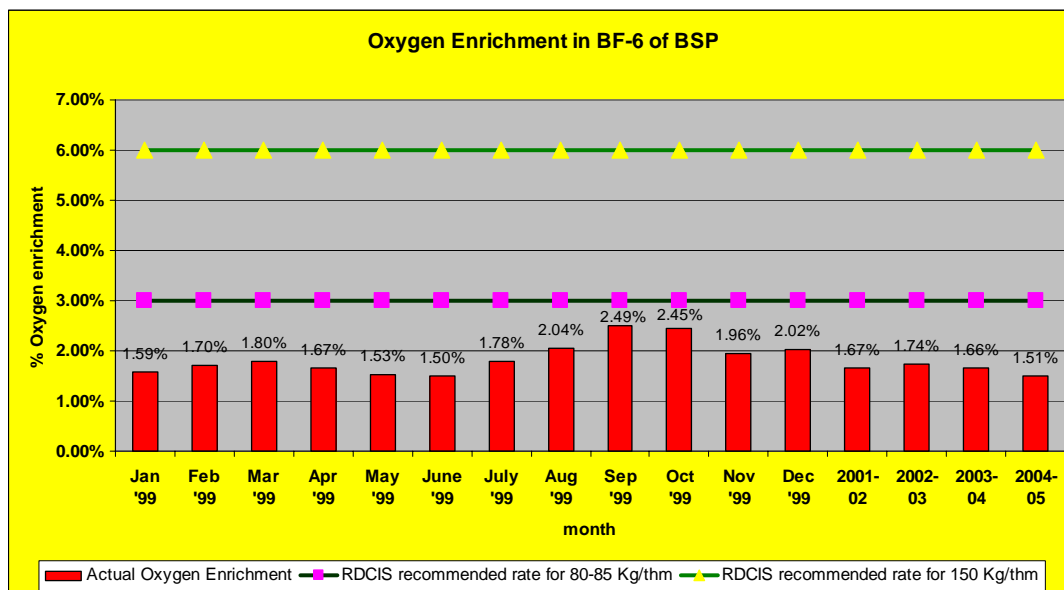
**9.8.2.2** In the initial period of CDI operation (1999), the actual oxygen enrichment in BF-6 of BSP ranged between 1.50 *per cent* (June 1999) and 2.49 *per cent* (September 1999). In subsequent periods also it remained in a lower range between 1.51 *per cent* in 2004-05 and 1.74 *per cent* in 2002-03.

Oxygen enrichment was even less than one *per cent* in BF-7 (BSP) and there was shortage of oxygen for enrichment of blast in BOSP.

The Company should have ensured the required level of oxygen enrichment before installation of CDI.

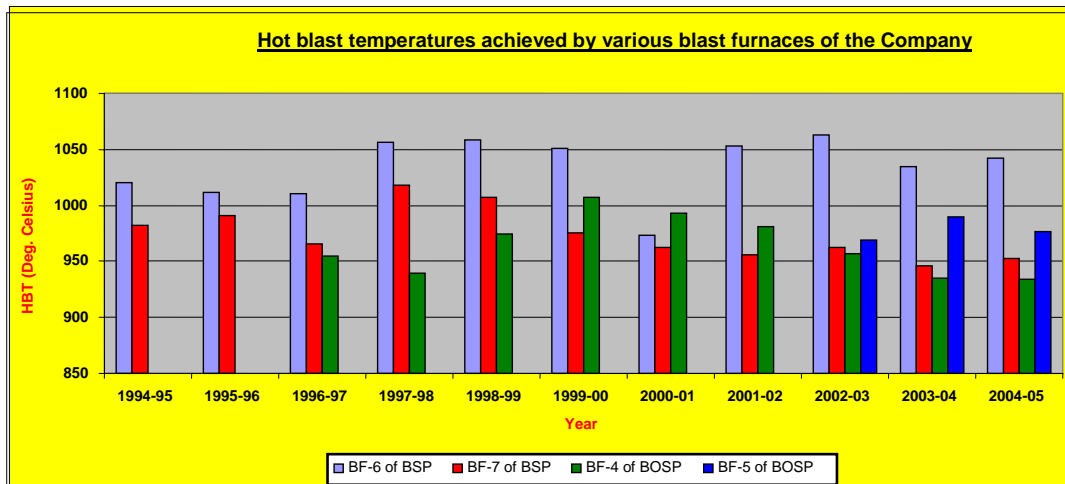
**9.8.3.2** The actual hot blast temperature in different blast furnaces containing the CDI during 1994-95 to 2004-05 (both pre as well as post CDI period) were as follows:

**9.8.3.3** Low hot blast temperature in blast furnaces was attributed to the inability of the refractory to withstand the hot blast temperature of 1100<sup>0</sup>C. Old design of hot blast stoves and burners and the existing tuyeres were not able to withstand higher hot blast temperature. Low hot blast temperature was one of the reasons for poor performance of CDI system.

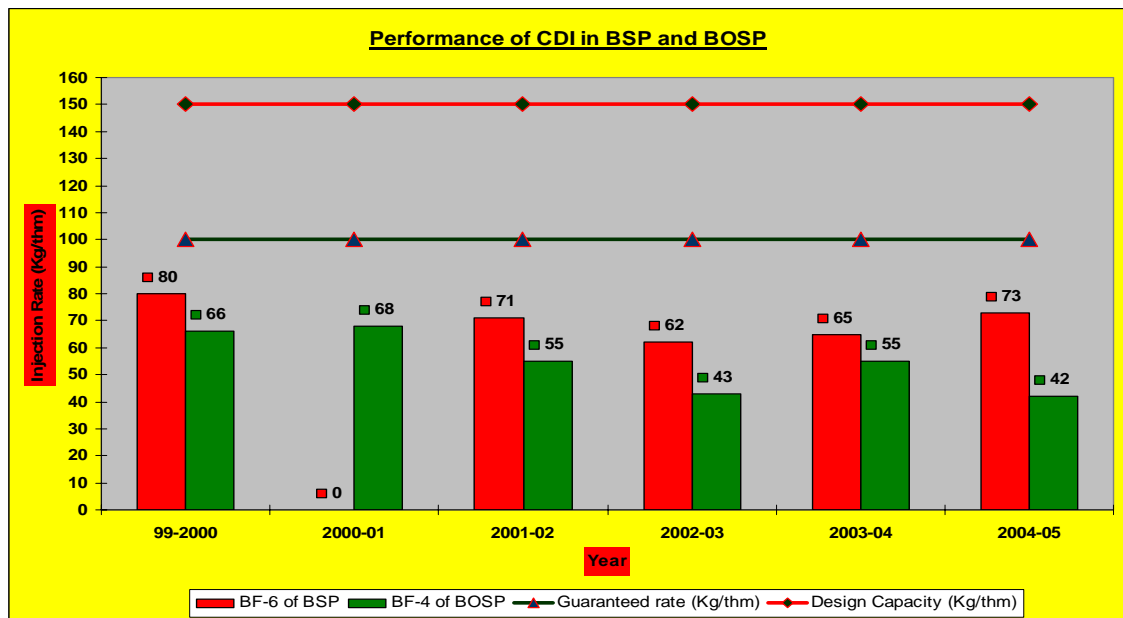
**9.9.1** As against the guaranteed injection rate of 100 kg/MTHM, the actual injection rate of CDI of BF-6 (BSP) and BF-4 (BOSP) was much less, as shown below:

**9.9.2** Based on the injection rate of 100 kg/MTHM and a coal-coke replacement ratio of 1:1, it was calculated in audit that there was a shortfall of coal dust injection of 4.45 lakh MT during 1999-2000 to 2004-05 in case of BF-6 of BSP and BF-4 of BOSP. This resulted in an extra expenditure of Rs.64.56 crore since costly coke had to be consumed in place of proposed non-coking coal.
