CHAPTER IV

ENCROACHMENTS

4.1 Encroachments contributing to the floods

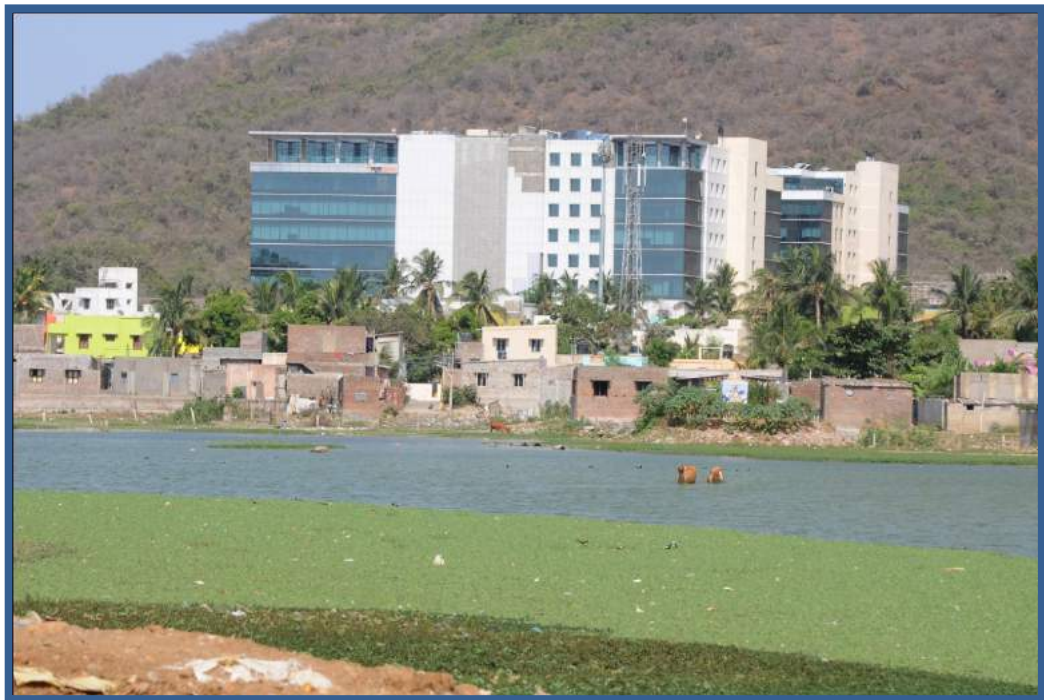
Exhibit 4.1: Encroachment in Perungalathur Big Tank

(B) Field visit to Perungalathur Big Tank (**Exhibit 4.1**) in Kancheepuram District and scrutiny of relevant records revealed that 279 encroachers had encroached 4.36 hectare of water spread area. WRD replied (October 2016) that efforts were being made for identification and removal of encroachment in coordination with line departments and agencies like Revenue Department, Police Department, Tamil Nadu Slum Clearance Board, etc.

Recommendation No. 12: We recommend framing stringent laws to fix responsibility on the officials responsible for non-enforcement of the provisions of the TN Tank Protection and Eviction of Encroachment Act in identifying and eviction of encroachments of any nature.

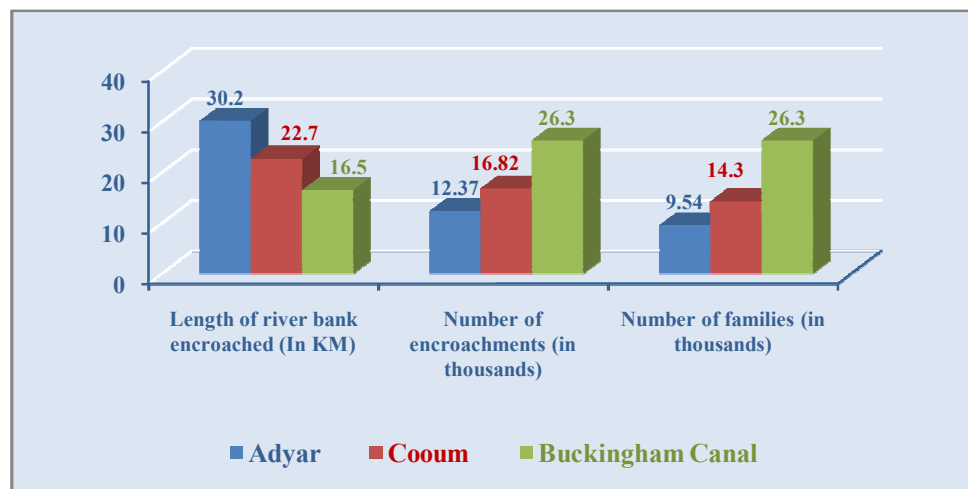
Chart 4.1: Encroachment along rivers

As may be seen from the above, either side of Adyar River bank was encroached to an extent of 30.2 out of 85 km (36 per cent) by 9,539 families. Absence of effective action in eviction of these encroachments resulted in obstruction of the flow of flood water in the Adyar River which caused inundation in the adjoining areas. During Joint Inspection (October 2016) of Accountant General's (E&RSA) Team along with officials of WRD, CE, WRD admitted that at the time of December 2015 floods, 9 out of 12 vents¹ under Maraimalai Adigalar Bridge across the Adyar River at Saidapet were encroached leading to overflowing of the river at Saidapet. We observed during the Joint Inspection that 5 out of these 12 vents were continued to be encroached (**Exhibit 4.2**) by slum dwellers indicating absence of effective steps in removal of encroachments despite huge loss to life and property in the catastrophic floods.

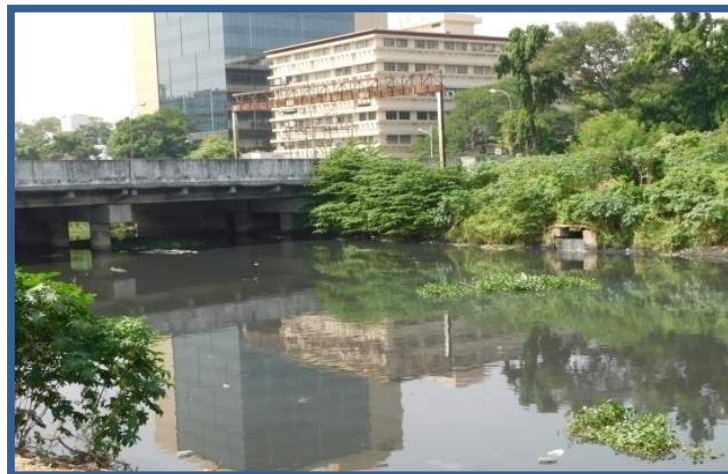
Exhibit 4.3: Encroachment along Cooum River

- Along Cooum River, out of the total length of 80 km of the banks, 22.7 km (28 per cent) was encroached by 14,257 slum families and others. We conducted a joint inspection of river bank along with officials of the line departments and found that the slum encroachment along the bund of the river (**Exhibit 4.3**) had reduced the width of its carrying capacity.

Blocked vent and sewage outfall (Langs Garden)

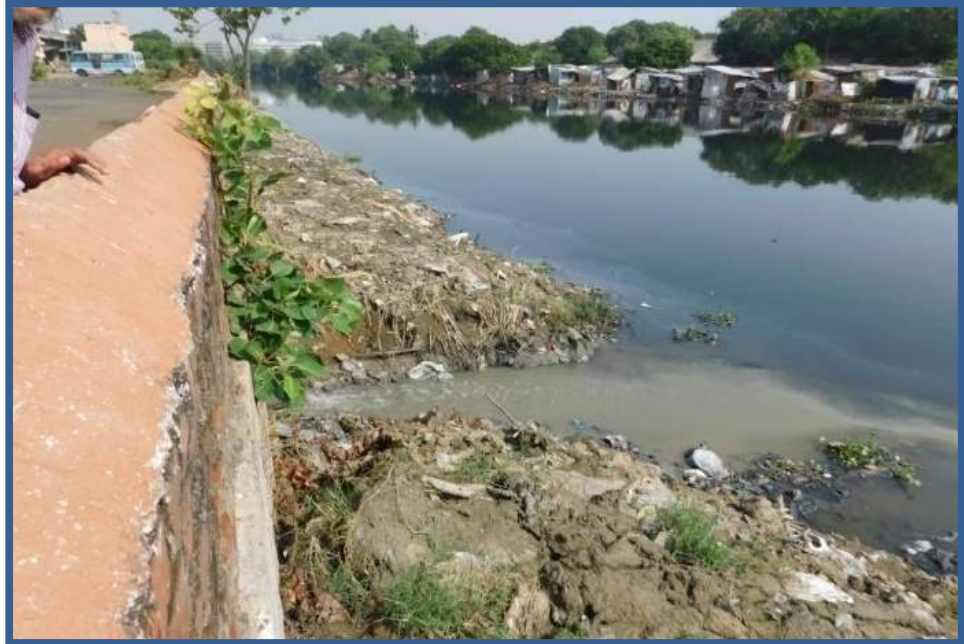
Encroachment and sewage outfall (Pallavan Nagar)

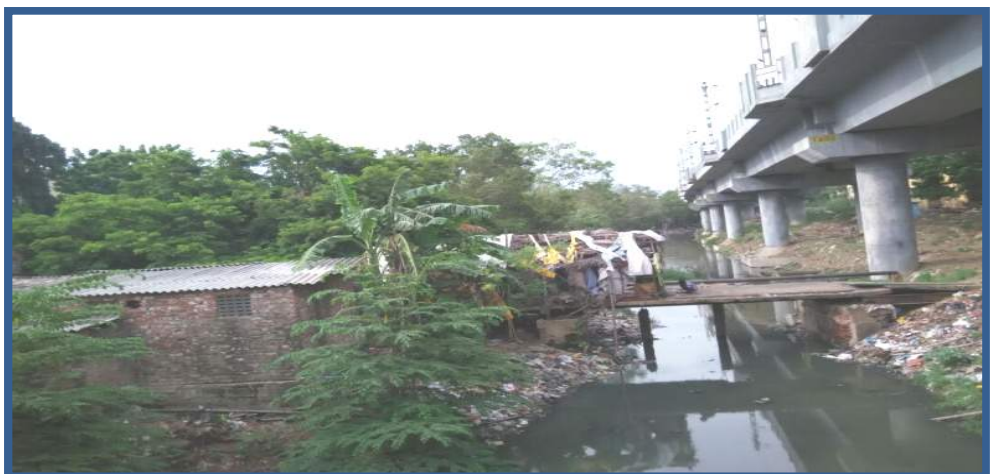
Exhibit 4.4: Encroachment in Buckingham Canal

- Seventeen *per cent* of the banks of Buckingham Canal (16.5 out of 96 km) was encroached by 26,300 families. Joint site inspection of central Buckingham Canal by the Audit team with the departmental officials revealed that encroachers were provided with electricity connection, proper roads, common water supply and ration cards indicating tacit support of the GoTN in helping encroachments. It was also noticed that the sanctioned flood protection works in Buckingham Canal could not be carried out due to existence of encroachments (**Exhibit 4.4**) to an extent of about three km.

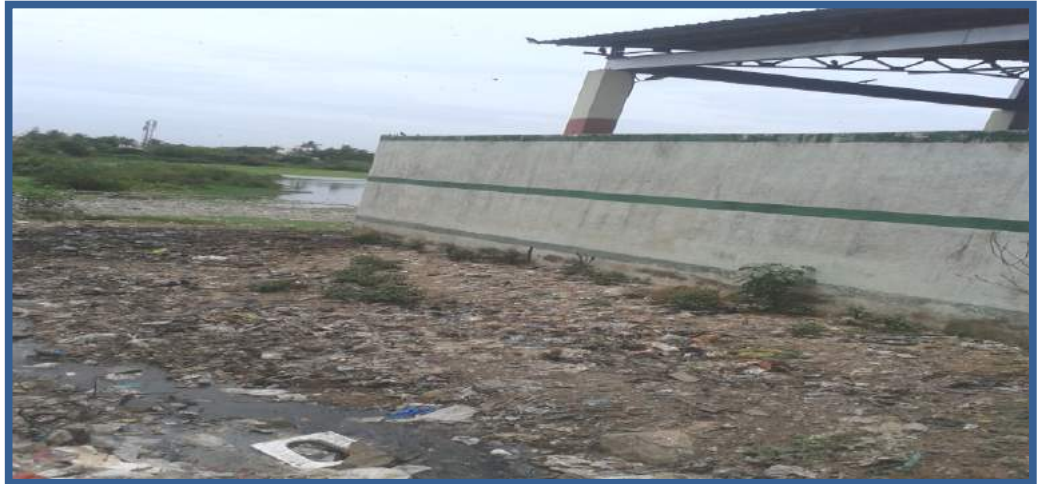
Exhibit 4.5: SWM facility inside Peerkankaranai Lake

(i) Peerkankaranai Town Panchayat requested (2004) the District Collector for assigning land for Solid Waste Management (SWM) facility. Without waiting for assignment of land by the District Collector, the Town Panchayat established (July 2005) the SWM facility in a 0.20 hectare plot inside Peerkankaranai Lake (**Exhibit 4.5**). Despite objection on environmental concern by the TN Pollution Control Board, the Town Panchayat constructed (July 2013) a compound wall at a cost of ₹ 20.84 lakh. In reply, GoTN stated (May 2017) that the District Collector had allotted (August 2016) an alternative land for construction of SWM facility and the unit will be shifted soon. We observed that WRD, which is responsible for maintenance of this tank failed in its mandated duties to prevent the Town Panchayat from the callous action of encroaching the water body for solid waste disposal. The failure of District Collector, who took 12 years to identify and assign a suitable land for the SWM facility, also contributed to the degradation of the lake.

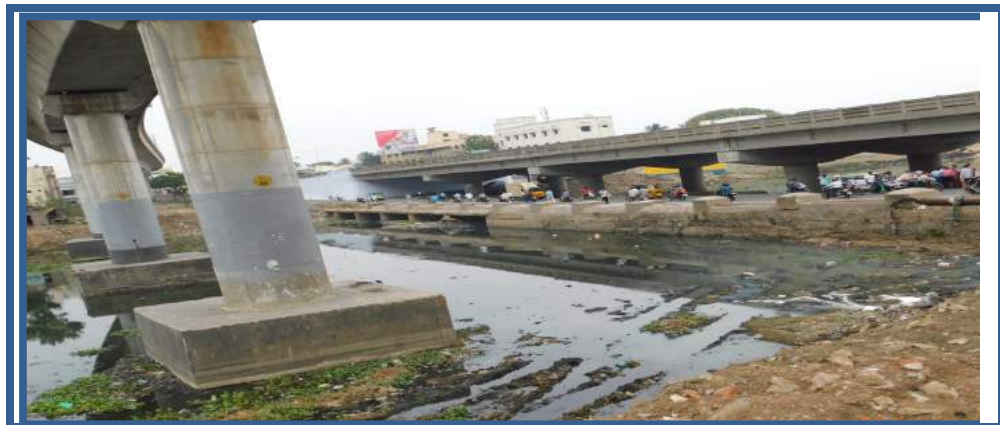
Exhibit 4.7: Metro Rail pile caps and old causeway

(ii) A causeway bridge at Jafferkhanpet, blocking the free flow of water in Adyar River, was not removed though an over-bridge in lieu of the causeway bridge was already constructed by Highways Department and put into use. At the same location, Chennai Metro Rail Limited (CMRL) had constructed a bridge across the river with its three pile caps protruding above the river bed (**Exhibit 4.7**) without obtaining NOC from WRD. We observed that WRD had turned a blind eye to these violations by CMRL, which is also a Government Agency. The existing causeway and the pile caps by CMRL in violation of Government instructions hindered free flow of water in Adyar River resulting in inundation of flood waters in Ekkaduthangal, MGR Nagar, Jafferkhanpet and K.K. Nagar areas.

The Divisional Engineer, Highways Department stated (December 2016) that line Departments had been requested for removal of utilities to enable dismantling of the causeway bridge. Government agreed (March 2017) to initiate action in this regard.

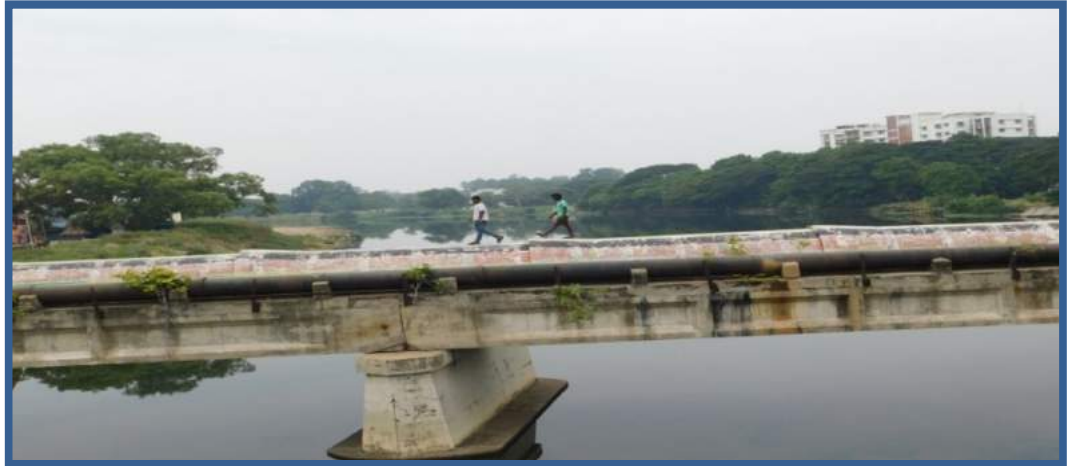
Exhibit 4.8: Old bridge blocking the free flow of water

(iv) Across Adyar River at Kotturpuram, a high level bridge was constructed in lieu of an old bridge. The old bridge, though not utilised for vehicular traffic, was not demolished. It was being utilised for carrying pipelines of CMWSSB (**Exhibit 4.8**), which acted as barricade to the flow of water and caused afflux of flood waters causing huge inundation in the upstream areas of Kotturpuram.

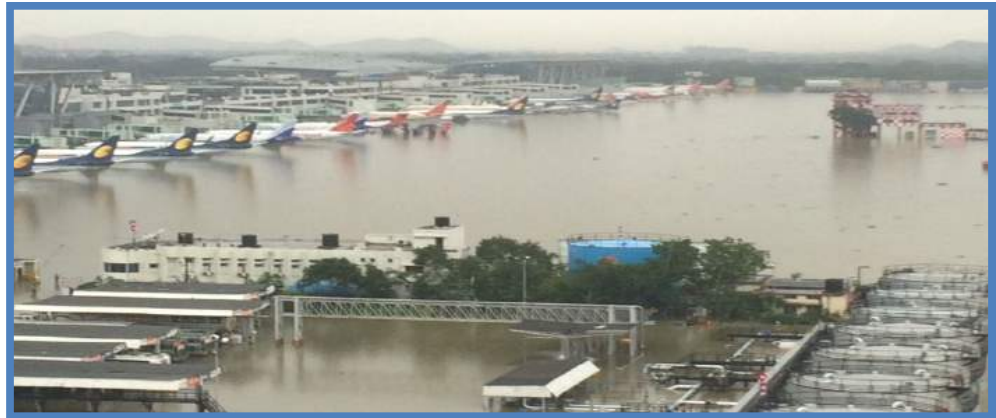
Exhibit 4.9: Flooding of Chennai International Airport

(v) Airports Authority of India approached WRD (May 2009) and sought NOC for expansion of Chennai International Airport by construction of secondary runway across Adyar River, which also necessitated dismantling recently constructed check dam. The proposal was agreed to by the GoTN and NOC was issued with conditions, *inter alia*, that (i) the construction cost of the check dam i.e. ₹ 3.52 crore be remitted to GoTN account, (ii) Airports Authority should deploy flood safety arrangements on either side of the bridge, and (iii) Airports authority should carry out periodical maintenance including desilting works. The Airports authority constructed (2011-12) the secondary runway. A study (2012) by Anna University indicated that the piles under the runway reduced the width of the Adyar River, thereby increasing the possibility of floods in the nearby areas. The findings of Anna University were proved right as the Airport and the adjoining areas were severely inundated during 2015 flood (**Exhibit 4.9**). During joint inspection conducted by the Audit team along with CE, WRD, it was noticed that the individual pillars supporting the runway, without any wall connecting them, acted as filth accumulators thereby obstructing the free flow of river.

We observed that WRD failed to ensure compliance to the NOC conditions relating to flood protection works and periodical maintenance by the Airport authority. GoTN stated (March 2017) that detailed survey would be done to tackle this issue. The reply did not address the audit findings as compliance to NOC conditions should have been monitored continuously by WRD.
