CHAPTER V

DRAINAGE SYSTEM IN CHENNAI METROPOLITAN AREA

5.1 Flood protection works

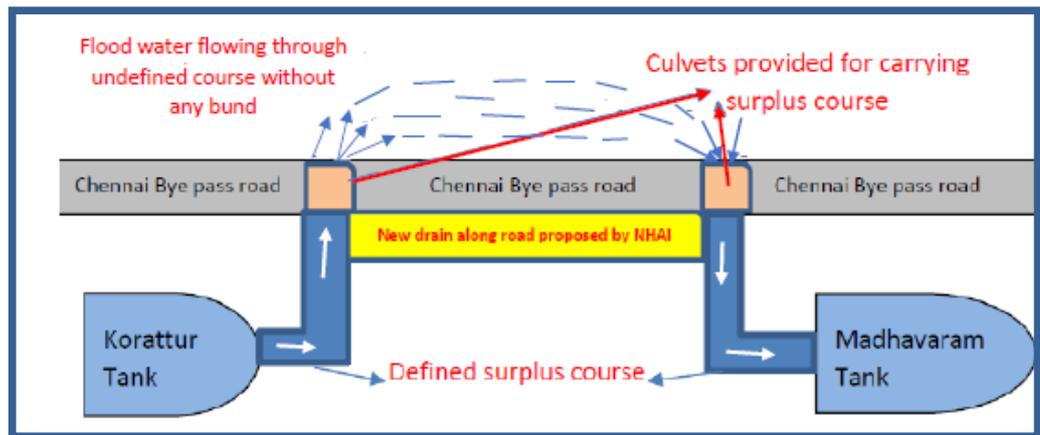
Exhibit 5.1: Illustrative sketch showing existing and proposed alignment of Korattur Tank's surplus course

construction of a drain along the service road for taking the Korattur Tank's surplus water to Madhavaram Tank (**Exhibit 5.1**). The proposal was discussed by NHAI and WRD authorities, and it was suggested by WRD for construction of box culverts at two locations to carry surplus water across the road to its natural drains. WRD had not agreed to the NHAI proposal of construction of a drain along service road. NHAI had completed (2011) Chennai Bypass road and service road with box culverts at two locations as suggested by WRD.

The bypass road work was completed with box culvert underneath the road to carry the surplus water of Korattur Tank, instead of constructing a drain along the service road as was suggested by NHAI. After crossing the bypass road through box culverts, the surplus water took natural course over the *patta* lands, thereby contributing to inundation in adjoining areas. The failure of WRD to agree to the proposal of NHAI resulted in continued flow of the surplus water through thickly populated areas contributing to the inundation in the adjoining areas.

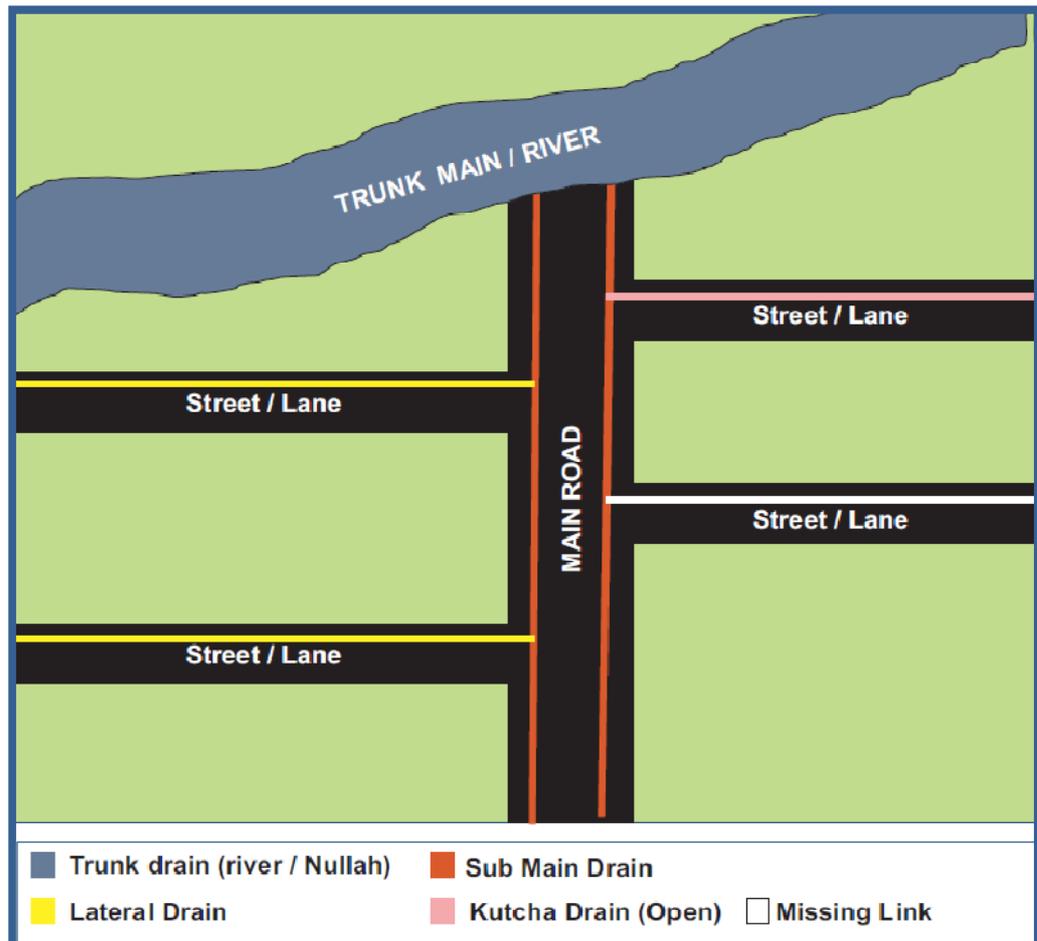
Exhibit 5.2: Illustrative sketch depicting SWD network

As per the existing system and as envisaged in the SMP, the local bodies are responsible for management of micro drainage system within their jurisdiction. In GCC areas, as against the road length of 7,303 km, SWDs were provided only for a length of 1,894 km which formed only 26 *per cent* of the total road length. Scrutiny of records of sampled zones revealed that SWD network was not adequate, as discussed in succeeding paragraph. A sketch depicting, macro drain, sub-mains, lateral drains and missing links in SWD network in Ward 127 of Kodambakkam Zone is shown in **Exhibit 5.2**.

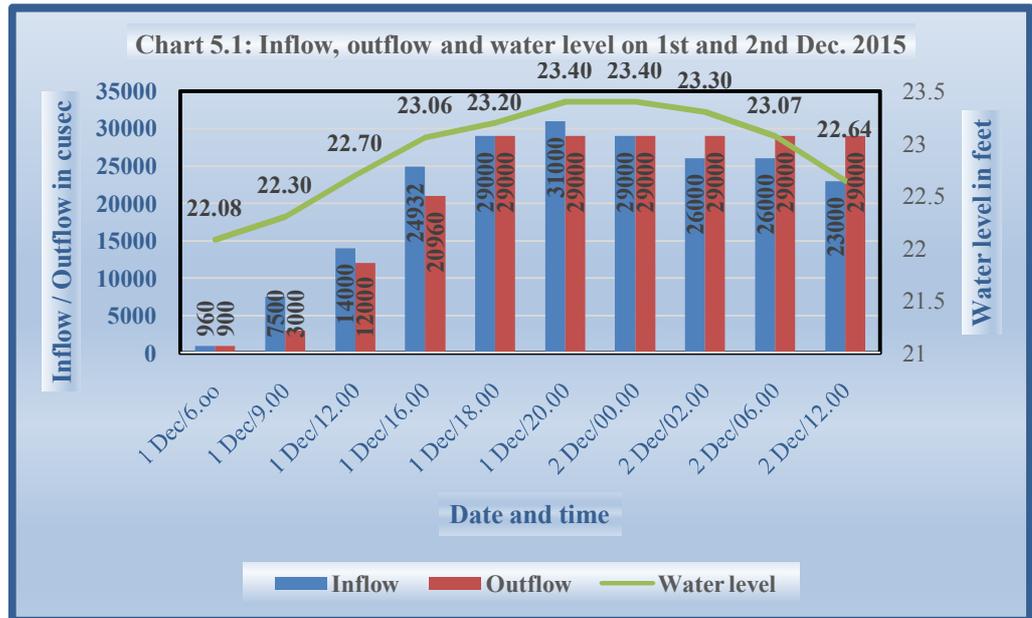
The details of inflow, outflow and water levels of Chembarambakkam Tank for the period from 16/11/2015 to 17/11/2015 and 01/12/2015 to 02/12/2015 are indicated in **Appendix 5.6**. The inflow, outflow and water levels pertaining to the crucial days of 1 and 2 December 2015 are shown in **Chart 5.1**.

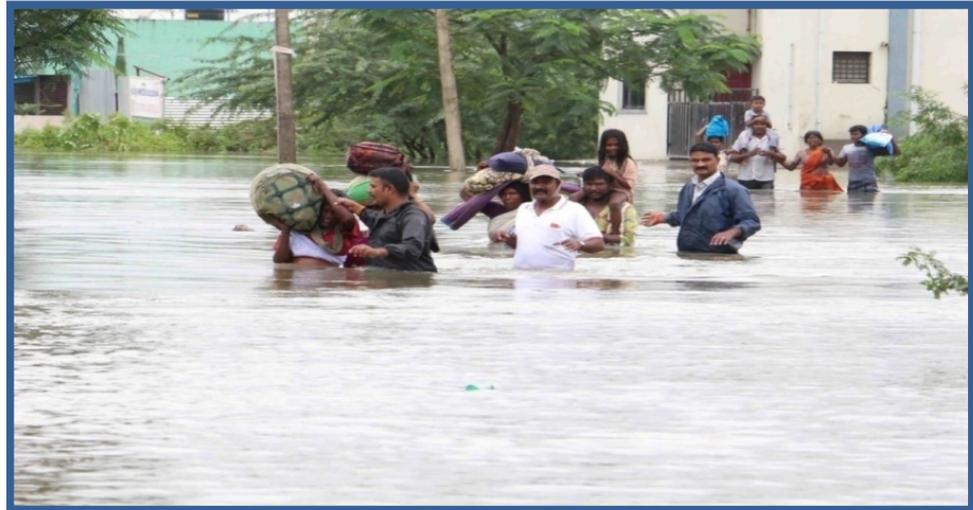
Exhibit 5.3: Heavy inundation in the areas of Ward 32 of Tambaram Municipality

Thus, the failure of CMDA in allowing constructions of residential buildings without preserving water course and WRD's failure in protecting the channel under its jurisdiction resulted in inundation of adjoining areas.
