EXECUTIVE SUMMARY

The Purpose

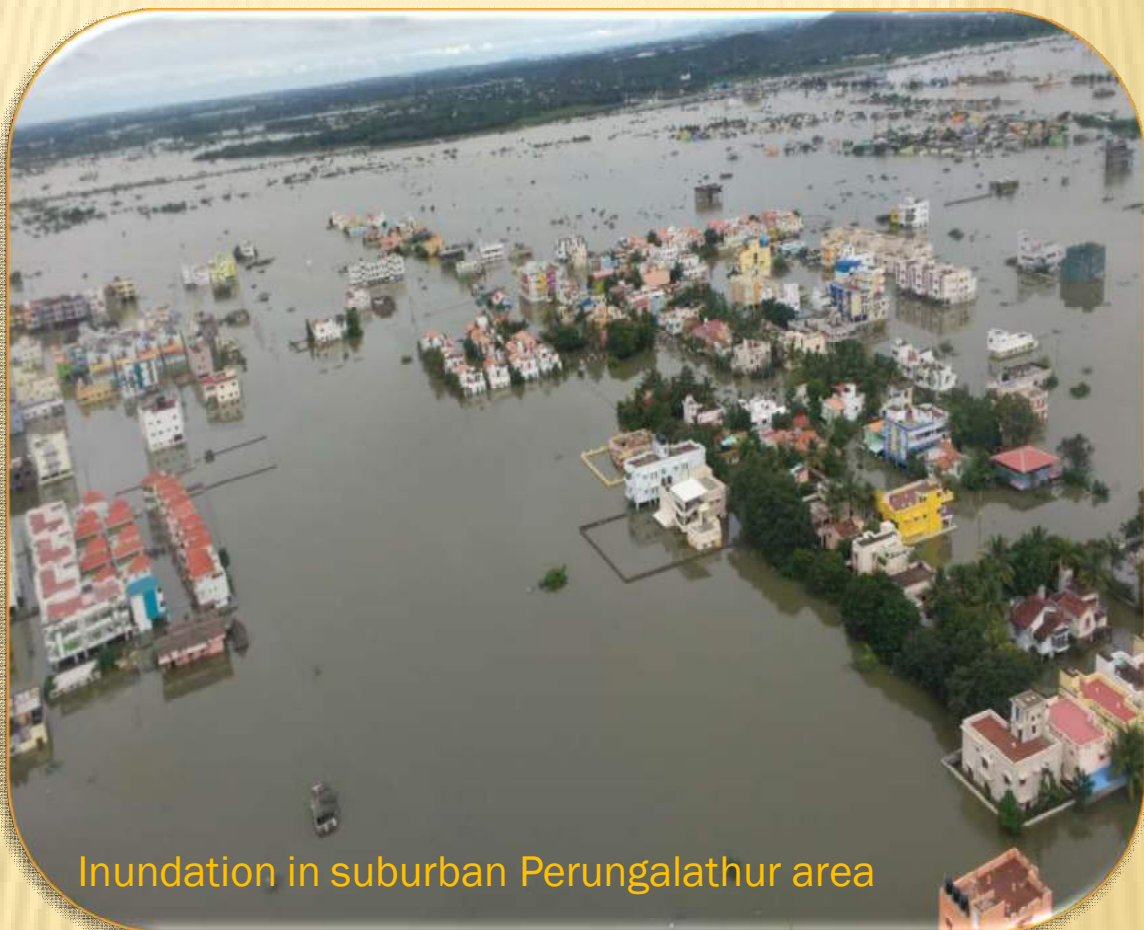
Inundation in suburban Perungalathur area
