Audit on Rejuvenation and Conservation of the Harmu River

CHAPTER 4
URBAN DEVELOPMENT AND HOUSING DEPARTMENT

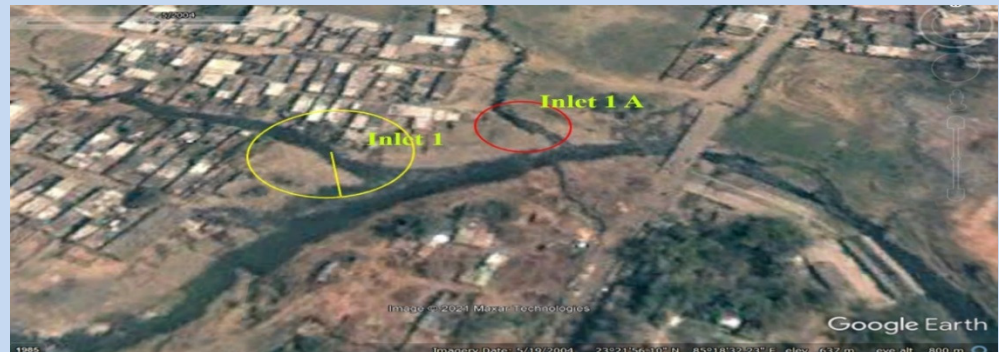
Picture 4.2: Satellite image (May 2004) of inlet 1 and inlet 1A

Audit examined the topography around the Harmu river, using a Google Earth image of 19 May 2004. It was noticed that two primary inlets near *Muktidham*, having coordinates 23°21'56.10"N and 85°18'32.23"E, were terminating into the Harmu river. These are marked as Inlet-1 and Inlet-1A, in the Google map below.

Though both the inlets were clearly visible in the Google map of 2004, the consultant identified only Inlet-1 in the DPR and not Inlet-1A. The CE, who had approved the DPR and granted TS, also did not verify the same. Even the contractor, who had reportedly conducted the survey and investigation, did not mention the existence of Inlet-1A. Inlet-1A was subsequently factored into the revised design, in February 2018, after it had caused heavy inflow and damage to the river embankments.

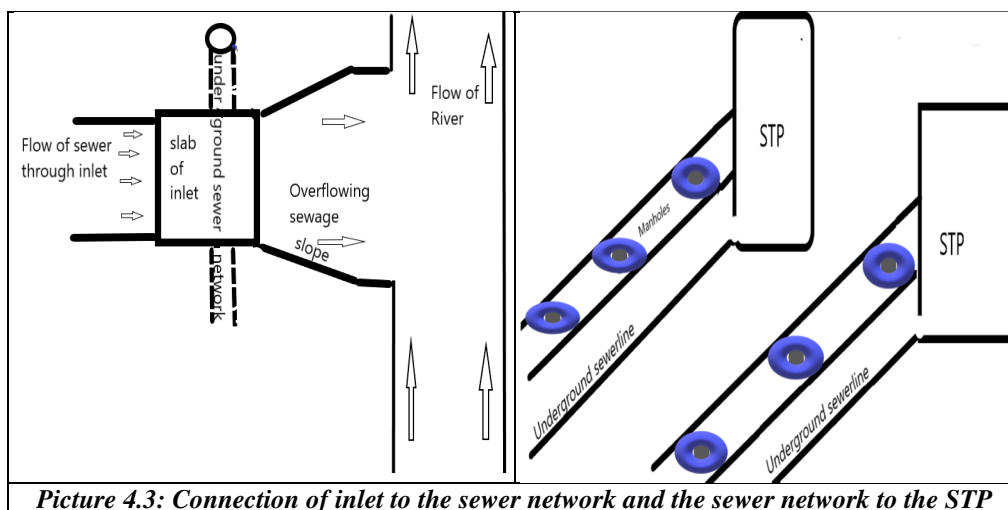
Audit noticed from concerned files that only nine¹⁸ (out of the 14 major inlets) were connected to the sewer line, for disposal of sewage to STPs, for treatment. A pictorial representation (prepared by Audit) of the connection of inlets to the sewer line and the sewer line to STPs, is shown in **Picture 4.3**.

The connection of the inlet to the sewer network was designed to pass through a hump-like structure, so that excess discharge (*i.e.* discharge more than the capacity of the sewer line) from the inlets would cross the hump and fall directly into the river. The design was adopted to protect the sewer network from excessive flow of storm water in the rainy season.

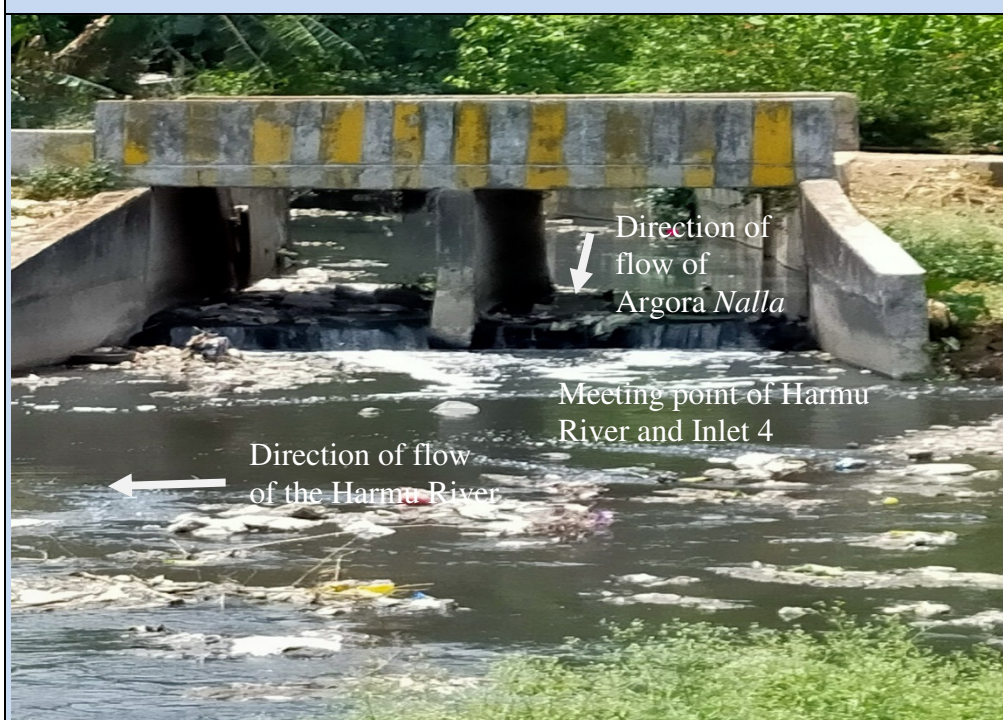
Picture 4.5: Discharge of sewage directly, through Inlet 4, into the Harmu river

Argora Nalla (a primary drain, categorised as inlet 4), a tributary of the Harmu river, originates 9.17 km away from the Harmu river, near the *Argora bypass road* and meets the river near *Nibaranpur*. During joint physical verification (4 May 2022), Audit noticed that the junction point was located in the *Tapovan* stretch (**Paragraph 4.6.1**), where no underground sewer network had been constructed. In the absence of a sewer network, the drain was carrying sewage (0.47 MLD) from its catchment (0.64 sq. km.) and discharging it directly into the Harmu river. In addition, the *Argora nalla* had been encroached upon by unauthorised *khattals*²⁰, particularly in *Gouri Shankar Nagar*, Doranda, resulting in discharge of a significant quantity of cow-dung and other solid waste *etc.*, directly into the *nalla*. The *Argora nalla* was carrying this untreated sewage to the Harmu river, contaminating its water. Government, therefore, needs to take urgent steps, to prevent discharge of sewage, dung, solid waste *etc.* into the storm water drains (*Argora nalla*) by taking steps to remove encroachments; ensure cleaning of the inlets at regular intervals; ensure monitoring of the area through satellite images; and consider constructing a STP on the *Argora nalla* itself, before it meets the Harmu river at *Tapovan*.

The Department stated (July 2022) that, after implementation of the Sewerage and Drainage Project, the additional flow of sewage (*i.e.* sewage exceeding the design capacity) into the Harmu river would be restricted.

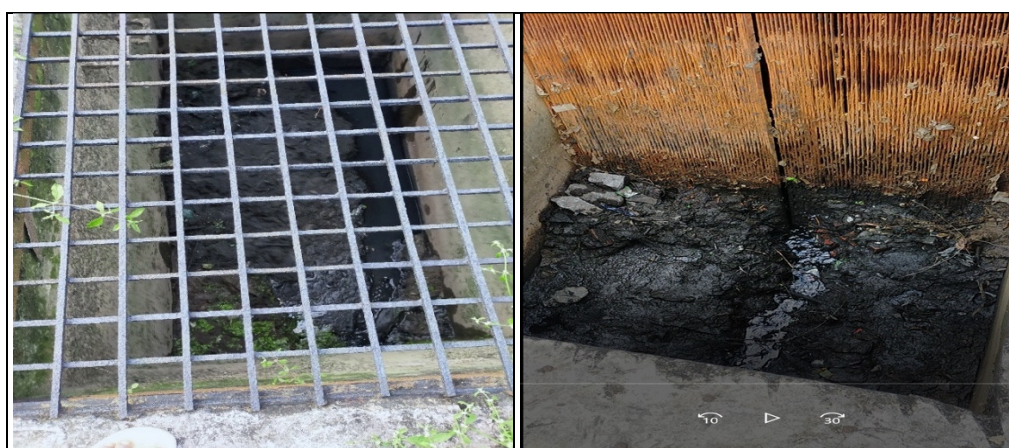
Picture 4.7: Chamber before STP-5 and the screen chamber of STP-5, filled with solid deposits

BIT, Mesra, stated that the design of the eight STPs did not have any scope for solid (sludge) management from the PST (primary treated sludge), the phytorid bed and from the collection tank.

During joint physical verification (October 2021), Audit noticed solid (sludge) deposits in chambers before STP-5 and in front of the screen chamber of STP-5, as shown in **Picture 4.7**.

The engineers, who accompanied Audit during the site verification, stated that these solid wastes were being cleaned regularly. However, the approved sludge management technique and the manner of disposal of the sludge, could not be explained to Audit.

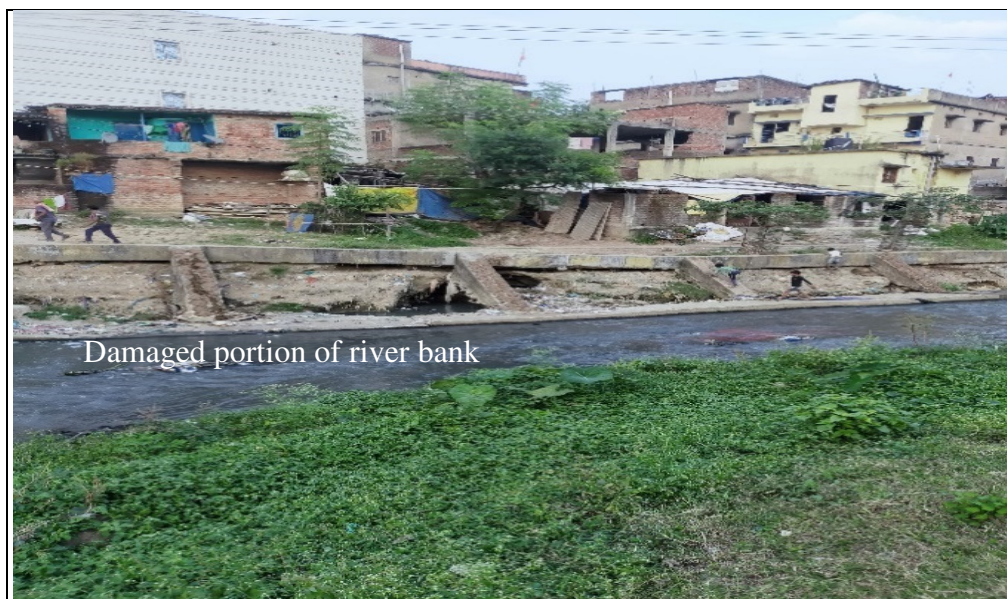
Picture 4.8: Damaged riverbank on the left side, between inlets 6B and 6C

During joint physical verification (25 October 2021) by Audit, with the engineers of JUIDCO, a stretch of the redesigned river cross-section on the left side of the river was found to have been damaged (approximately 100 metres of riverbank between inlet 6B and 6C), as shown in **Picture 4.8**. The Project Manager, who accompanied Audit for the site verification, stated that heavy discharges from inlets during the rainy season had caused the damage.

Thus, the designing of the river sections, based on understated discharges, resulted in the creation of narrow river sections. As a result, the entire river section (as mentioned in **Table 4.6**) is fraught with the risk of damage, in the event of maximum discharge for a 50/100-year period.

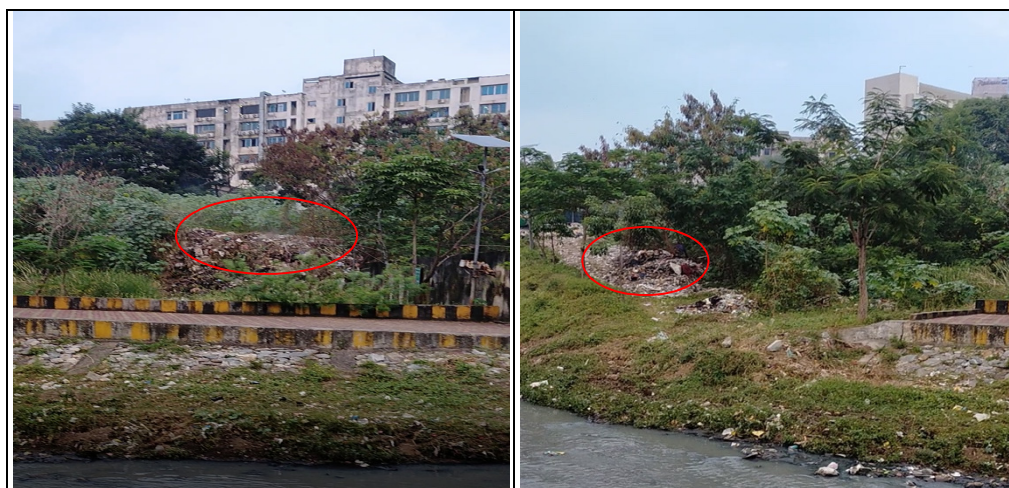
Picture 4.12: Garbage dumped near STP-3

In the approved DPR, provision was made for 40 community waste bins (₹ 10.14 lakh), two three-wheeler auto tippers (₹ 8 lakh) and four tricycles (₹ 0.82 lakh). During joint physical verification (October 2021) of different stretches of the Harmu river by Audit, with the engineers of JUIDCO, almost every stretch was found filled with solid waste. Dumping of solid waste was noticed on the way to and in the construction site of STP-3, near Radisson Blue Hotel. The engineers stated that the Ranchi Municipal Corporation (RMC) was using the place as a dumping yard for garbage. **Picture 4.12** shows the river and riverbank filled with solid waste.

Further, Audit observed that no alternate arrangements had been made by JUIDCO, or by the Department, for the disposal of solid waste, which was found scattered at various places, in the absence of dedicated community waste bins. Further, most of the river stretches and its surrounding areas were so dirty (due to dumping yard of solid waste, operation of *khattals etc*) and it was unlikely that the proposal of keeping community bins, to collect waste, would serve the intended purpose.

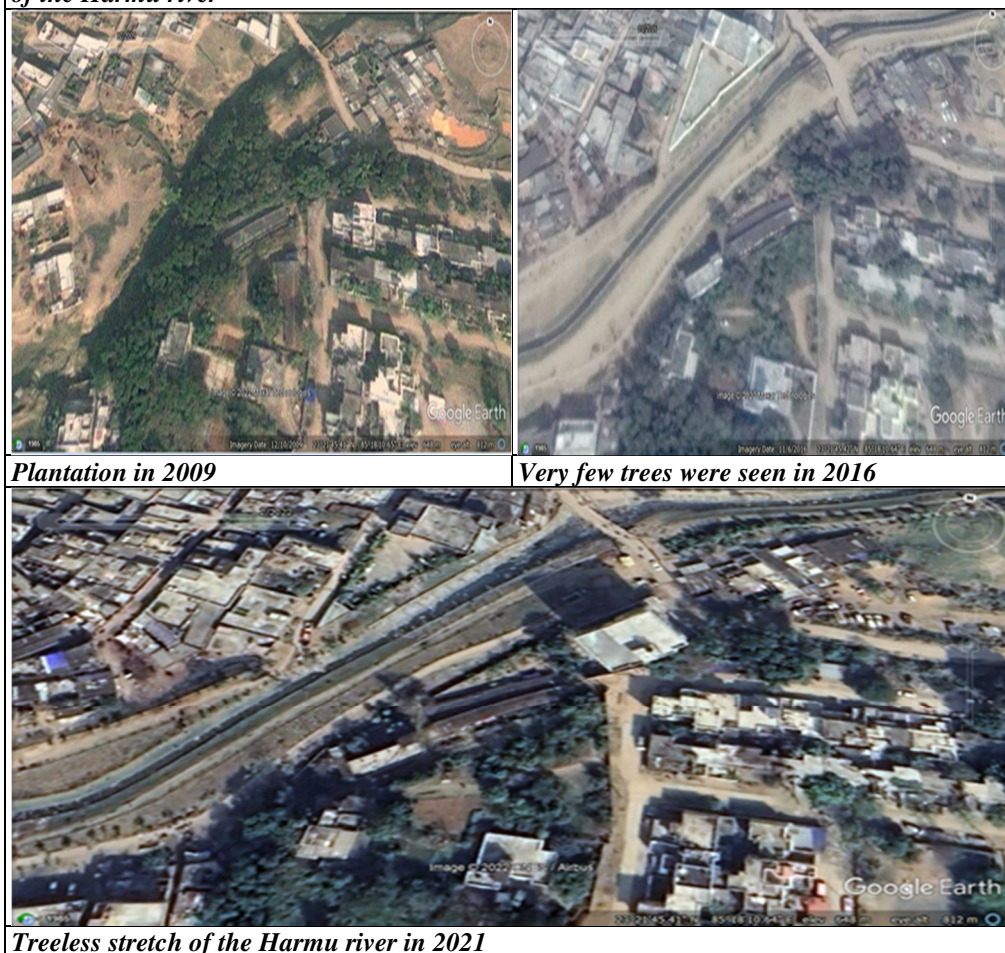
Picture 4.13: Deforestation between Ganga Nagar and Karamtoli, during the rejuvenation of the Harmu river

Audit analysed the plantation works near the Harmu river, during the last 12 years (October 2009 to June 2021), through satellite images of different stretches (*Appendix 4.5*) and noticed a gradual decline in the green cover, over the years, on the banks of the river. An instance of such deforestation, between Ganga Nagar (starting point of the urban stretch of the Harmu river) and Karamtoli chowk, in 2009, 2016 and 2021, is shown in **Picture 4.13** below.

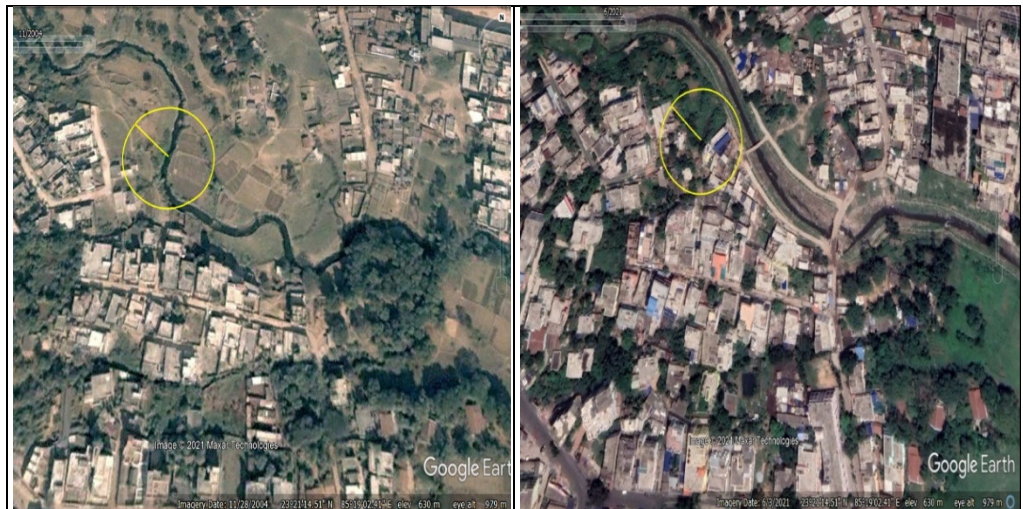
Audit examined the satellite pictures (for the period between November 2004 and June 2021) of the different stretches of the river and observed substantial changes in the course of the river, such as reduction in the river width (**paragraph 4.5.4.3**), change in the river course, encroachment of the river

<p>Picture 4.14: Satellite images of the river (Geographical co-ordinates: 23°21'14.51''N and 85° 19' 2.41'' E), showing encroachment of land (approximately 1,844 sq metres)</p>	
<p><i>The meandering flow of the river, prior to its rejuvenation (date of image: 28 November 2004)</i></p>	<p><i>The meandering portion was straightened after rejuvenation of the river (date of image: 3 June 2021)</i></p>

The changes in the river course resulted in encroachment of the riverfront and the land adjoining the river course. The land, which emerged as a result of changes in the river course, and is seen vacant in **Picture 4.14**, is not protected either by JUIDCO or by RMC and may get encroached.

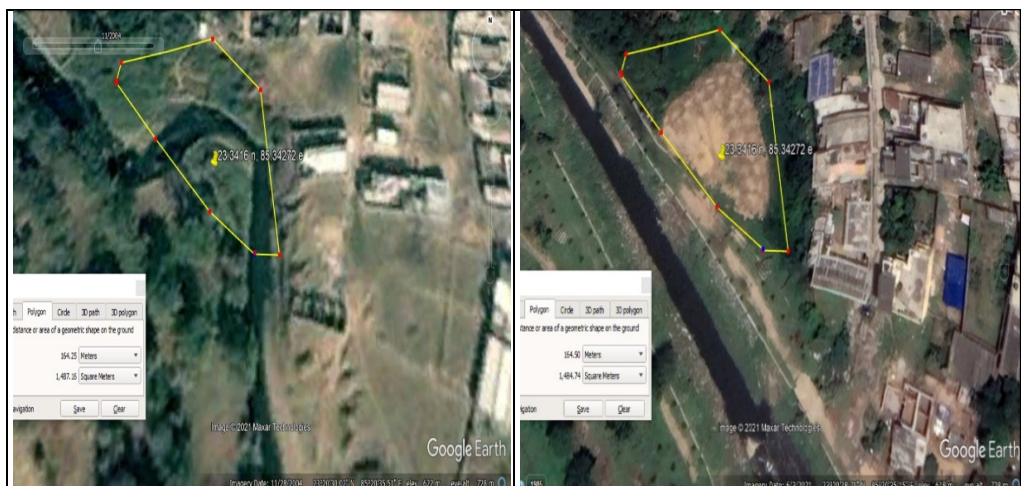
<p>Picture 4.15: Satellite images of the river (Geographical co-ordinates: 23.3416 north and 85.34272 east), showing emergence of land (approximately 1487 metre sq), due to mechanical straightening of the meandering portion</p>	
<p><i>Meandering flow, before rejuvenation of the river (date of image: 28 November 2004)</i></p>	<p><i>The meandering portion was straightened during rejuvenation of the river (date of image: 3 June 2021)</i></p>
