**Report of the  
Comptroller and Auditor General of India on  
Performance Audit on  
Degradation of Kshipra River  
for the year ended 31 March 2021**

**Government of Madhya Pradesh**  
*Report No. 6 of the year 2023*

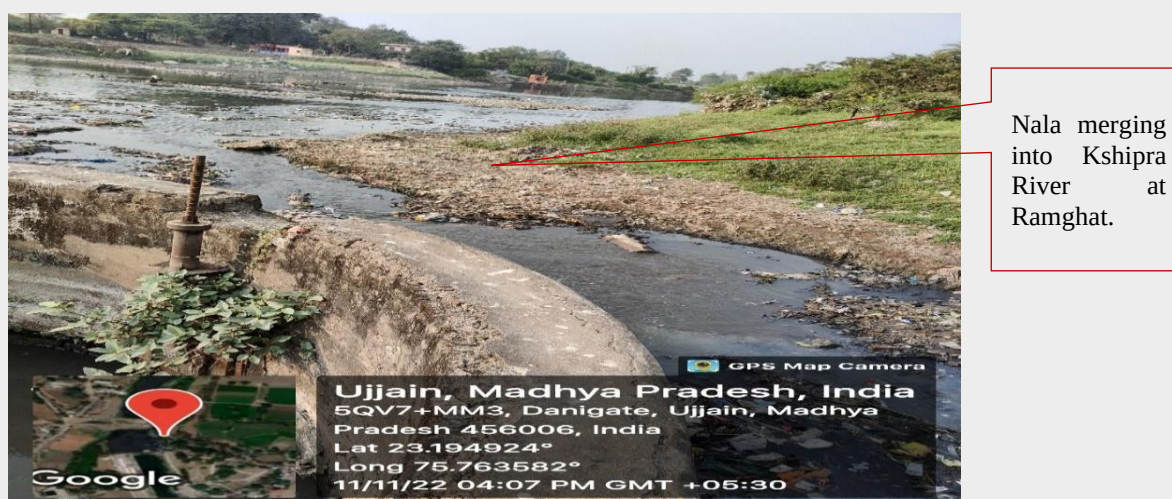
**Images 2.1 to 2.4: Nala merging into Kshipra and Kahn Rivers.**

Further, water quality tests conducted by MPPCB and IIT, Indore (detailed in Chapter 3) also confirm the fact that water quality is not as per prescribed standards as sewage waste is merging into River.

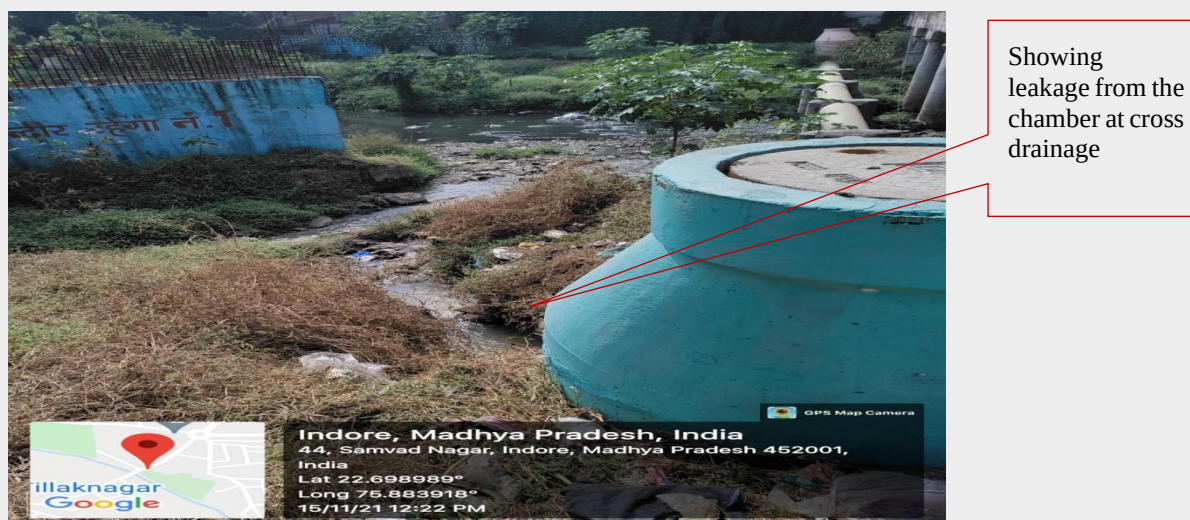
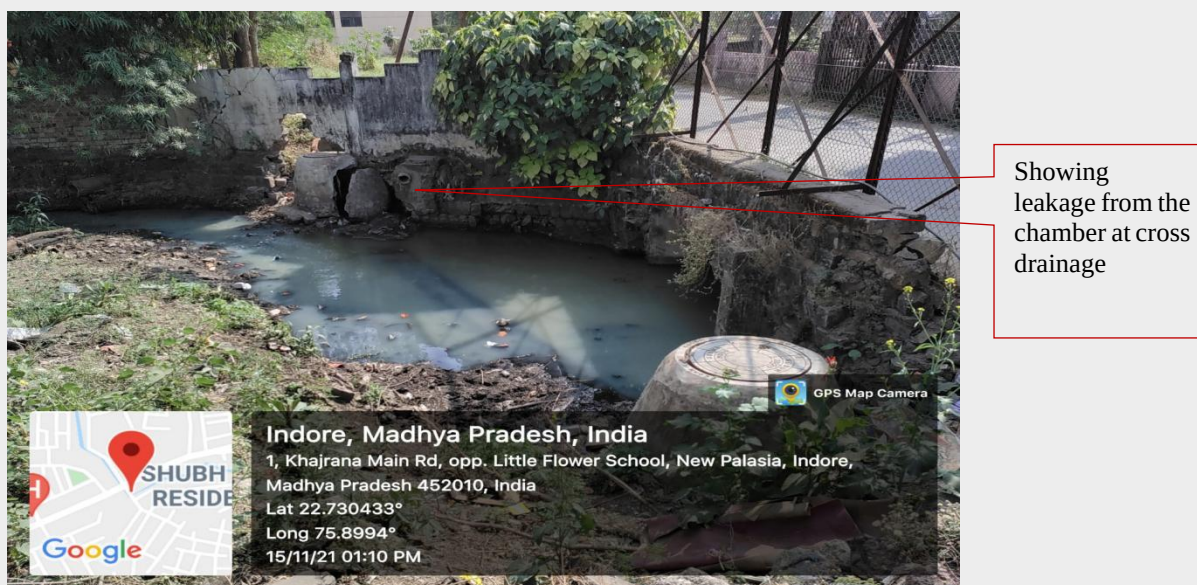
**Images No. 2.10 and 2.11: Showing leakage from the sewerage pipeline in the nala Crossing**

Showing leakage from the chamber at cross drainage

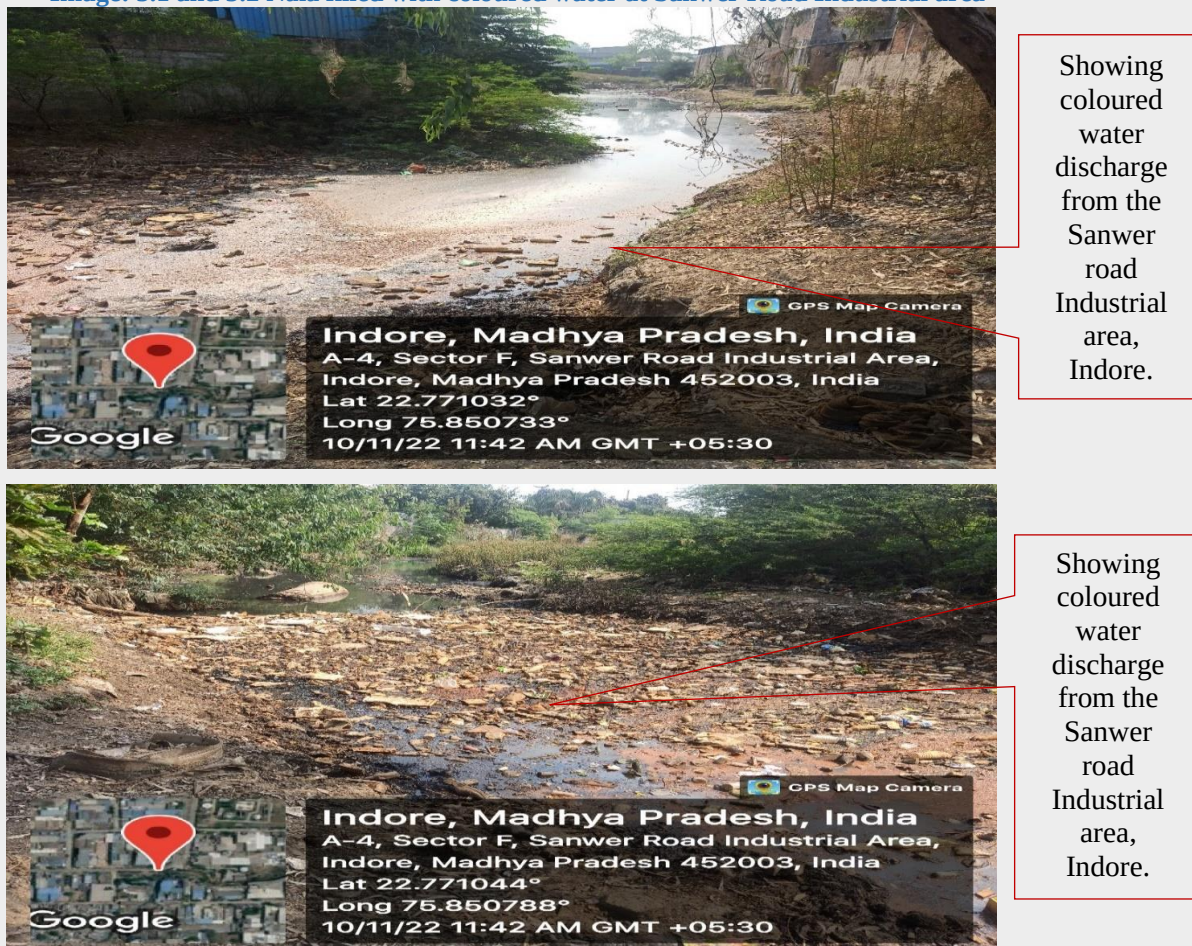
**Image: 3.1 and 3.2 Nala filled with coloured water at Sanwer Road Industrial area**

From the above images, it is clear that industries are discharging industrial waste in nearby drains which were ultimately merging in Kahn River/Kshipra River. Accordingly, findings on above hypothesis are discussed in detail as below:

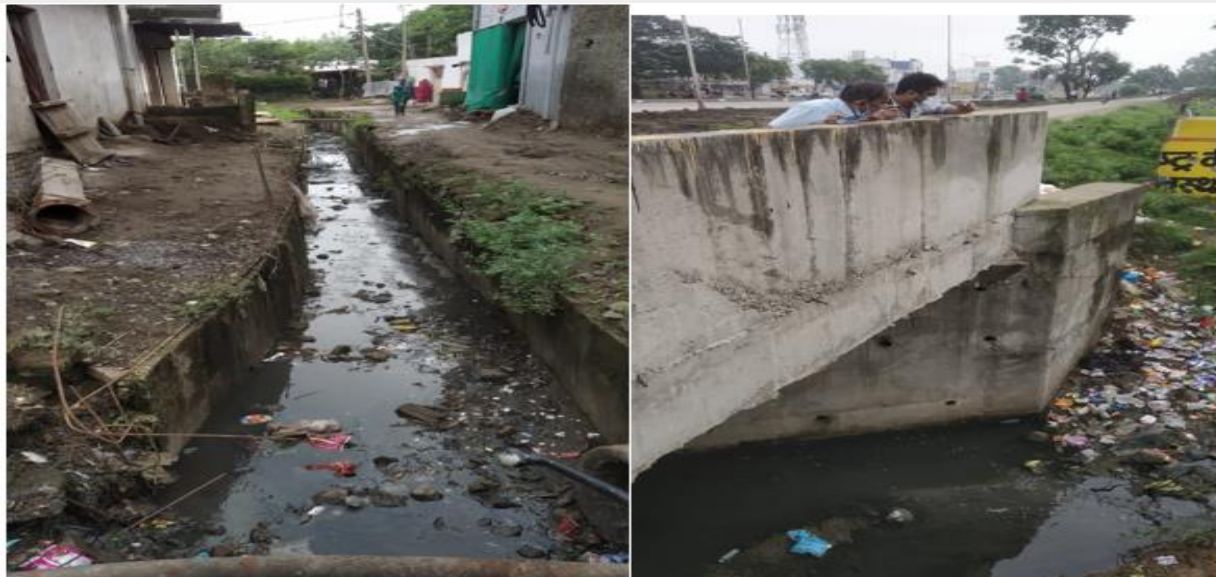
**Images 4.24 and 4.25: Images captured during Physical Verification of Nagdhaman Nala at ULB, Dewas showing solid waste pollutants in the water body**

It is evident from the above that in violation of Municipal Solid Waste Management Manual, the solid waste was flowing through the drains/water bodies in above ULBs. However, no actions were taken in this regard by the concerned ULBs, despite huge expenditure on the processing of solid waste.

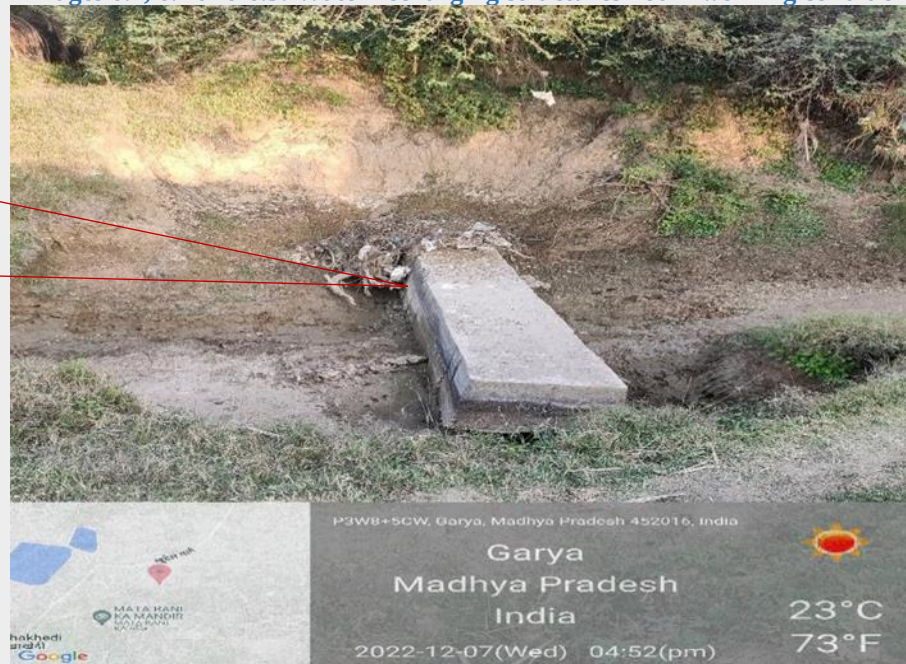
Stop Dam in  
Garya village,  
Indore in  
completely  
damaged  
state.

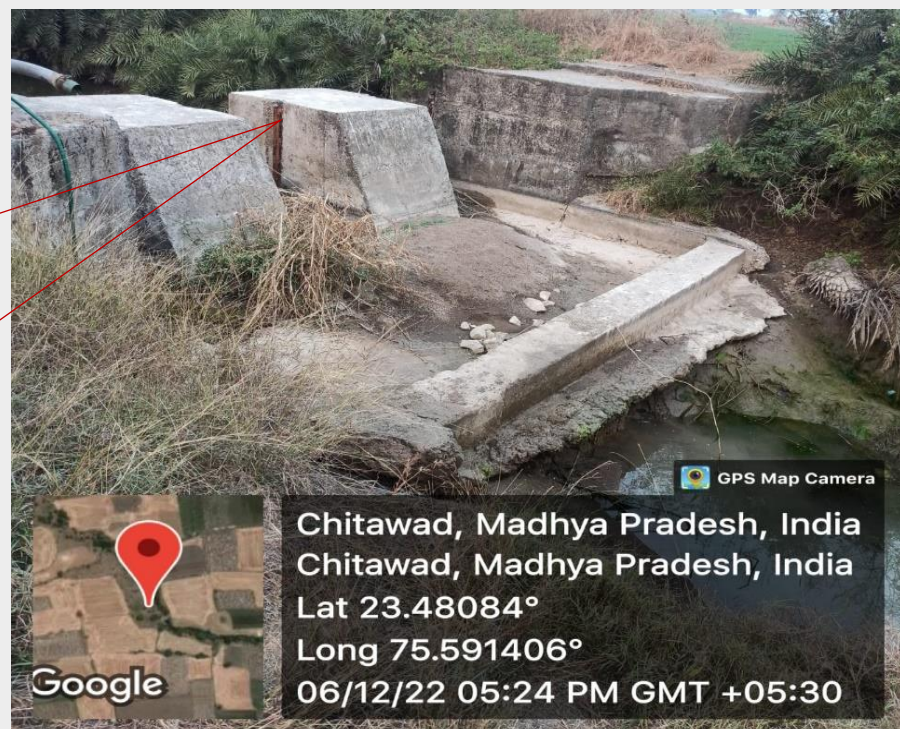
Gate of Stop  
Dam is  
completely  
broken in  
Mundla-  
Parwal  
village in  
Ujjain  
District,  
therefore,  
structure is  
unable to  
retain water.

From the above, it is very clear that due to improper functioning of these water recharging structures, purpose of recharging/ enhancing groundwater in the vicinity of Kshipra sub-basin was not fulfilled.

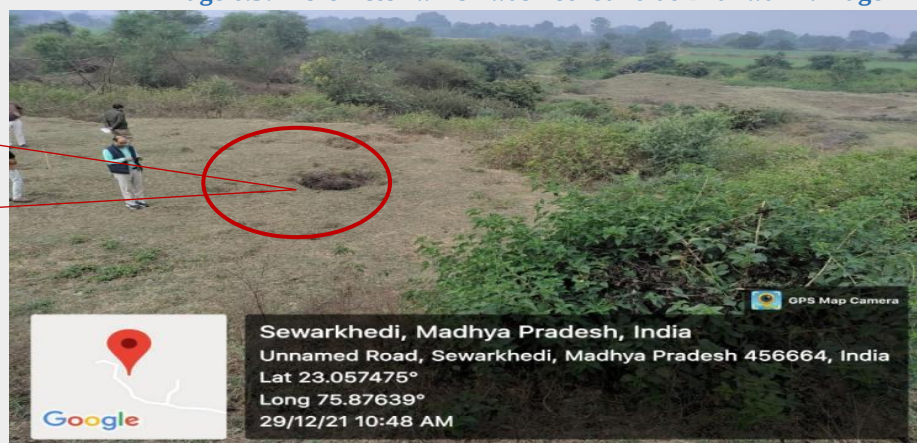
Image 6.5: Piezometer which was not found at Bhanwari Village

Piezometer which was not found in physical verification at Narwar, Ujjain.

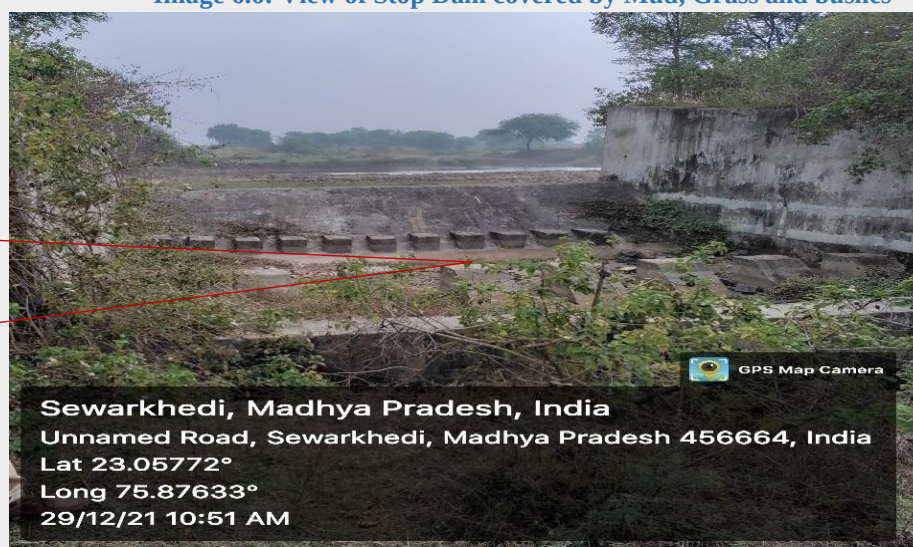
Stop Dam covered with Mud, Grass and Bushes at Narwar, Ujjain

The EE, PHE Division, Ujjain stated (December 2021) that this work was constructed using the Central Fund of CGWB and after construction, no allotment was received either from Central or State Government. Therefore, proper maintenance of these structures was not carried out. Piezometers were not in the scope of work, however, nine Piezometers were constructed by the Mechanical Division to check water level of the particular vicinity.
