Chapter - 5
Execution of Works

MGNREGS ensure basic employment guarantee in rural areas to strengthen the livelihood resource base of the rural people. The focus of the scheme is on works such as water conversion, drought proofing, micro and minor irrigation works, renovation of traditional water bodies, rural connectivity and land development *etc.* Creation of durable assets is another important objective of MGNREGS. As per the Act, the cost of material component shall not exceed 40 *per cent* at the district level. Further, the Operational Guidelines, 2013 prescribes that the State Government should devise a mechanism for transparent method of purchase of materials to be used under the scheme. Audit noticed several deficiencies in execution of works such as shortfall in execution of work, execution of inadmissible works, doubtful execution of work, wasteful expenditure, non-deduction of royalty, non-verification of bills/ vouchers, irregularities in payment of wages of unskilled, skilled/semiskilled labour and material payment, *etc.* which are discussed in the succeeding paragraphs.

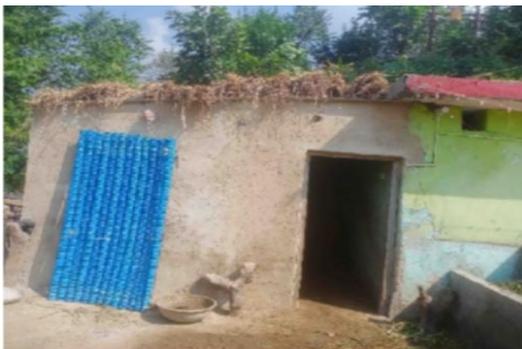
Figure-5.1: Status of asset before start of work as per Geo-tagging (29.10.2022).

Geo-tagged photograph of first phase (before start of work) of the work showed that the work already existed as can be seen from the photograph given below. Further, during physical inspection (06.08.2024), the work already existed had no change in its built structure. Hence, the expenditure of ₹ 0.65 lakh on already existed asset was doubtful.

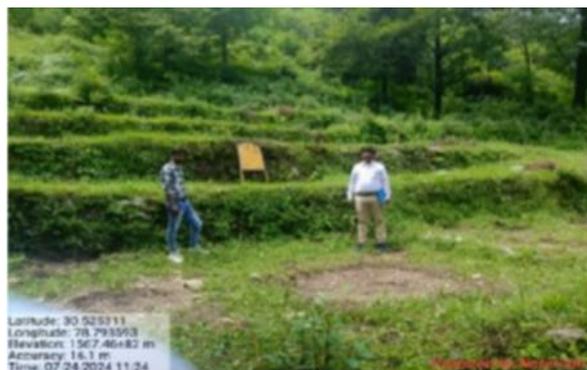
Figure-5.3: Gherbad/Bhumi Sudhar/Bhagwani/Nursery work in GP Meher Gaun (24.07.2024).

During the physical inspection (24.07.2024) of the above work, the audit found only a few scattered dug pits. There was no evidence of land development work such as levelling, drainage, or other activities associated with projects. Only a few saplings were planted. The actual work on the ground does not align with the sanctioned project. A critical component of the project, the nursery was non-existent, and land preparation appeared minimal even after an expenditure of ₹ 3.24 lakh as per NREGASoft on payment of wages of unskilled labour. Thus, lack of physical evidence indicated that the project funds have not been utilised effectively.

In the Exit Conference (January 2025), the Secretary of RDD assured that these matters, along with similar issues in other Blocks that were not part of the audit sample, would be investigated and action would be taken against officials found responsible.

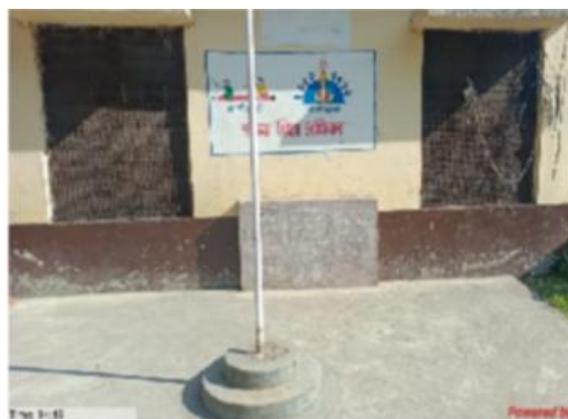
Figure-5.4: Amrit Vatika/Poudhropan karya in GP Bunga (10.10.2024).

During the physical inspection in GP, *Bunga* (10.10.2024), it was found that a "*Shilaphalakam*" was already erected at the site, signifying that the work had been completed. However, upon cross- verification the status of the work in NREGASoft, the work was listed as approved but reflected zero expenditure. Further, physical records like work order, muster rolls used, bill in respect of purchase of material, MB, etc. was not available at

GP as well Block levels. The absence of any expenditure from the MGNREGS fund raises questions about the source of funding and adherence to prescribed processes. The completion of the project without any financial record suggests either unreported expenditures or picking up of an already completed project.

In the Exit Conference (January 2025), the Secretary of RDD assured that the matter would be investigated, and action would be taken against any officials found responsible.

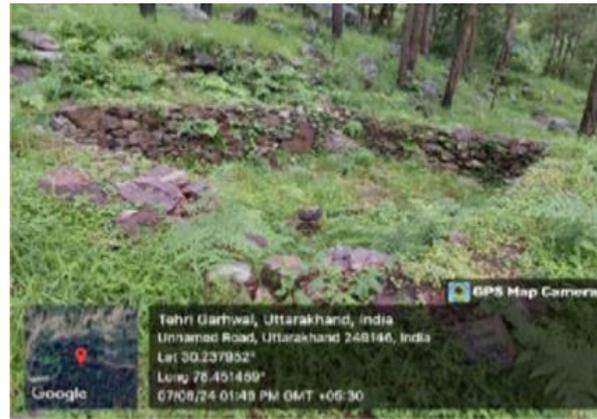
Figure-5.5: Chahel Nirman/Water conservation work in GP Thanyul. (07.08.2024).

- The pond had grass and other vegetation growing inside it, indicating that it had not been maintained or utilised effectively for water conservation.
- There was no inlet channel observed at the site, which is critical for channelling water into the pond.
- Further estimate for the project included a provision of ₹ 21,205 for creating contour furrows, which are necessary for preventing soil erosion and aiding water conservation, absence of contour furrows raised concerns about the proper utilisation of the allocated funds for water conservation.

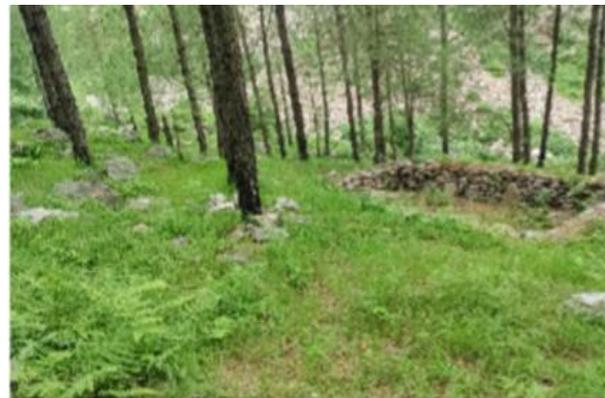
Figure-5.6: Geotagged photograph after completion of work (19.07.2022).

Analysis of uploaded geotagged photographs, dated 19.07.2022 (after the completion of work), corroborated these findings.

The photos revealed that there was no inlet channel, no contour furrows, and grass had already grown over the area. These observations confirm the absence of critical design features and validate the deficiencies noted during the physical inspection.

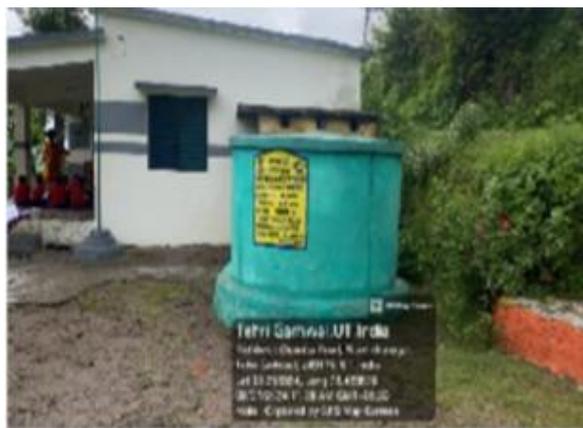
Figure-5.7: Rainwater harvesting tank in GP Dandli (07.08.2024).

The sanctioned work involved the construction of a rainwater harvesting tank at the primary school of Dandli village. During physical inspection (07.08.2024), it was found that construction of the tank did not include important features required for effective rainwater collection and storage, such as the tank missing key design

elements, particularly the inlet system, which is crucial for efficiently collecting rainwater and carrying it into the tank. Additionally, the tank did not have an adequate overflow management system, which is crucial for ensuring the longevity and functionality of the structure. This indicates lack of proper planning and adherence to the technical specifications required for such type of project. This indicates that the tank is not functional as a rainwater harvesting system, and as a result, it did not fulfil its intended purpose.

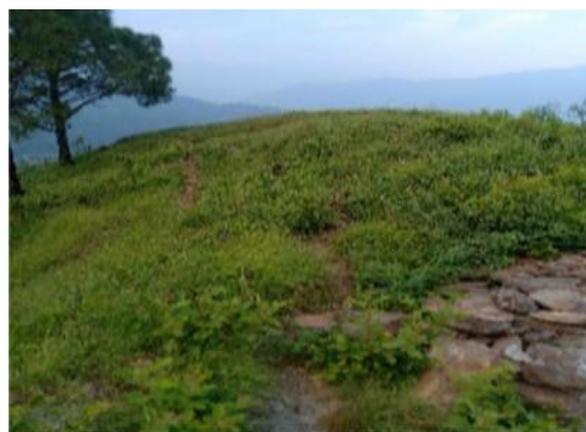
Figure-5.8: Vanikaran work in GP Dandli (07.08.2024).

During the physical verification (07.08.2024), no surviving plant was found at the site, indicating either failure in plantation and maintenance or a complete lack of implementation on the ground. The installation of a signboard to provide details about the project was also missing, further indicating a lack of transparency.

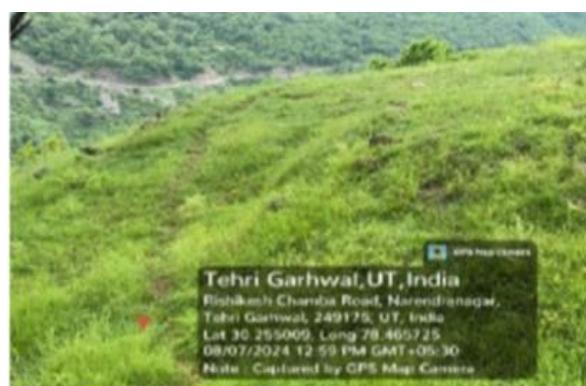
Figure-5.9: Geotagged photograph after completion of work (08.07.2021).

The geotagged photograph uploaded after completion of work on 08.07.2021 (after the project was declared completed) revealed no signs of plantation or saplings at the site. This strongly indicates that the Gram Panchayat did not carry out any plantation activity, corroborating the audit observations and raising serious concerns about the authenticity of the reported work.

In the Exit Conference (January 2025), the Secretary, RDD assured that these matters, along with similar issues in other Blocks that were not part of the audit sample, would be investigated and strict action would be taken against officials found responsible.

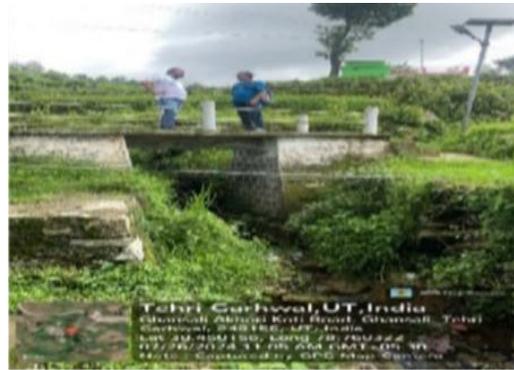
Figure-5.10: Construction of Puliya in GP Akhodi. (26.07.2024).

During physical inspection (26.07.2024), it was found that the construction of the bridge has significantly benefited the local community, especially during the rainy season. The construction of the bridge has improved the accessibility for villagers, allowing them to travel safely and conveniently, even when the drain is flooded. The completion of this work under MGNREGS has not only provided essential infrastructure but also empowered the local workforce by engaging them in the construction process, thereby enhancing their livelihood opportunities while improving the overall quality of life in the area.

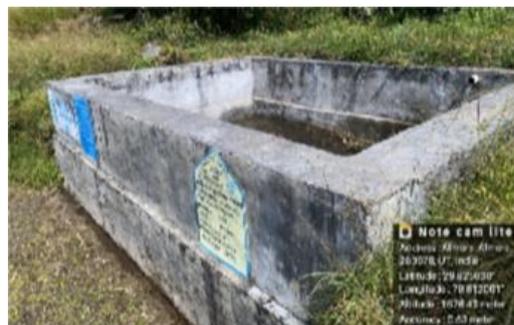
Figure-5.11: Construction irrigation channel and tank in GP Jeetap (10.10.2024).

During the physical inspection (10.10.2024), it was found that the irrigation channel and tank were both well-constructed and functional, with the irrigation channel actively channelling water into surrounding agricultural fields. This irrigation infrastructure has provided great benefits to local farmers, enhancing crop production and ensuring a more reliable water supply for cultivation. The work also led to improved crop yields and significant reductions in the unpredictability associated with water availability.

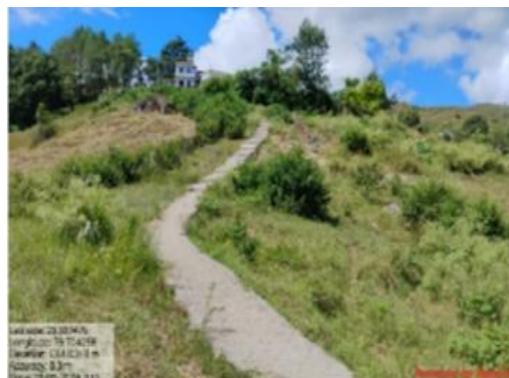
Figure-5.13: Construction of C.C Marg in GP Tatik (28.09.2024),

During the physical inspection (28.09.2024), it was found that the constructed road was well-built. The road has significantly enhanced connectivity for residents, facilitating access to essential services such as schools, markets, *etc.* The project provides employment opportunities to villagers, with fulfilling the core objective of MGNREGS. This case underscores the importance of MGNREGS as a transformative tool for rural development.

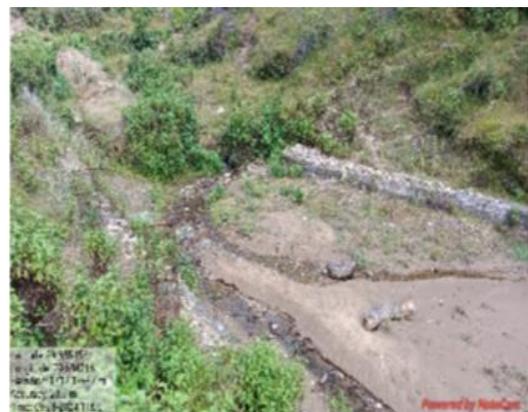
Figure-5.18: Construction of Amrit Sarovar in GP Matena showing lack of inlet channel and silt trap (28.09.2024).

- Essential provisions, such as catchment demarcation, runoff calculation, inlet channels, silt traps, and durable masonry structures, were neither included in the project estimate nor executed during construction.
- This non-compliance with Government of India guidelines may impact the Sarovar's functionality and efficiency.

During the Exit Conference (January 2025), the Secretary of RDD assured that the matter would be thoroughly investigated and strict action would be taken against responsible officials.

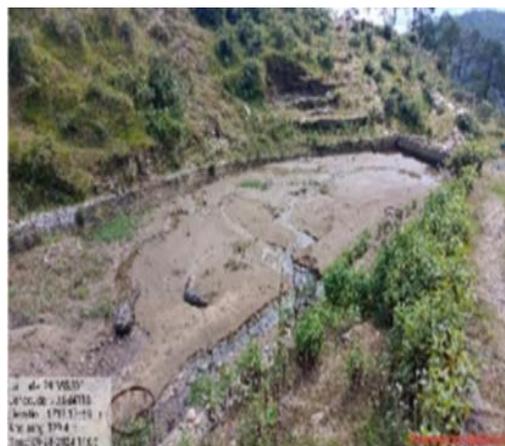
Figure-5.19: Showing silt in Sarovar (28.09.2024).

- The lack of proper catchment demarcation and inlet channels may result in uncontrolled water flow, leading to soil erosion, formation of gullies and reduced water retention capacity.
- Without silt traps, sediment accumulated in the Sarovar, further may reduce water storage capacity and increasing maintenance costs.

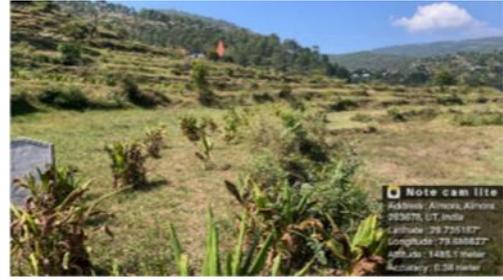
Figure-5.20: Work of Damask rose cultivation in GP Esalna (09.10.2024).

- No Damask rose plant was found alive at the site, with no evidence of the 2,700 pits reportedly dug for planting.
- Analysis of uploaded geotagged photo dated 23.11.2021 (after completion of work) also revealed that there was no evidence of any dug pit and plantation of damask rose.
- Financial records also revealed discrepancies. As per the Measurement Book (MB) an expenditure of ₹ 1.06 lakh for unskilled labour under MGNREGS, was shown. However, verification with muster rolls indicated that only ₹ 0.96 lakh was spent on payment of wages to labourers, the discrepancy of ₹ 0.10 lakh highlights gaps in documentation and reporting.

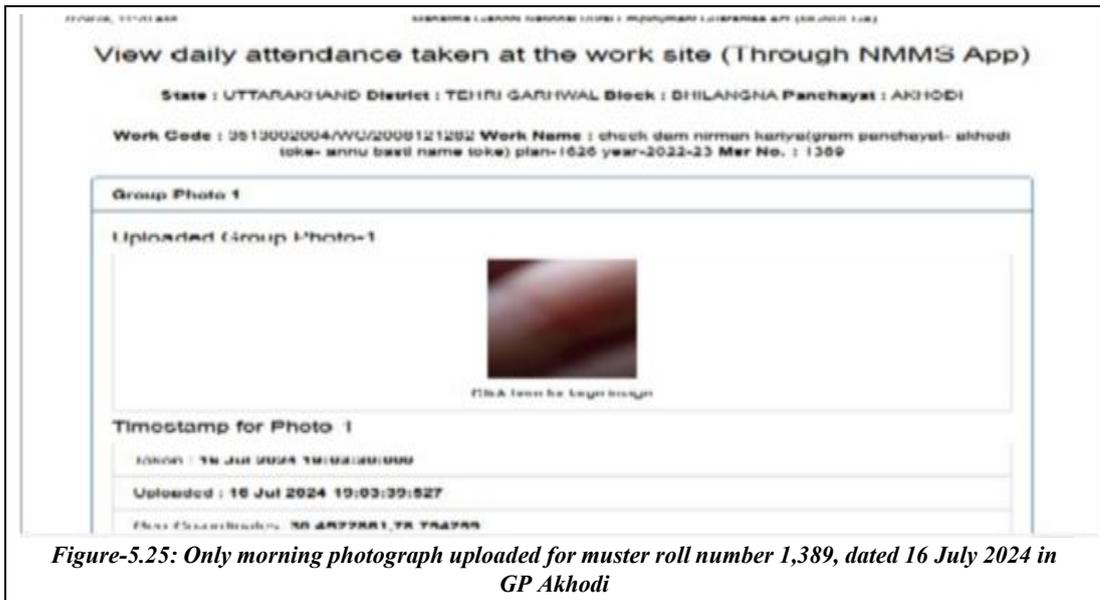
Figure-5.25: Only morning photograph uploaded for muster roll number 1,389, dated 16 July 2024 in GP Akhodi

- ❖ On 16 July 2024, for muster roll number 1,389, only the morning session photograph was uploaded which showed the finger only, no photograph was uploaded for the evening by the gram panchayat Akhodi of Bhilangana Block.

In the Exit Conference (January 2025), the Secretary, RDD, intimated that corrective measures are being implemented.
