## CHAPTER-IV

### ILLEGAL MINING

Audit examined sites of 217 leases of 16 districts from Google Earth and found instances where minerals were excavated outside lease area and without grant of mining lease. It was also found that lessees did not follow the sand mining guidelines and provisions of the UPMMC Rules, 1963 and excavated the mineral with the help of excavators. Some observations are illustrated below with images obtained from Google Earth highlighting the objected areas:

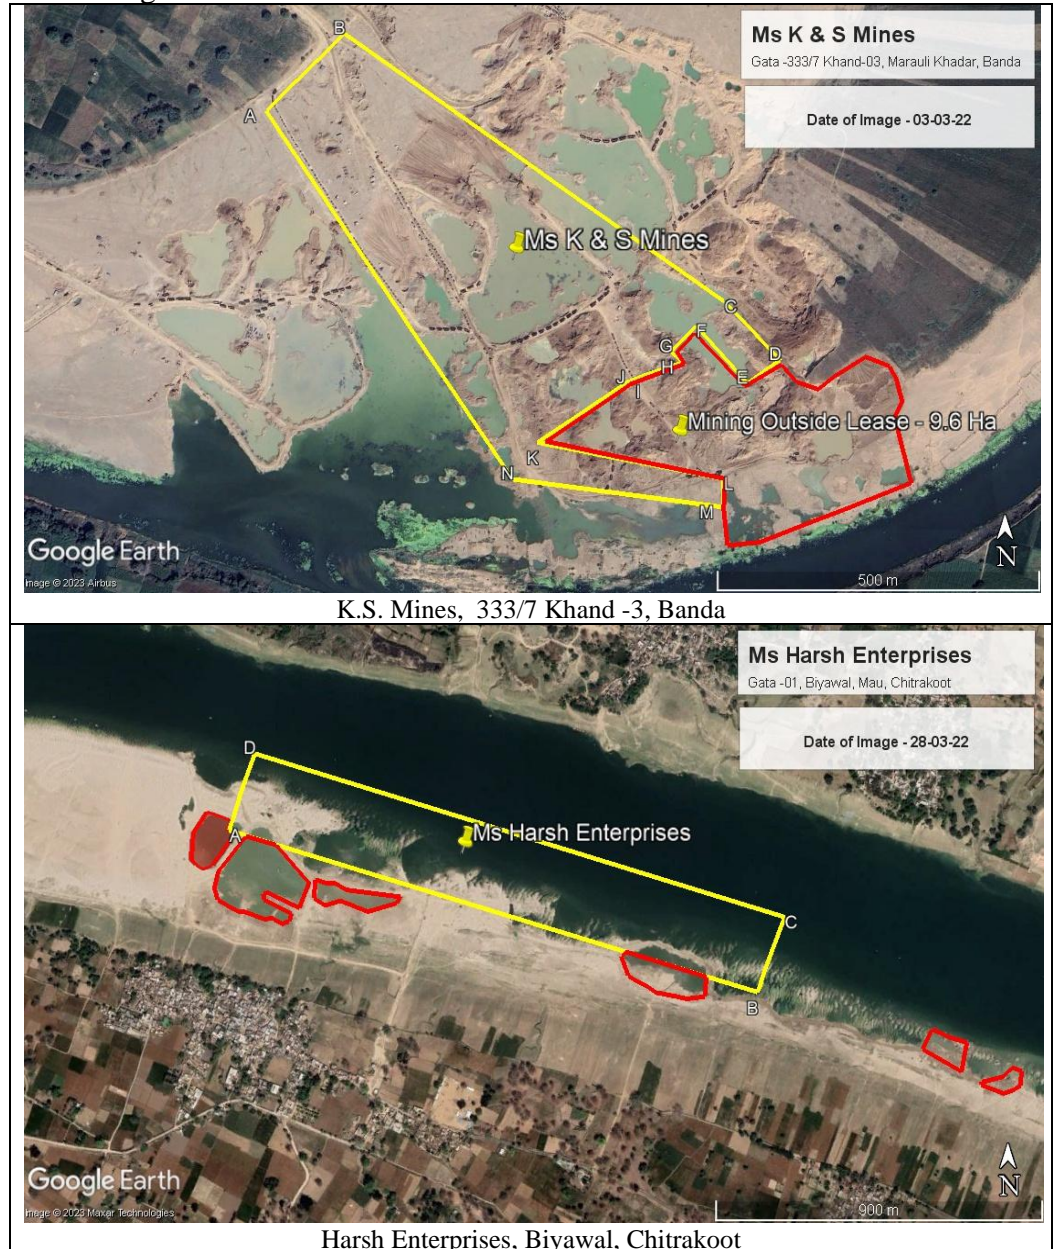
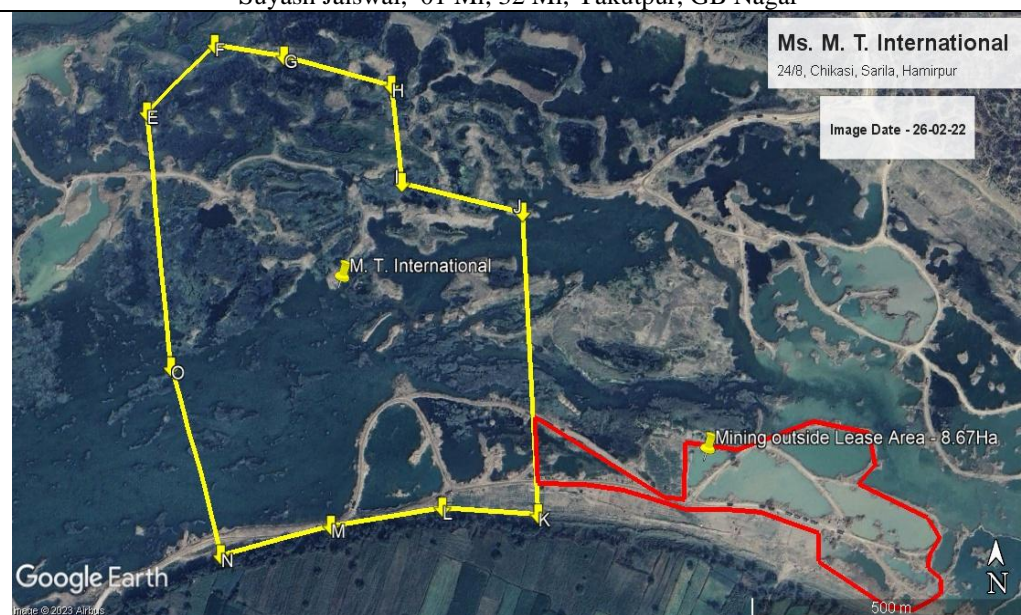
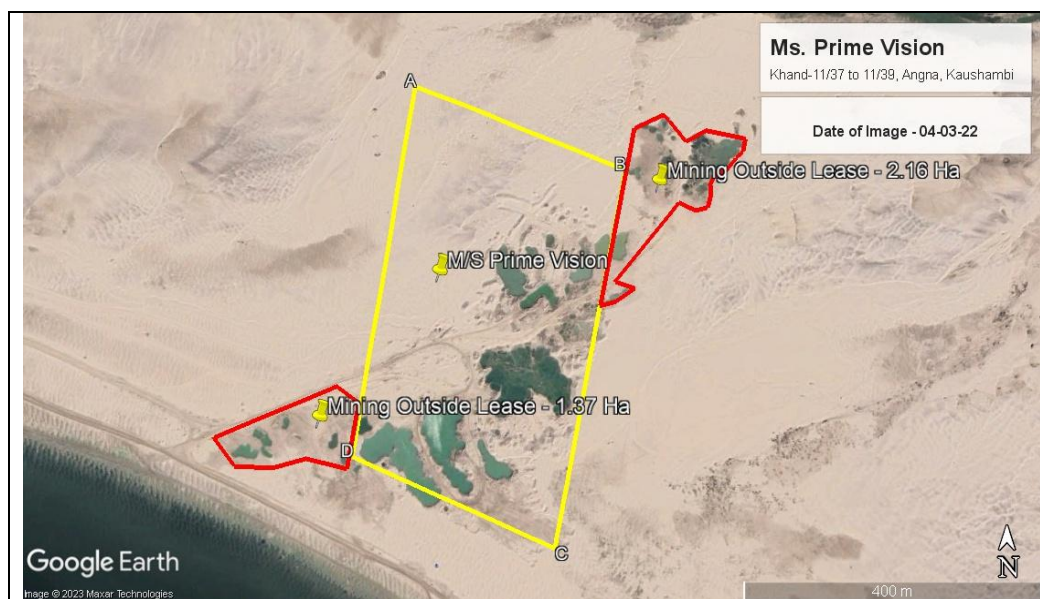
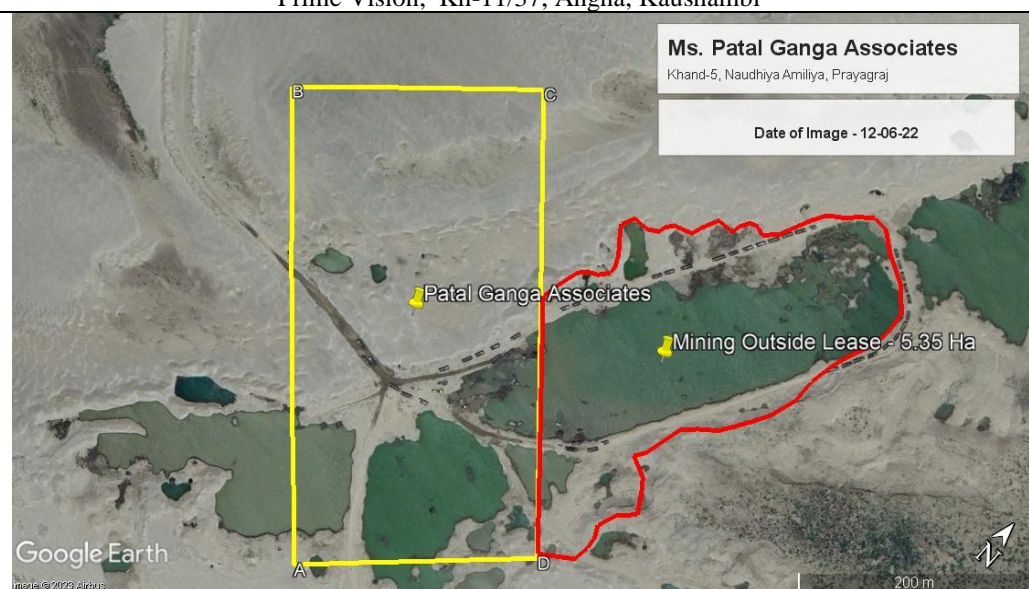
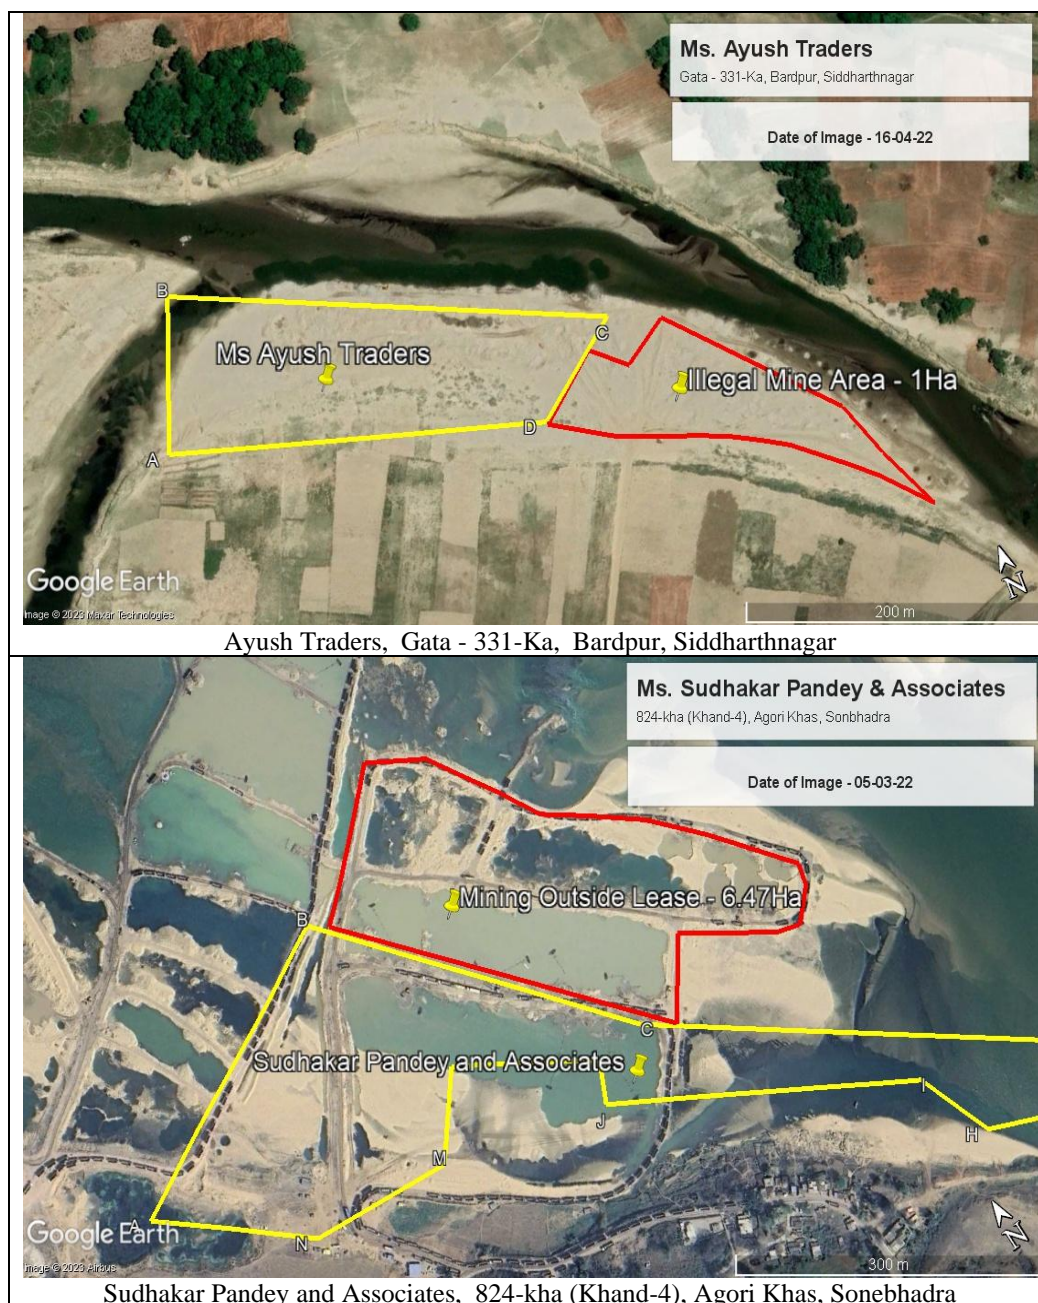
Figure 4.1- Excavation of minerals outside lease area  
(Lease area – Yellow Polygon, Illegal mined Area- Red Polygon)

After plotting the geo-coordinates of 217 mining leases of 16 districts as shown in EC/demarcation report, Audit observed in 11 districts that minerals were excavated outside lease areas allotted to 45 lessees and total area in which illegal mining was done was approximate 268.91 hectare (26,89,100 square meter). On the conservative side, taking depth of minimum one meter,

Tesmus Trading, Composit - Sangoli Gadha Fatehpur

Suyash Jaiswal, 01 Mi, 32 Mi, Yakutpur, GB Nagar

M. T. International, 24/8 – Chikasi, Hamirpur

Prime Vision, Kh-11/37, Angna, Kaushambi

Patal Ganga Associates, Khand -05, Naudhiya Amiliya, Prayagraj

Ms Prime Vision, Gata No.-1/1, Dariya Baramad, Saharanpur

The Department, in its reply (July 2023), stated that the mining work being done by the lessee is periodically checked by the district level Task Force. Apart from this, through technological intervention, illegal mining is checked by conducting drone survey. Action is taken as per rules if illegal mining is found outside the sanctioned mining area during inspection. Legal action is not possible on the basis of the image obtained from Google Earth and the estimated measurement of the mining pits outside of the area.

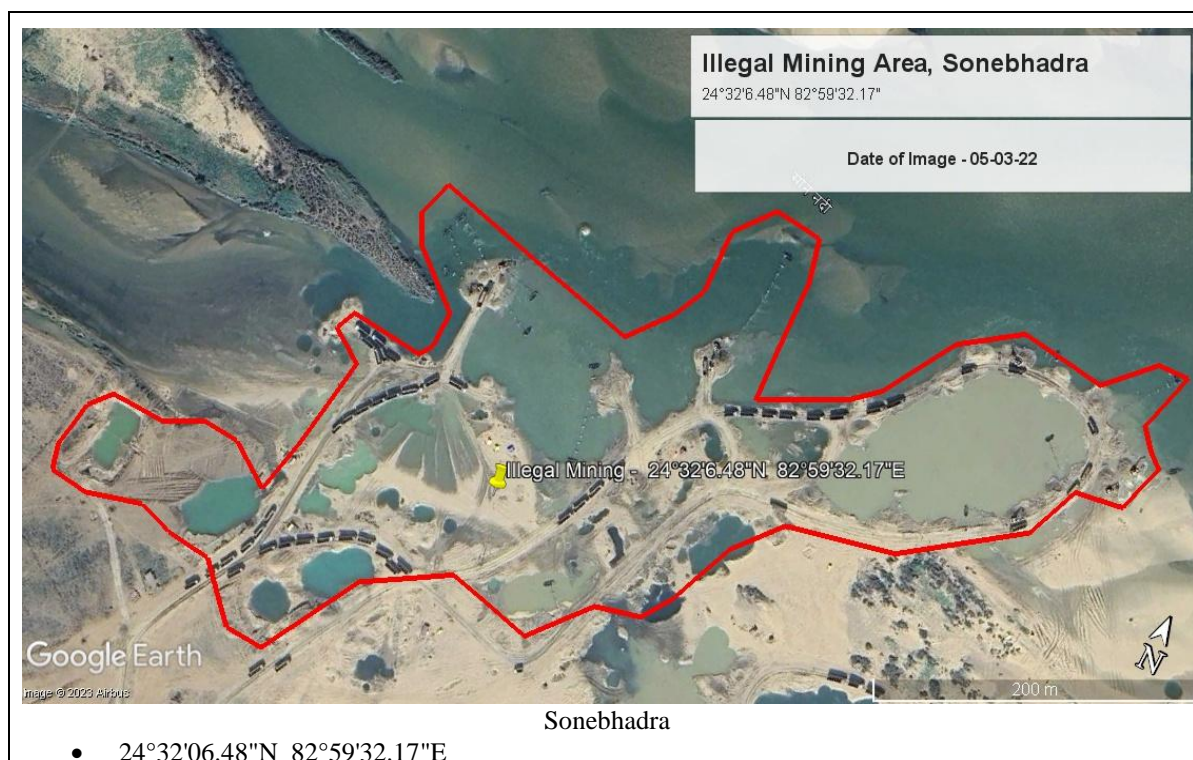
Figure 4.2- Excavation without grant of mining lease (Illegal mining area – Red Polygon)

After plotting the geo-coordinates of 217 mining leases of 16 districts as shown in EC/demarcation report, Audit observed that in three districts, five cases of mining excavation occurred in an area of 30.40 hectares without the grant of mining leases. The satellite imagery clearly showed a consistent pattern of vehicular movements, presence of poclains/excavators/suction pumps and surface texture indicative of mining activities in these areas. The details of the observed cases are provided in **Table-4.4**.

The Government, in exit conference, assured to take necessary action on matter of mining excavation without grant of mining lease.

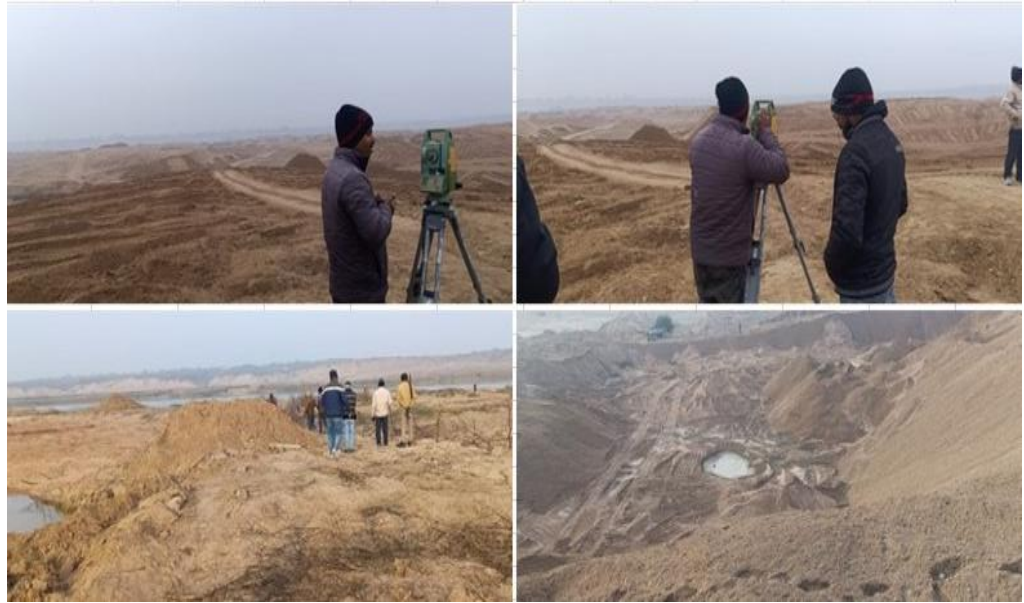
Figure 4.4: Photographs captured during data collection

Further, on field visit total five large pits of 6-10 meter depths from reference level along with 4 small pits were found in AOI-1 which were not clearly visible from Google Earth imagery of 15 May 2022. The undisturbed lands are taken as a reference level and an elevation contour map is prepared

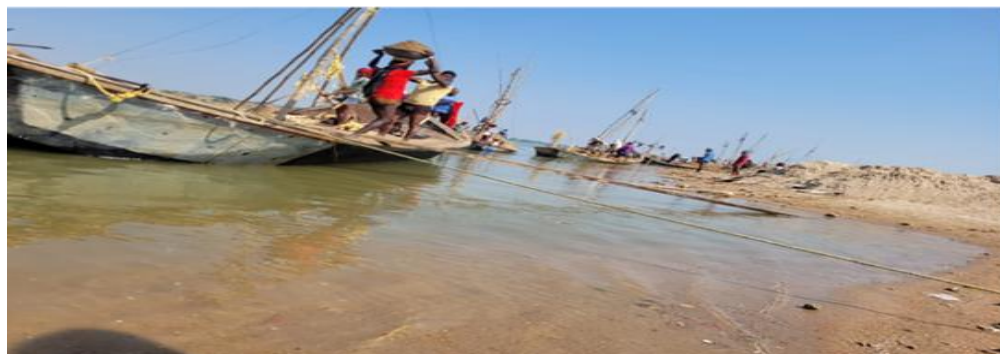
Figure 4.9: Photographs captured during field visit of Prayagraj

During field visit in February 2023, Audit noticed that lease site had not been utilised efficiently for mining purpose instead it was being utilised for dumping the sand. Sand was being brought by boats from other places and the lease site was being used for dumping purpose (Figure 4.9).

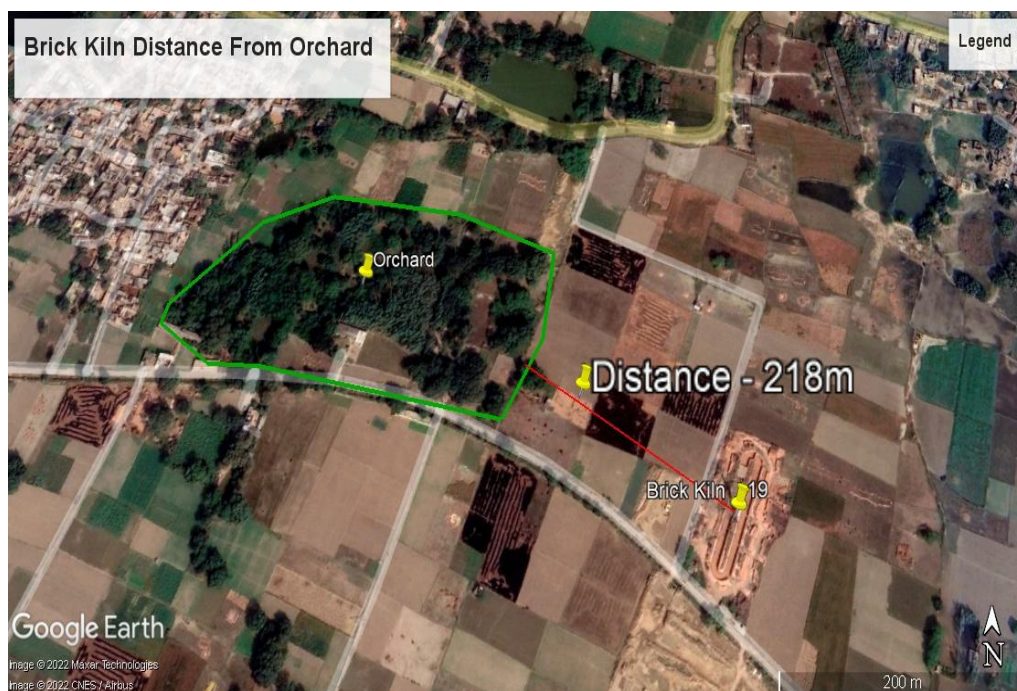
Audit noticed that one brick kiln in district Kaushambi was established violating 800m distance norm from Orchard.

Figure 4.24: Distance from orchard (Kaushambi)

**The Government may ensure that all brick kilns established in violations of the norms and operating illegally are closed.**
