Chapter 1

FIRE ACCIDENTS IN PASSENGER COACHES IN INDIAN RAILWAYS

1.1 Executive Summary

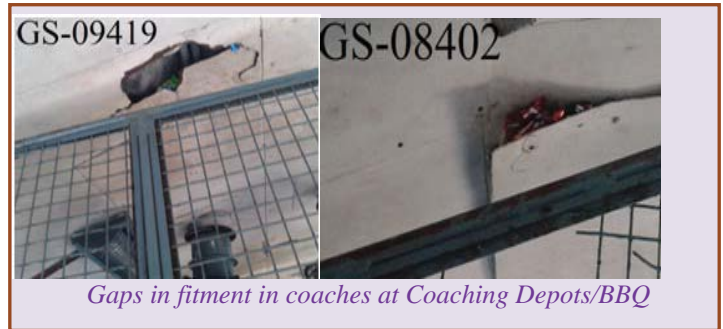
Thus, the RB instructions regarding fire safety during maintenance remained to be complied with in a significant number of coaches. Inadequate compliance indicates the existing system of monitoring was not effective/ inadequate.

The reply is not convincing as the instances pointed out indicate that RB instructions were not followed scrupulously. As many as 28 out of 49 fire accidents (57 per cent) during the period from 2011-12 to 2013-14 took place on account of short circuits which could have been avoided by strict enforcement of RB instructions on coach maintenance. Hence, RB should closely monitor the strict adherence to these instructions.

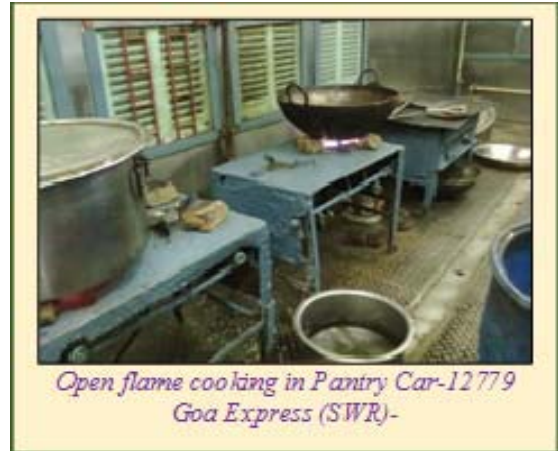
6	Accumulation of empty card board boxes and other waste materials	7 (CR-1, NER-3, WR-2, SR-1).
7	Exhaust fans not in working condition in non-AC pantry cars	2 (NER-1, NFR-1)
8	Tapping of power from fan and light through open wires to connect mobile phones etc.	5(CR-2, NER-3)
9	Suitable space for stocking and servicing meals not earmarked	12 (CR-1, ER-7, SWR-1, SECR-2,SR-1)
10	Food wastes dumped near toilets and vestibule area	11 (ER-2, NER-2, NFR-2, SER-1, NR-2, SR-2).
11	The maintenance and upkeep of refrigerators, boilers, electronic devices, wiring system, chimney and junction boxes not done during maintenance	14 (CR-3, NER-3, NFR-2, SER-2, SECR-3, SR-1).

The above deficiencies/ non-compliance indicated that the monitoring mechanism to prevent fire in pantry cars was not effective posing a threat of fire to the travelling public.

RB replied (April 2015) that a policy to provide precooked food to passengers and another project to enable passengers to book meals of their choice through internet/SMS has been initiated to ensure reduction in onboard cooking. It was also stated that to curb the fire hazards in pantry car, RB issued guidelines for upkeep of pantry cars.
