**Report of the  
Comptroller and Auditor General of India  
on  
Water Injection Operations  
in Western Offshore, ONGC**

**Union Government  
Ministry of Petroleum & Natural Gas  
No. 19 of 2021  
(Compliance Audit)**

**Water Injection Operations  
in Western Offshore, ONGC**

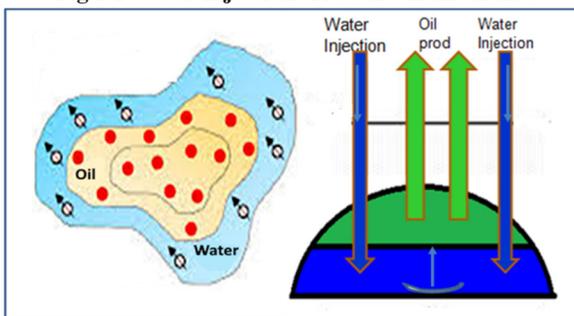
**Fig 1.1 Water Injection: Pressure maintenance**

The water is injected in the aquifer through several injection wells surrounding the production well.

Water is injected to support pressure of the reservoir (known as voidage replacement) and also to sweep or displace oil from the reservoir and push it towards the well. Water injection is one of the most useful techniques for enhancing the oil production not only because of the low cost of water but also because of the characteristics of water which helps sweep the trapped oil efficiently. It is the most successfully used secondary oil recovery method in oil fields of all sizes all over the world.

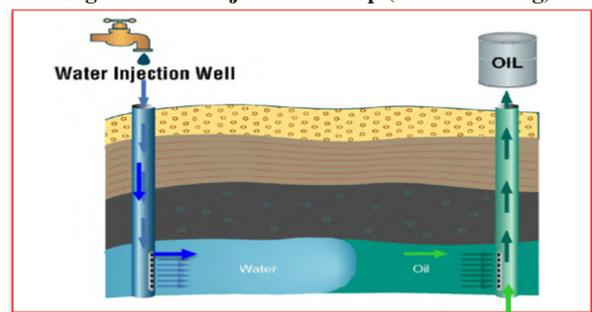
**Fig 1.2 Water injection: Sweep (water flooding)**

The water is injected in the oil zone to create sweep effect.

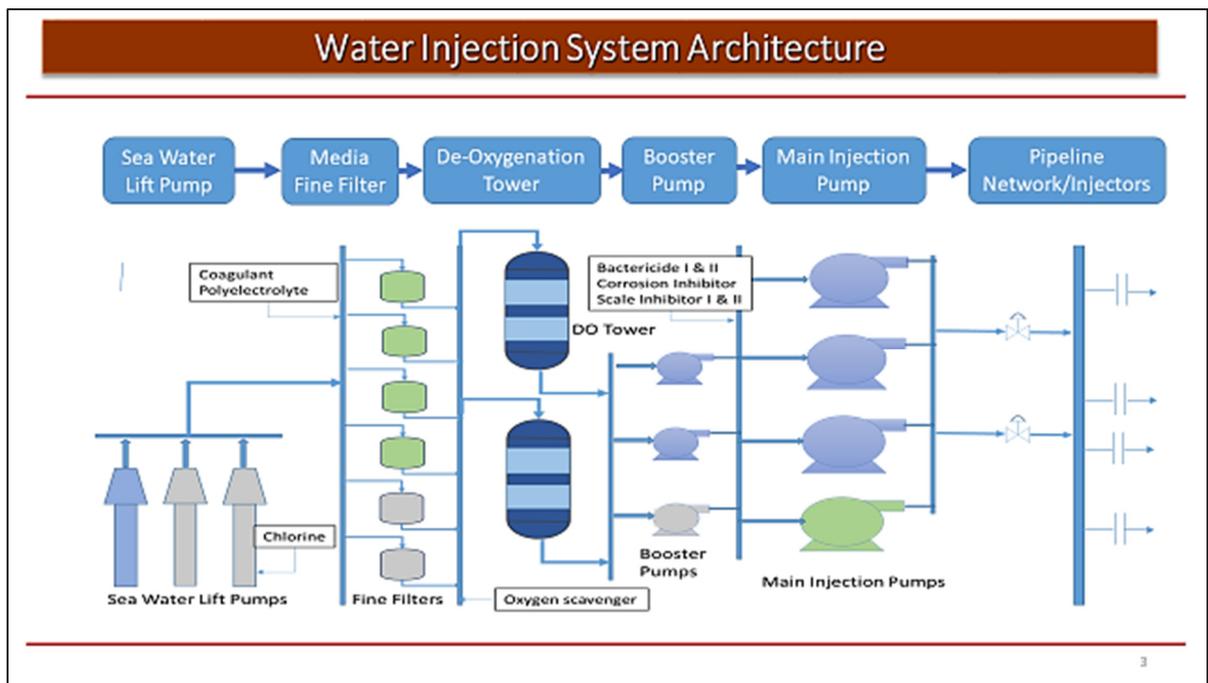
**Fig 5.1 Water injection system architecture**

Hence it is essential that the seawater is treated effectively before it is injected. The treatment scheme for injection water is therefore designed to be such that water is free from above problems.

The equipment used in the water injection process has been described in Para 4.2. The treatment of seawater on water injection platform mainly comprises of following sub-processes:

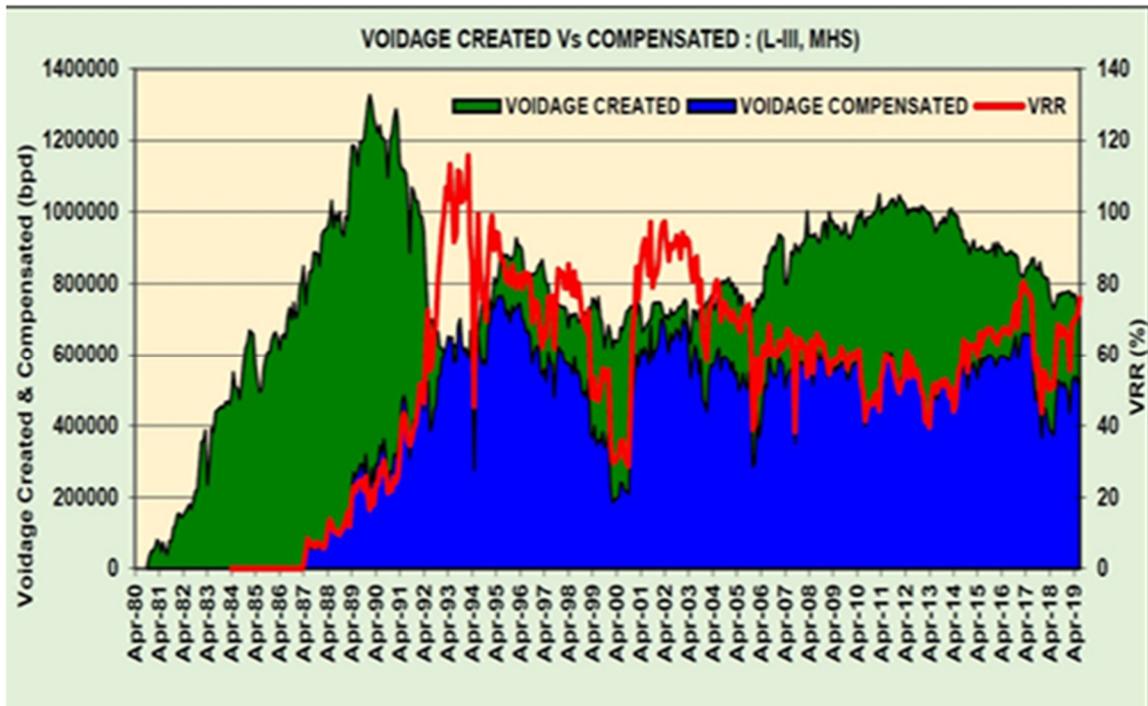
**Annexure-IV  
(as referred to in Para 3.6)  
Mumbai High South**

VRR - Voidage Replacement Ratio

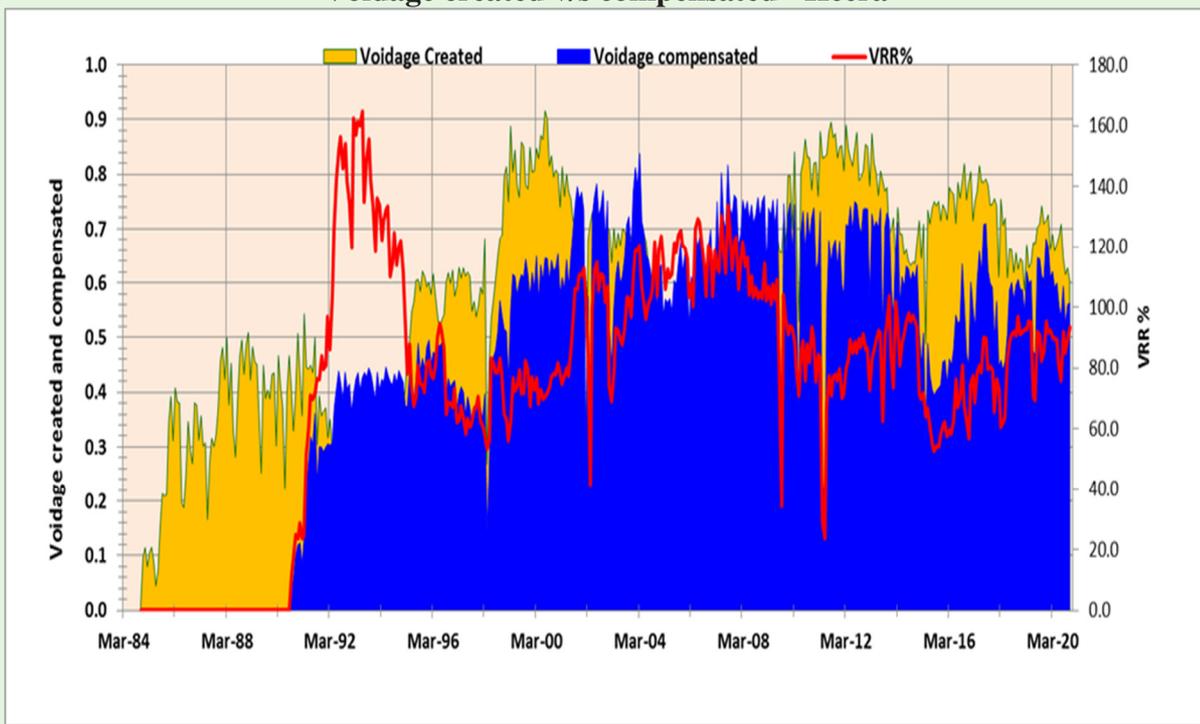
### Voidage created v/s compensated - Heera

VRR - Voidage Replacement Ratio
