**Report of the  
Comptroller and Auditor General of India  
for the year ended March 2021**

# **Derailment in Indian Railways**

**Union Government (Railways)**  
Performance Audit  
Report No. 22 of 2022

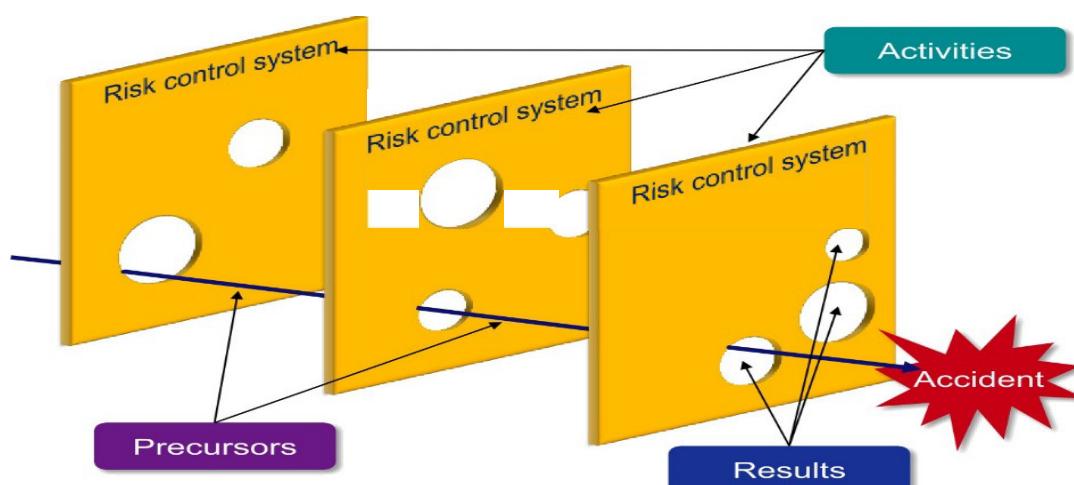
**Figure-1.0: Swiss cheese model of accident causation**

The ‘Swiss cheese model’<sup>1</sup> was used for analysis of causes of accidents. The model recognizes that accidents happen when the different level of preventive checks fail simultaneously. This is akin to the holes in a cheese. The slices of cheese represent the barriers or risk controls systems that are put in place. The holes in the cheese represent the weaknesses in those defences. Should the holes align (i.e. should failures occur simultaneously) an accident could occur. Figure 1.0 is a pictorial representation of this model.

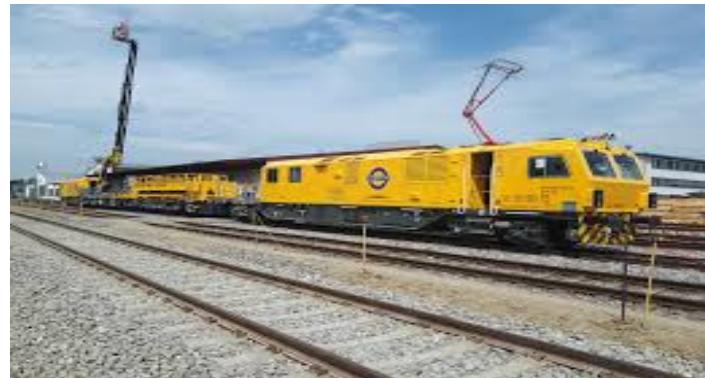
The track should be maintained either by mechanized maintenance system or by conventional system. The conventional maintenance system, normally deployed on tracks consisting of other than pre-stressed concrete sleepers, involves maintenance activities undertaken by sectional gangs. In mechanized track maintenance system, maintenance of track consisting of concrete sleepers is normally done by mechanized means.

The track structure has become sturdier and less amenable for manual maintenance due to continuous developments in various track components namely rails, sleepers, fastenings, points, crossings etc. This led to gradual proliferation of use of track machines for mechanized maintenance of track. Over the years, extent of mechanized maintenance gained importance for reliable track maintenance with high degree of precision and quality with minimum dependence on human factor.

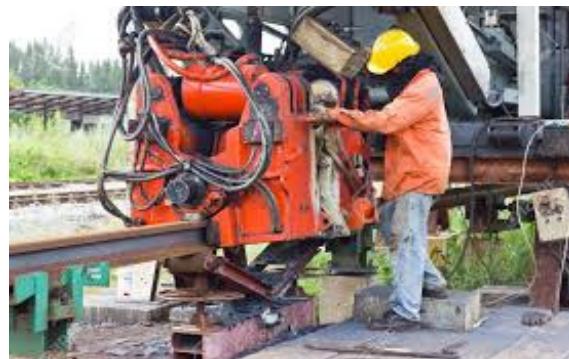
The rail joint is an important part of the track system. On IR, Alumino Thermit (AT) welding, and Flash Butt (FB) welding processes are used for welding of rail joints. The AT welding is used to repair or splice together existing continuous welded rail segments. This is a *manual* process, which uses molten iron to weld the gap between rails. The AT bonded joints are less reliable and more prone to fracture.

The preferred process of FB welding involves an automated track-laying machine running a strong electrical current through the touching ends of two un-joined pieces of rail to form a strong weld. The FB welding was being done on ZRs departmentally, using stationary FB welding Plants. Mobile FB welding Plants, capable of in-situ FB welding of rail joints, were also in operation on some of the ZRs.

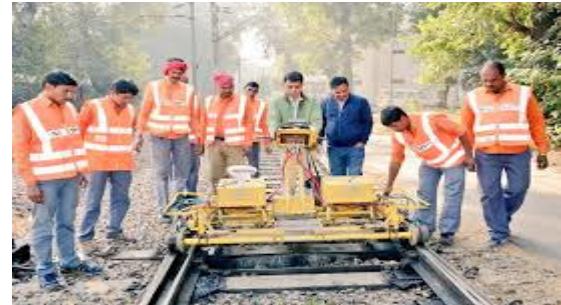
To ensure safety, the rails and welds were routinely tested by ultrasonic testing procedures at the prescribed frequency as per the ultrasonic flaw detection (USFD) manual. The testing of rails and welds using USFD machines has been prescribed in Para 302 (i) (d) of IR Permanent Way Manual (IRPWM). The Rail and weld testing is carried out by SSE (USFD) either departmentally or through contracts. The work of SSE is subject to supervision by Assistant Divisional Engineer and Sr. Divisional Engineer. As per IRPWM, the Assistant Engineer/Assistant Divisional Engineer is generally responsible for the maintenance and safety of P.Way<sup>15</sup> and works in his charge including USFD test check of welds<sup>16</sup>.

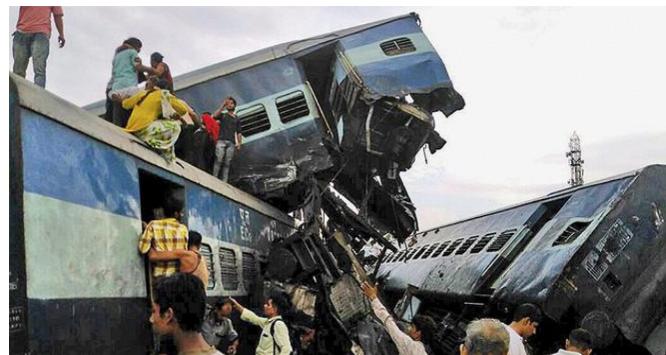
On 19 August 2017, the 18478 Puri-Haridwar Kalinga Utkal Express derailed in Khatauli near Muzaffarnagar, Uttar Pradesh

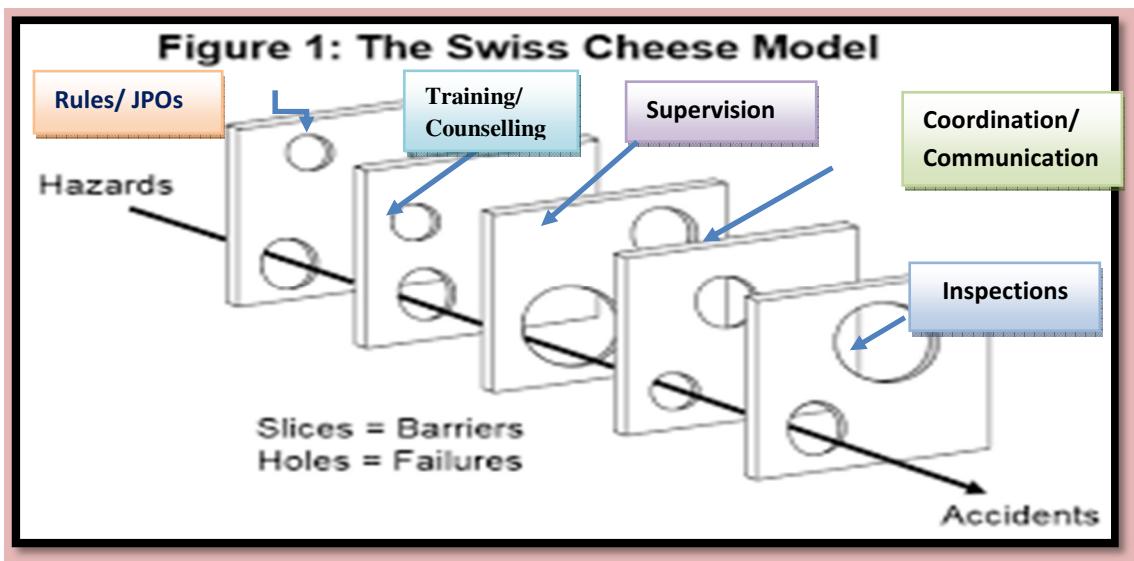
The causes of derailments on IR were analyzed in accordance with the ‘Swiss Cheese Model’. From the review of the derailment cases, the cascading factors of series of failures have been identified which includes (i) Rules and Joint Procedure Orders (JPOs), (ii) Training/Counselling of staff, (iii) Supervision of operations, (iv) Coordination and communication between staff of different departments and (v) Scheduled Inspections, in the IR System. These could be considered as the layers of ‘Swiss Cheese Slices’ or ‘defense barriers’ for prevention of accidents as depicted in figure below:

Based on the results of the accident investigations, several factors that lead to the derailments were obtained. These factors translated into ‘Swiss Cheese Model’ and a straight line was drawn to connect one factor of each layer to obtain a conclusion. From the above figure, it can be concluded that most of the derailments occurred due to simultaneous failures of each of the five barriers. Examples of individual cases of derailments occurred due to simultaneous failures of each of the five barriers depicted in the figure are shown in **table 3.4.1** below.

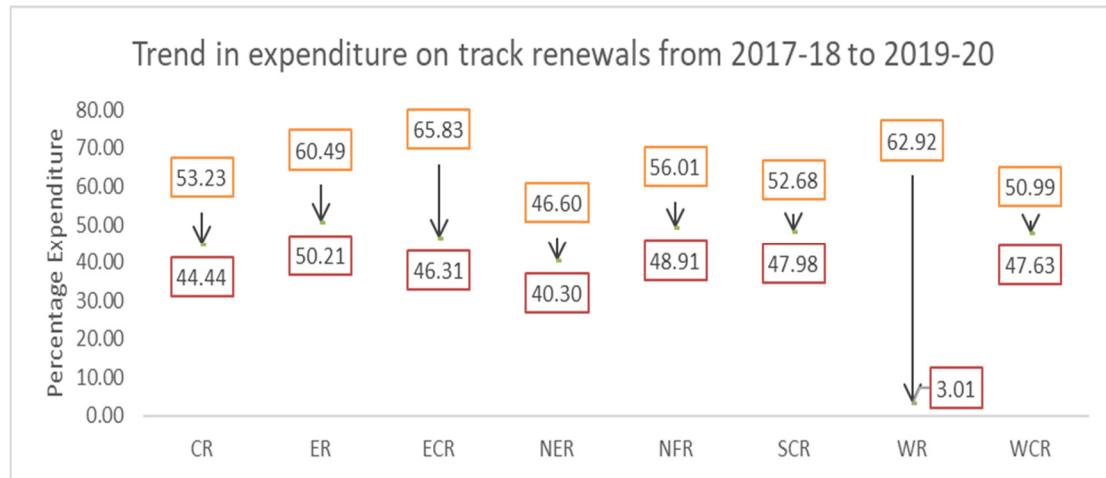
- In eight ZRs, the expenditure on track renewal works showed a *decreasing trend* from the year of introduction of RRSK as shown below:
