CHAPTER III

SEGREGATION, COLLECTION AND TRANSPORTATION OF WASTE

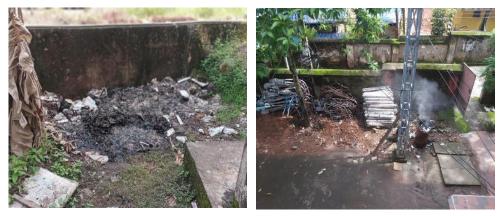
During joint physical verification (JPV) at Government offices and hospitals, Audit observed that separate bins were not allotted and all the waste were collected in single bins as mixed waste, making segregation difficult and time consuming. Instances of burning mixed waste were noticed in four Government offices⁴¹ and seven Government hospitals⁴² which would cause hazardous impact on human health and environment.

Burning of Mixed Waste at Cheruvannur CHC, Kozhikode Corporation (October 2021)

Open burning of plastic waste at Municipal office, Aluva (July 2021)

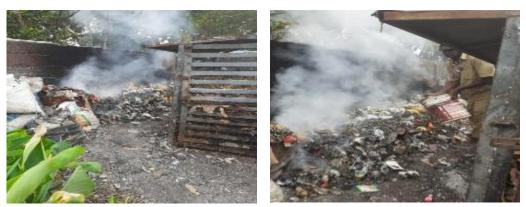
Burning of Waste by Thumboormuzhi workers in Thiruvananthapuram Corporation (August 2021)

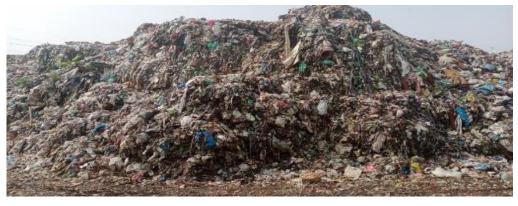
Kochi Corporation - Mixed waste dumped as rejects at the Brahmapuram processing site (November 2021)

As the ULBs could not ensure segregation of waste by waste generators, biodegradable waste mixed with non-biodegradable waste reached the processing site. Audit noticed that nine⁴⁴ out of 22 test-checked ULBs had centralised/community level facilities⁴⁵ for processing biodegradable waste. However, JPV conducted in these nine facilities revealed that only partial segregation was performed at four⁴⁶ sites. As such, recovery of recyclable items became difficult which also affected the quality of compost produced. For want of effective segregation at source, ULBs had to incur substantial amount for disposal of waste generated in their jurisdiction.

Four ULBs⁴⁷ disposed 1313.21 tonnes of mixed waste as rejects during 2020-21 through Clean Kerala Company Ltd. (CKCL) to KEIL for land filling, thereby committing payment of ₹156.14 lakh. Thiruvananthapuram Corporation as part of converting dumping yard at Erumakkuzhi into a garden, transferred (October 2020) 62.61 tonnes of unsegregated waste to KEIL. As per SWM Rules, 2016, only the non-usable, non-recyclable, non-biodegradable, non-combustible and non-reactive inert waste and pre-processing rejects and residues from waste processing facilities were to be sent to sanitary landfill. Audit observed that ULBs/CKCL violated these Rules by sending unsegregated waste to landfill.

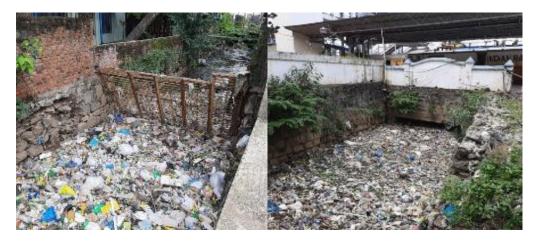
Littering/dumping of waste in water bodies

places⁵², road sides⁵³, water bodies⁵⁴, etc. as evident from photographs presented below.

Aamayizhanjan thodu near KSRTC Central bus stand, Thiruvananthapuram Corporation (July 2021)

Killi River, Thiruvananthapuram Corporation (August 2021)
