REPORT OF THE COMPTROLLER AND AUDITOR GENERAL OF INDIA

PERFORMANCE AUDIT OF MANAGEMENT OF STORM WATER IN BENGALURU URBAN AREA

GOVERNMENT OF KARNATAKA
REPORT NO. 2 OF THE YEAR 2021

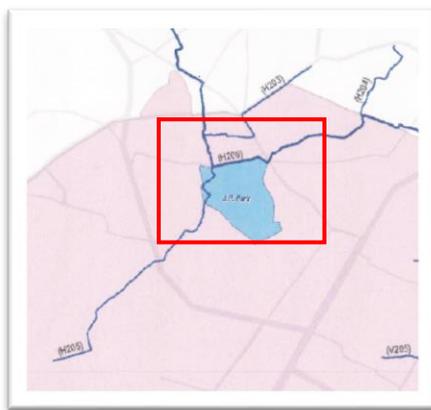
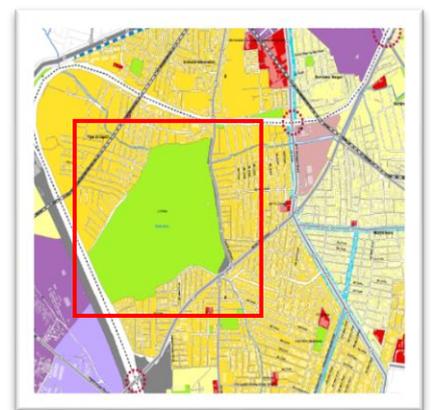
Shown as a water body

Shown as a park

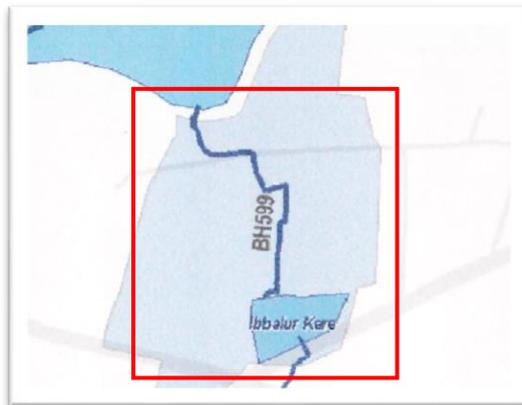
SWD shown between Bellandur and Ibbalur tanks

No connectivity between two tanks

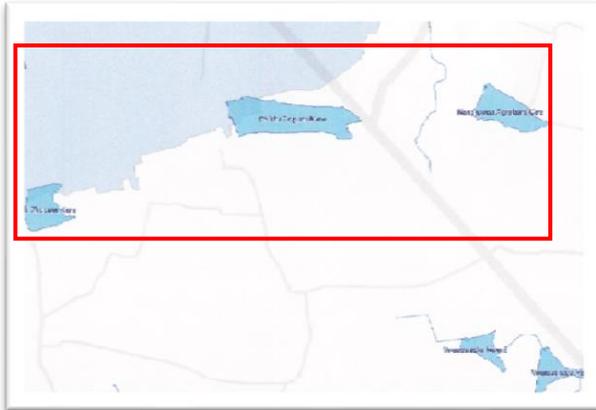
Water bodies shown around Thoguru village

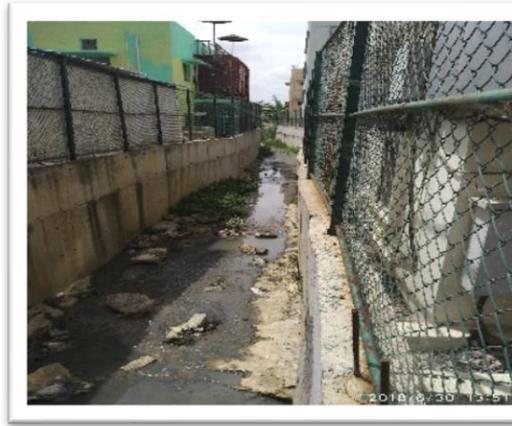
Bommanahalli Zone

Absence of buffer zone

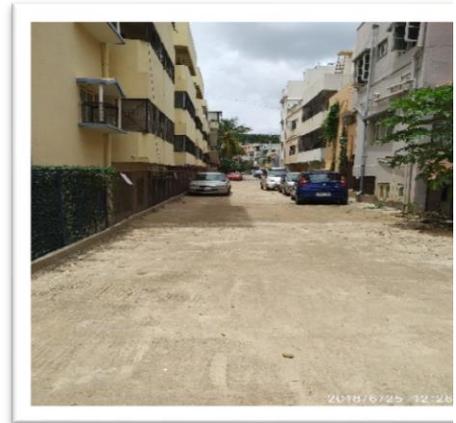
South Zone (Covered Drain)

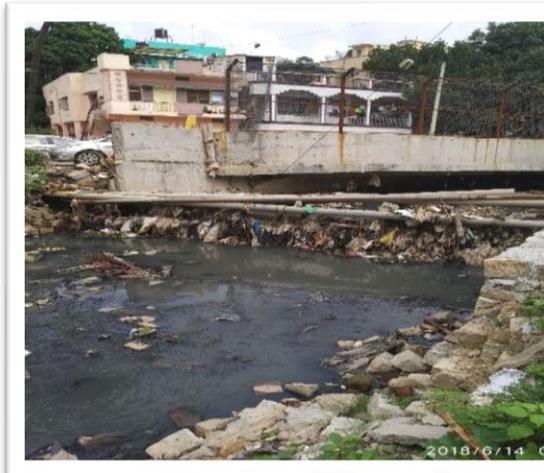
Koramangala Zone

Utility lines blocking flow

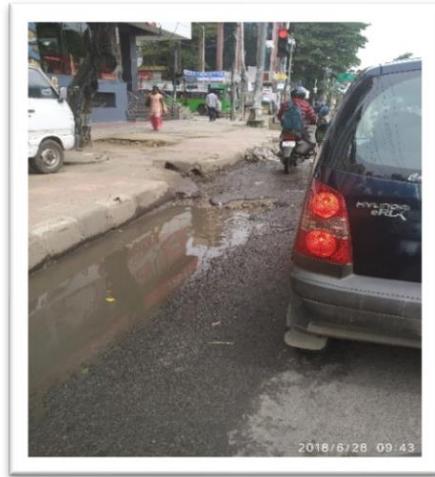
Koramangala zone

Exhibit 4.8: Photographs showing unscientific construction of roads/drains – absence of proper gradient/alignment

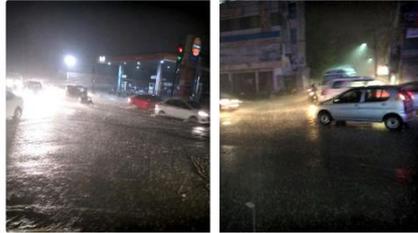
Due to heavy rain, water logging at Bannerghatta main road, between Bangalore Dairy toward Bilekahalli junction, slow moving traffic our staff regulating traffic.

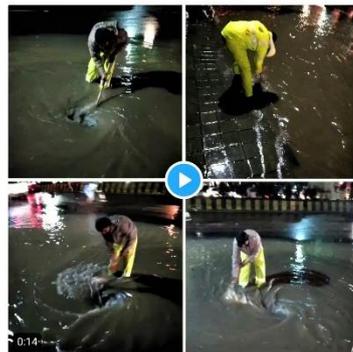
Ashoka nagara personnel getting into drains to ease free flow of traffic at Mayo hall junction

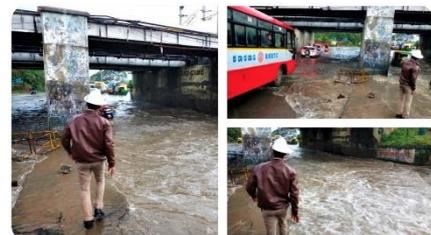
waterlogging at ph underbridge slow moving traffic [@blrcitytraffic](#)
[@AddICPTraffic](#) [@DCPTrWestBCP](#)
[@BBMPCOMM](#)

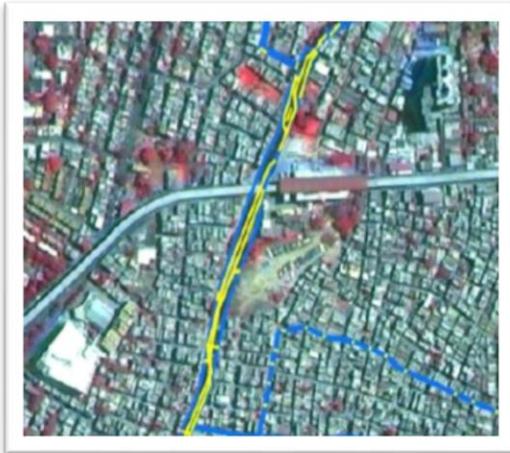
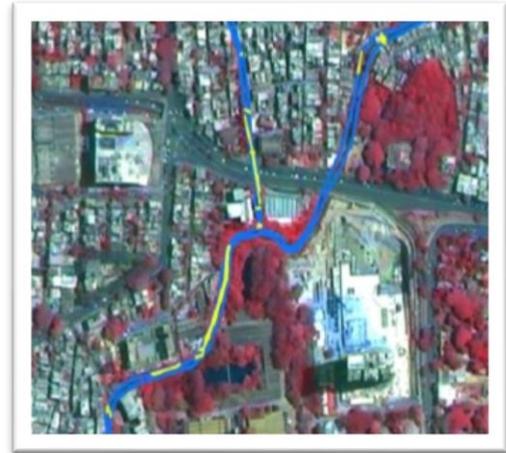
Overlap of sewer line (yellow colour) and drain (blue colour)

Audit also observed that sewerage lines were laid inside the SWDs and large quantity of sewage was invariably let into SWDs in complete disregard of the codal provisions. Out of 1,440 MLD of sewage generated in BBMP areas, about 780 MLD (54 per cent) was discharged into SWDs/water bodies without treatment. BWSSB, which is responsible for sewage disposal within the jurisdiction of BBMP area currently operates 27 Sewage Treatment Plants (STPs) with an operational capacity of 1,073 MLD. The utilisation efficiency was only 60 per cent with 644 MLD of total sewage reaching these STPs. Works in respect of 11 STPs with an operational capacity of 520 MLD were in progress as at the end of March 2021. Further, though 110 villages were made part of the BBMP area in 2007, BWSSB was yet to provide sanitation facilities to these villages.

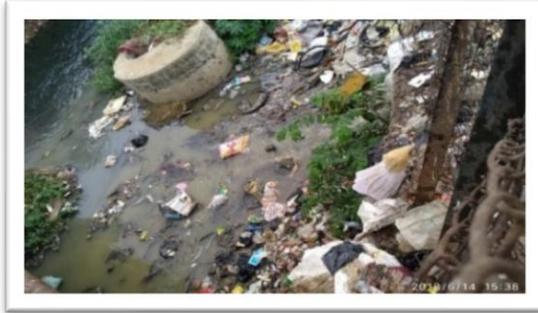
Sewage Mixing

Sewage flowing in SWD at Ejipura, Koramangala Zone

***Recommendation 3:** BBMP and BWSSB should jointly prepare a plan of action to prevent sewage flow into SWDs within a definite time schedule and the implementation thereof should be monitored by the State Government.*

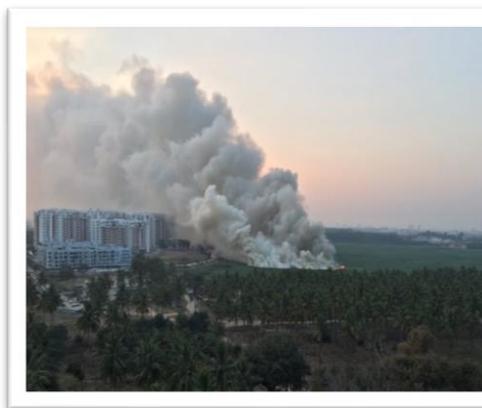
Exhibit 5.3: Photos showing lakes in Bengaluru affected by pollutants

Fuming Bellandur Lake

Recommendation 16: *BBMP should accord high priority to prevent discharge of sewage into SWDs. There is a need to prepare and execute (i) medium term strategy for complete cessation of sewage contamination of storm water and lakes eventually and (ii) a short-term strategy for installation of sewage treatment plants in coordination with BWSSB to prevent contamination of water bodies.*

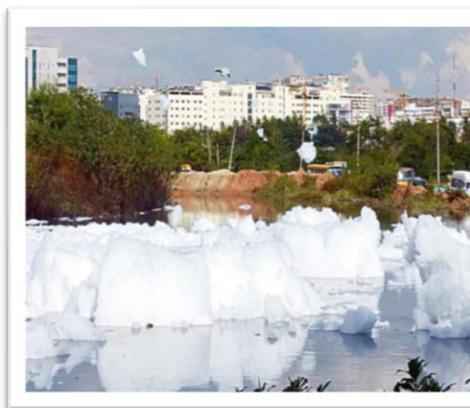
Frothing Yamaluru Lake

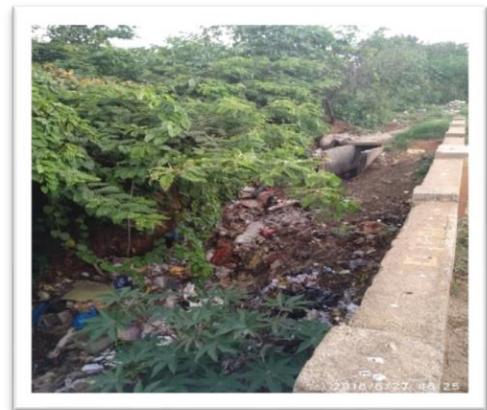
Pattanagere, Rajarajeshwarinagar Zone

The details of periodical inspection of drains by field engineers carried out if any, were not made available to audit for scrutiny. During the joint inspections, audit observed severe blockages of surface drains as well as SWDs (**Exhibit 5.8**) indicating either that inspection was not carried out by the field engineers or that no action was taken on the report of the field engineers.

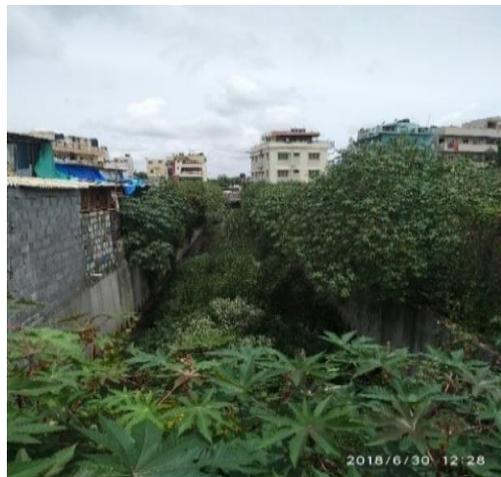
Audit observed during joint inspections of drains that SWDs were filled with debris, vegetation and were heavily silted indicating absence of regular maintenance of drains (**Exhibit 5.9**).

Vegetation inside SWD Akshaya Nagar, Bommanahalli Zone

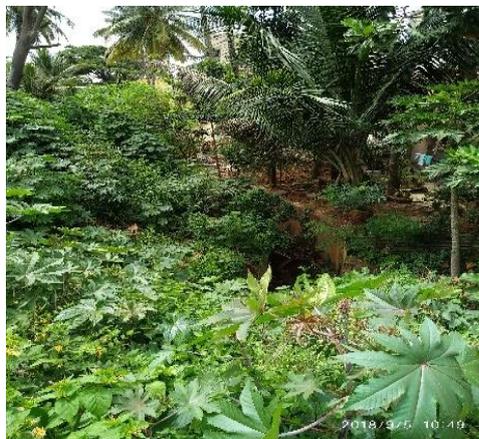
Vegetation inside SWD at Vyalikaval, West Zone

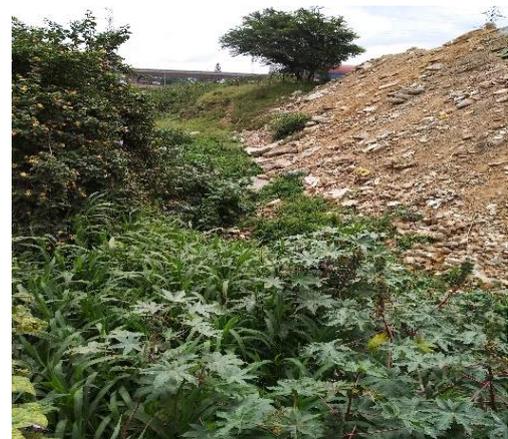
Vegetation inside SWD at Peenya, Rajarajeshwarinagar Zone
